## PMI/M KM 2017 ART Lifeboat 5Y PM

During 25<sup>th</sup> April – 25<sup>th</sup> May 2017

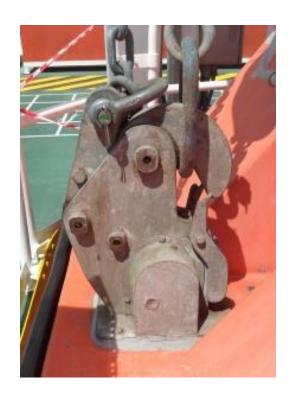
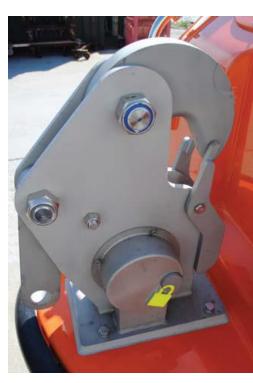
Upgrade both FWD & AFT Hooks

#### **New TOR MK2 features:**

- Double lock system
- Compliant to the new regulations MSC 320/321
- Non-corrosive material Duplex stainless steel
- Not sensitive to wear and tear
- Prevention against premature release
- PADLOCK for visualization of open and closed hook

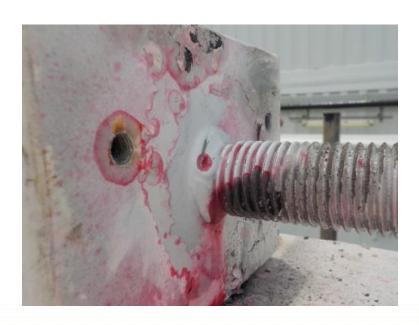
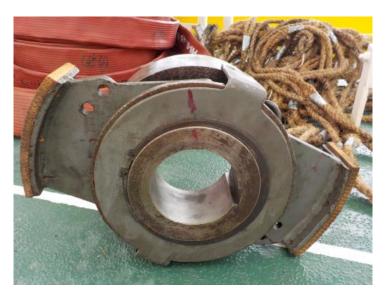
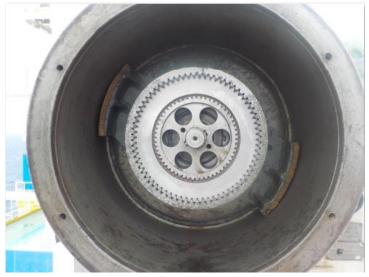
- Replace wire rope
- Replace band brake and clutch
- Replace winch foundation
- Replace oil seals and bearing
- Replace adjustable sheave of davit no.2

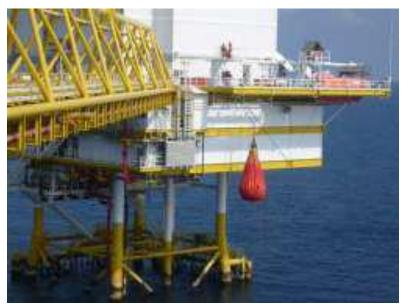
Lower 2-fall sling to secure with spreader beam on <a href="mailto:supply boat">supply boat</a> deck

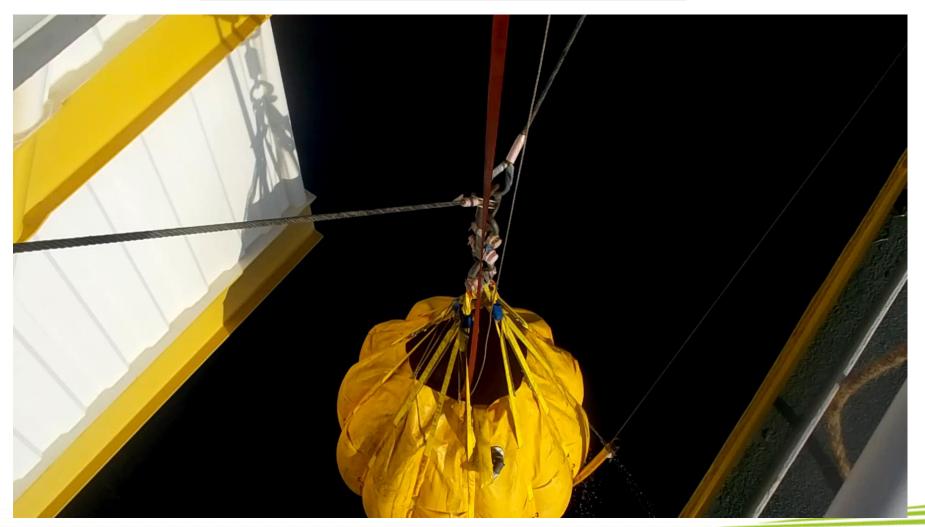
Lower test load and break for 3 times

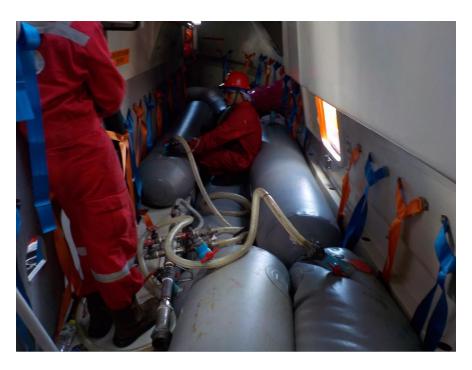
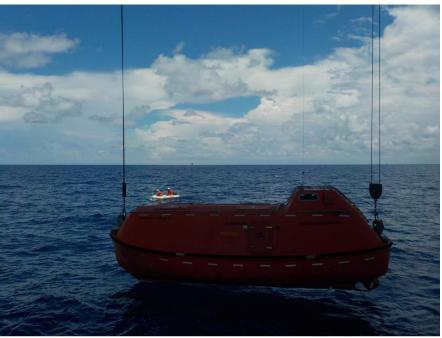
Suspend boat loaded with pillow bags at 1.1SWL

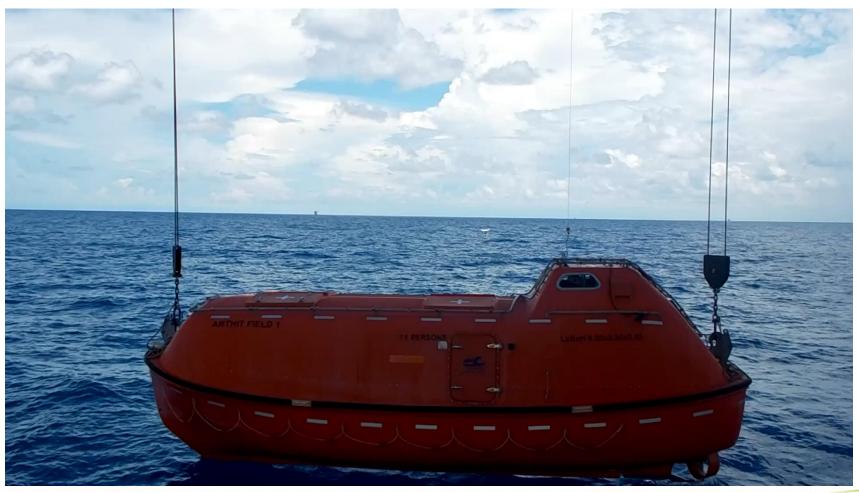
Suspend boat loaded with pillow bags at 1.1SWL

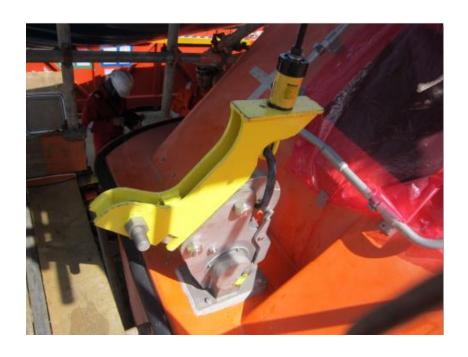
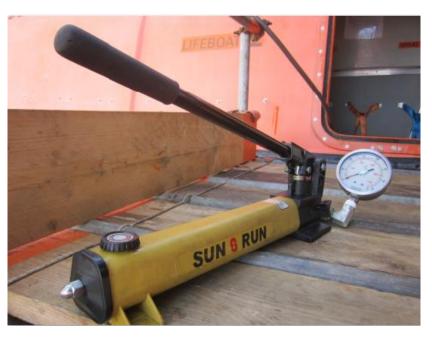
• Using hydraulic test kit at 355 Bar

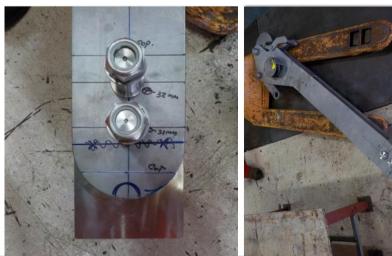
New FWD hook is too short to install
 => need extension bar

New AFT hook is too long=> trim out

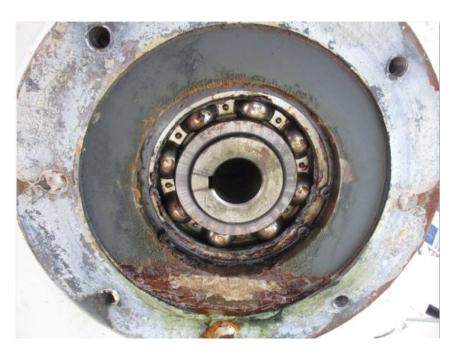
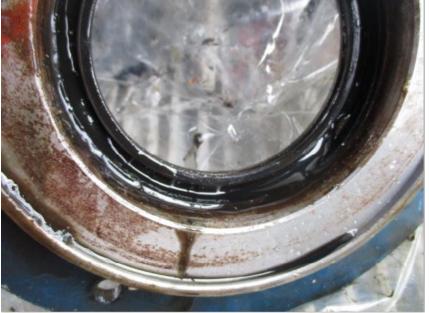
Winch bearing and oil seals replacement are not included in work scope
 => order new from SKL

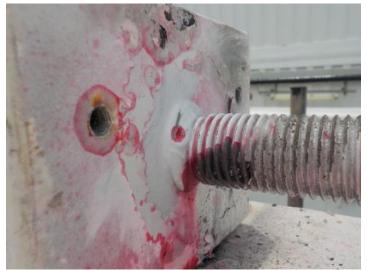
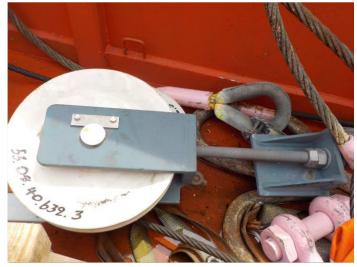
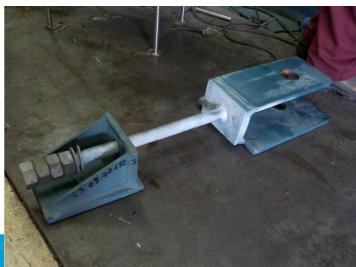
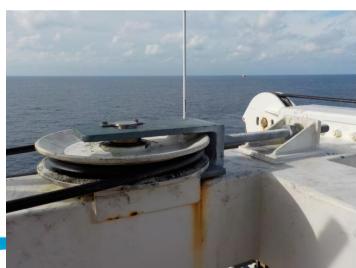
Found crack at welding of adjustable sheave of lifeboat no.2 after performed dynamic load test

New adjustable sheave => welding => prove welding by dynamic load test and confirm no crack by MT

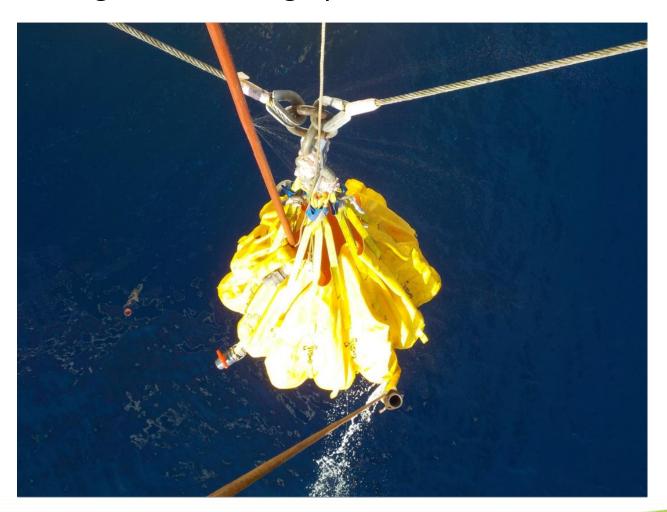
Water bag broken during dynamic load test at winch no.1
