Repair of Foundation Tanks Report

Storage Tanks

TOCGC (EA Unit)

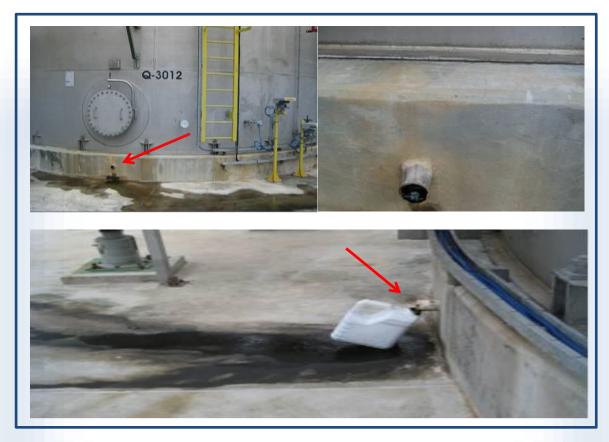
According to EA plant have storage tank about 18 units. The past time foundation of tank had the unknown water flow through into sleeve pipe bottom foundation tank (Fig.1). Operation department collect this water and sent to Laboratory department for examination. The result of water was rain of water. So that EA team tried to find out cause from the history of construction for foundation concrete tank (Fig.2) which they found that the root cause of water occurred raining of water and then water was move through into cracking concrete foundation (Fig.3), Asphalt, Sand and throughout sleeve pipe. Therefore the aim of this work was protect water to foundation of storage tanks.

Fig.1 Photographs illustrating the water flow into sleeve pipe (water is indicated by red arrow)

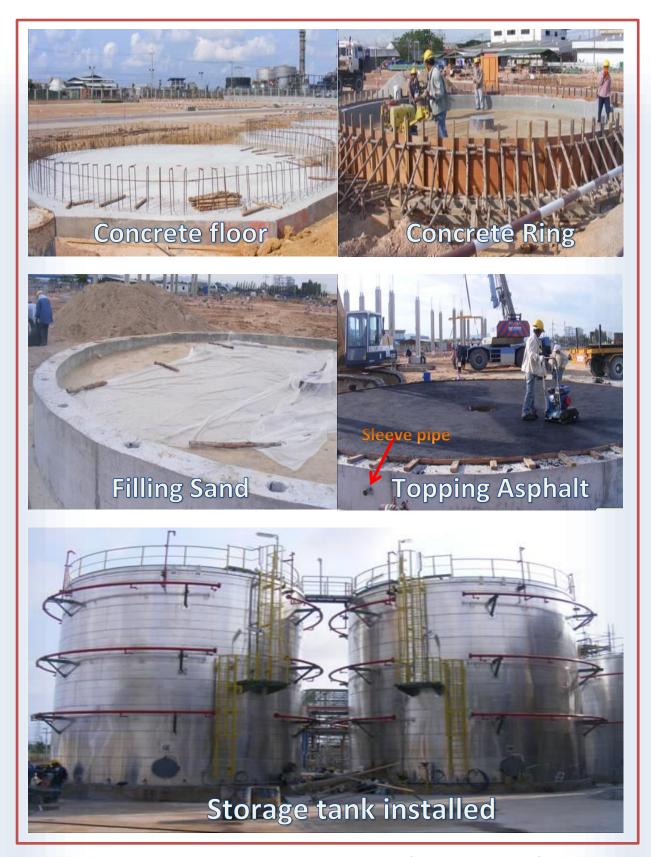
Fig.2 Photographs illustrating the History of construction for foundation concrete tank.

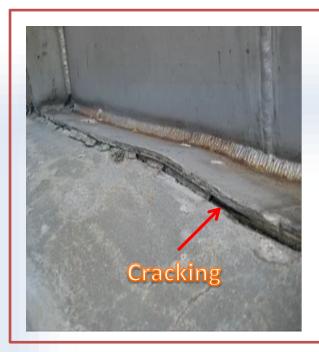
Fig.3 Photographs illustrating the cracking about bottom plate of tank with foundation concrete tank.

Concept of repair: Chisel foundation of concrete and clean and pouring new concrete grouting and then seal joint sealant, fibre mesh and the last step is painting LANKO 451 which can show to work method statement as below:
