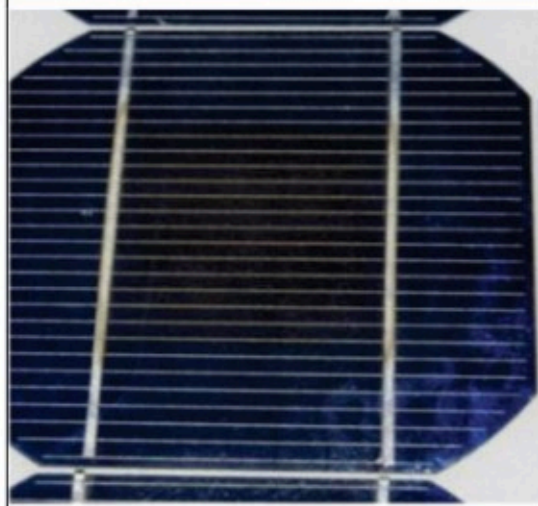
Slightly browned EVA in the centre of the cell with photobleaching at the edges [Köntges14].

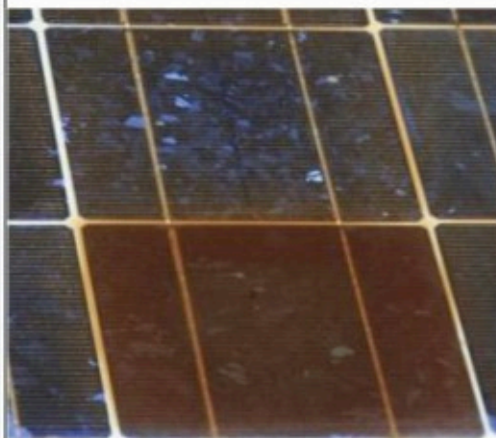
Single cell browned much faster than the others due to local heating [Köntges14].

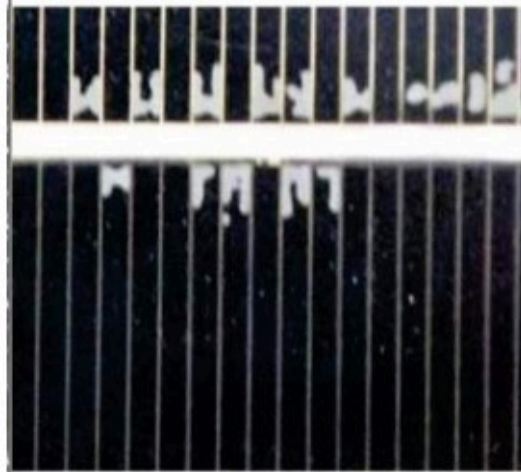
Encapsulant delamination from cell along grid fingers and bus bar [Packard12].

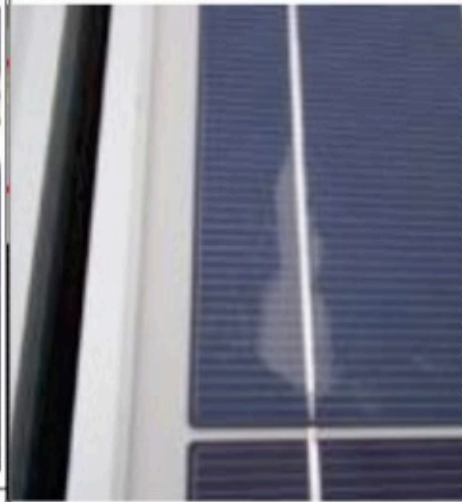
Encapsulant delamination along a bus-bar in a cell close to the module edge [Moser17].
