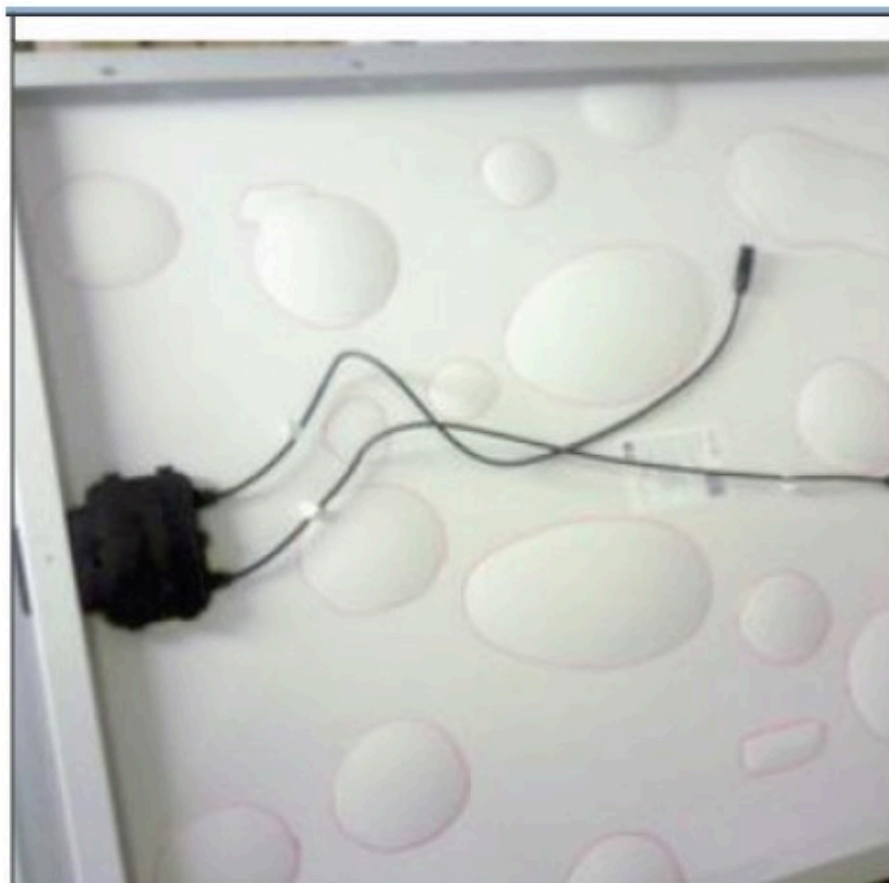
Multiple bubbles in the centre and edge of the backsheet [Köntges16].

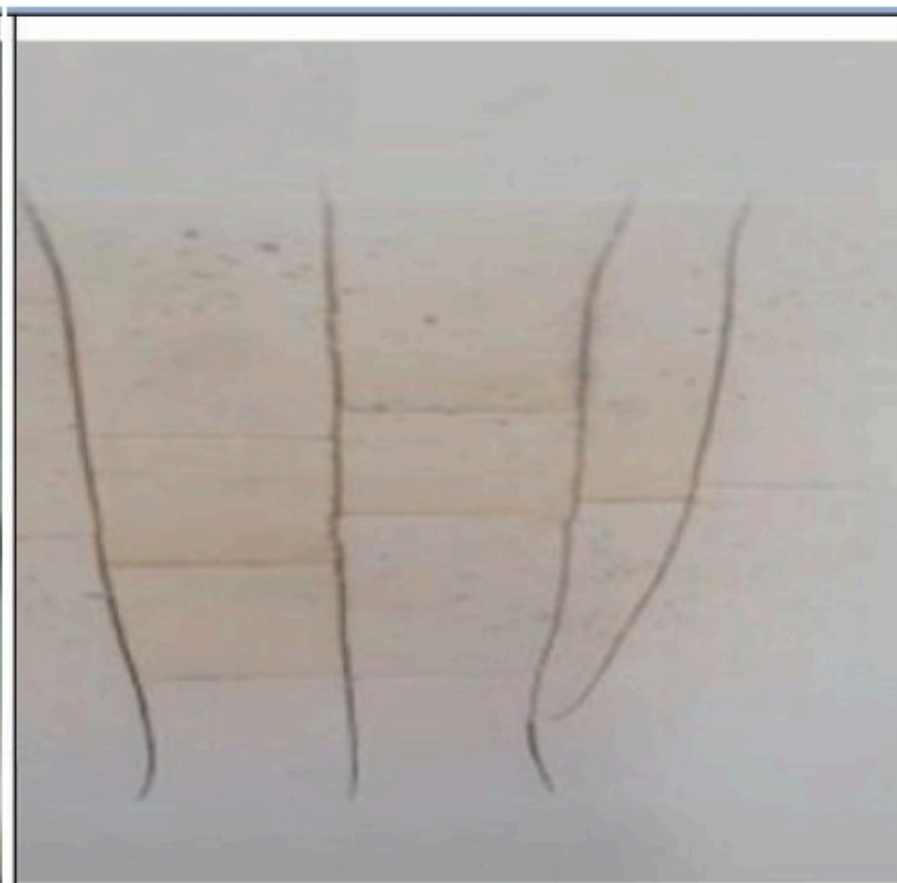
Cracked backsheet in combination with yellowing under a hot cell [Eder19].

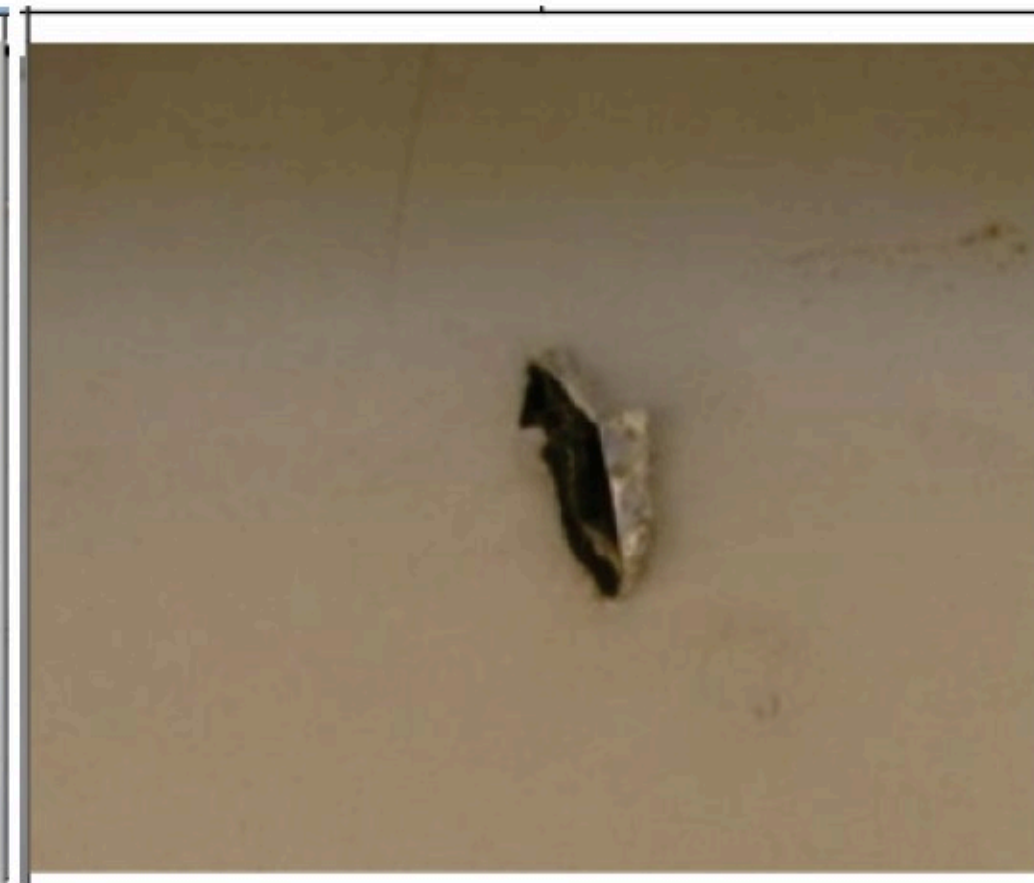
Deep scratch on backsheet [By the courtesy of TUV Rheinland].

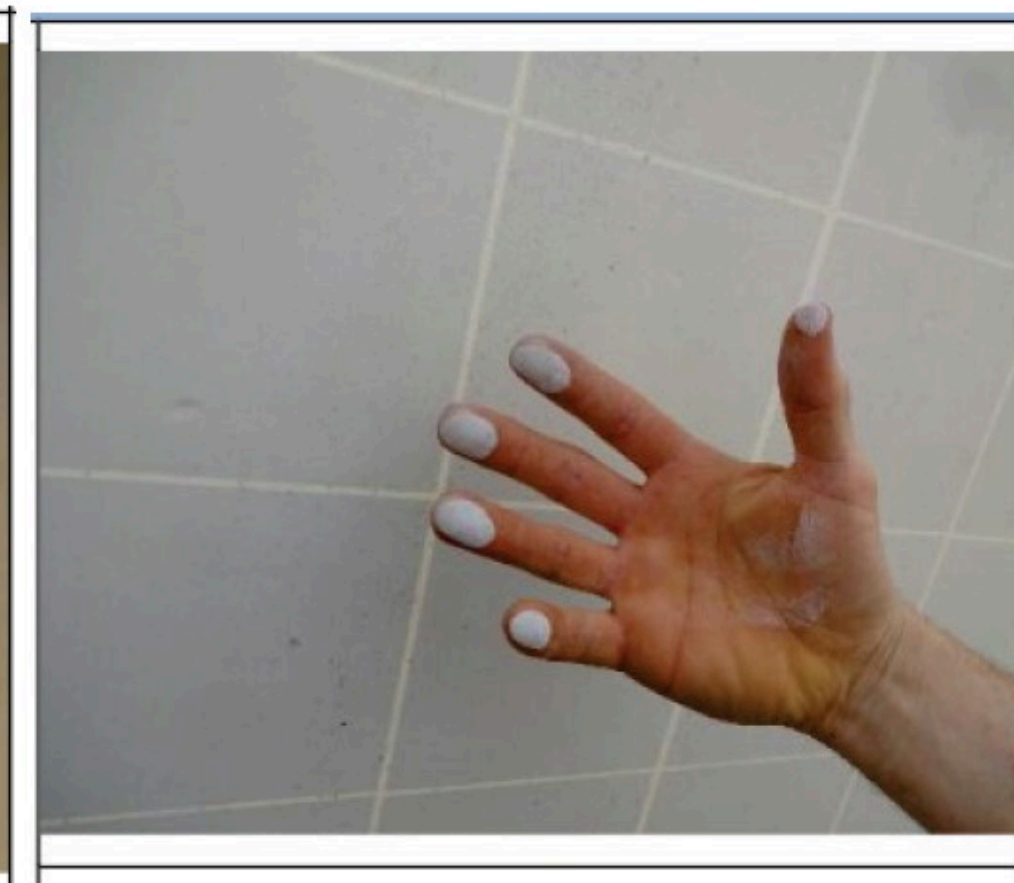
Finger with white powder [By the courtesy of TUV Rheinland].
