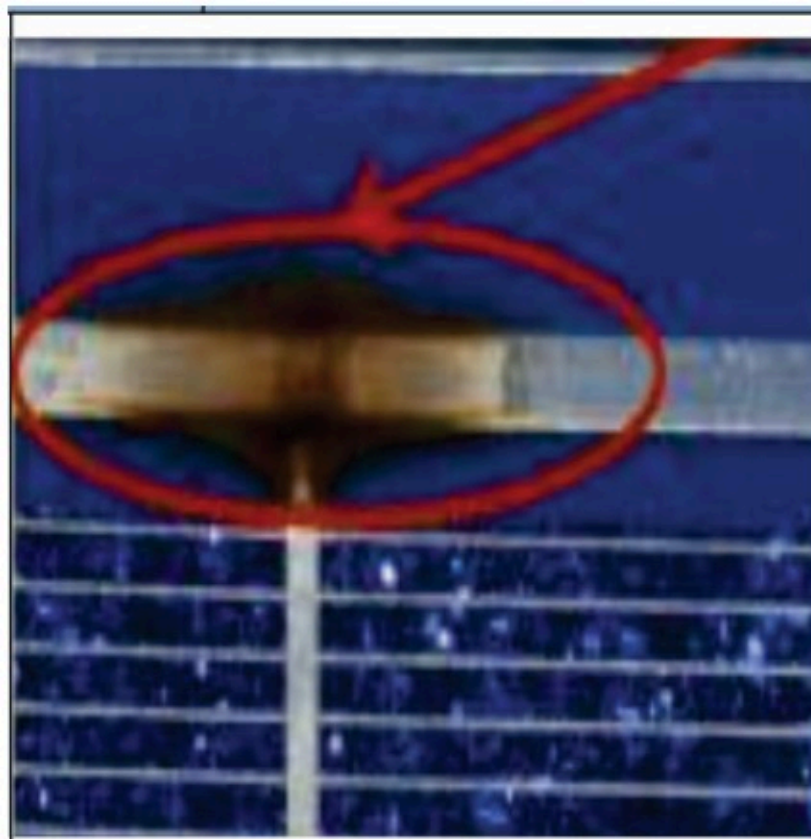
Burn mark associated with overheating along the metallic interconnection (without back-sheet damage) [Köntges14].

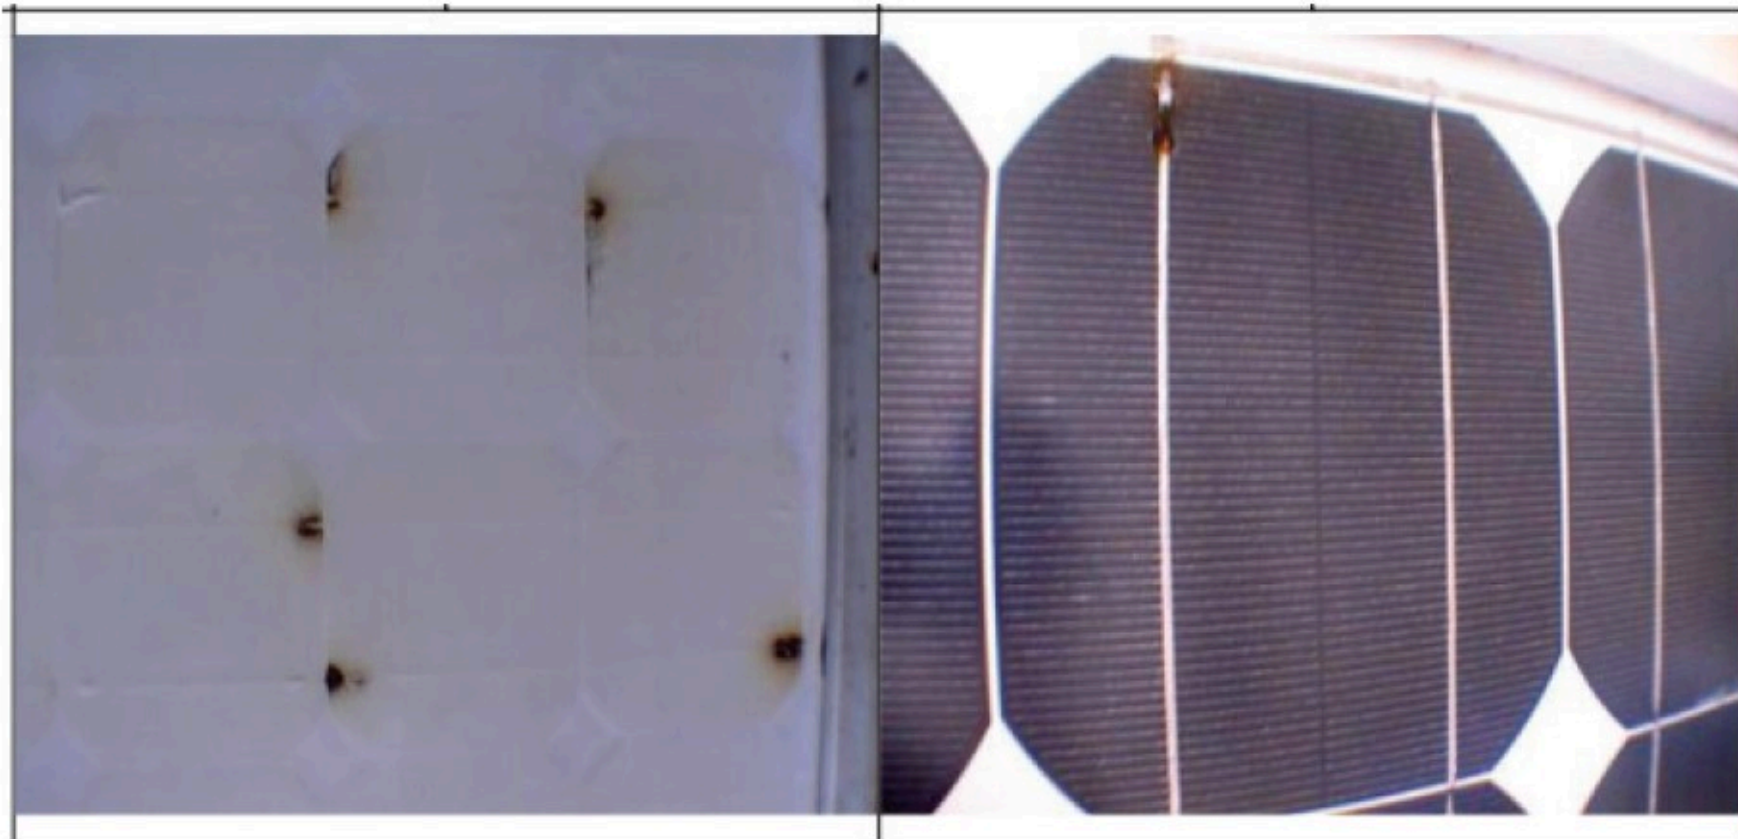
Front and back side view of burn marks caused by open-circuited bypass diodes and current mismatch conditions (due to shading or cracked cells) [Köntges14].
