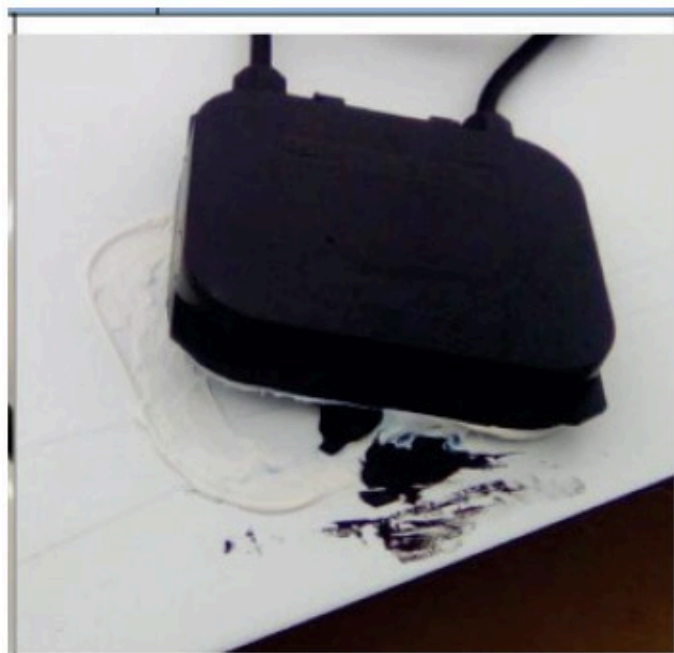
Detached junction box from backsheet [By the courtesy of SUPSI PVLab].

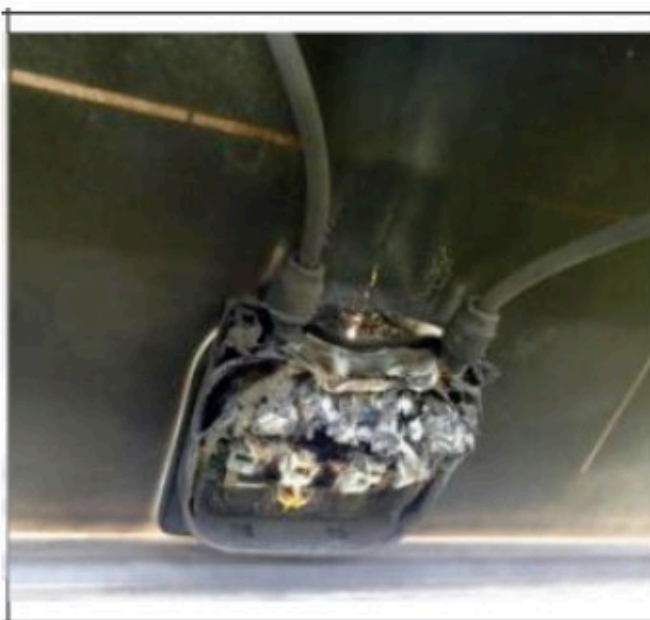
Burned junction box caused by corroded contacts within the junction box [By the courtesy of TUV Rheinland].

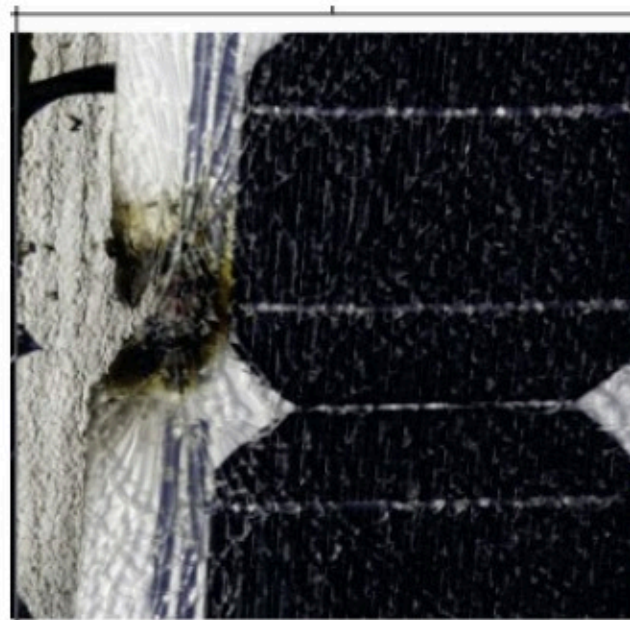
Overheating due to the poor Jbox interconnect leading to burn mark and glass breakage [Yang19].

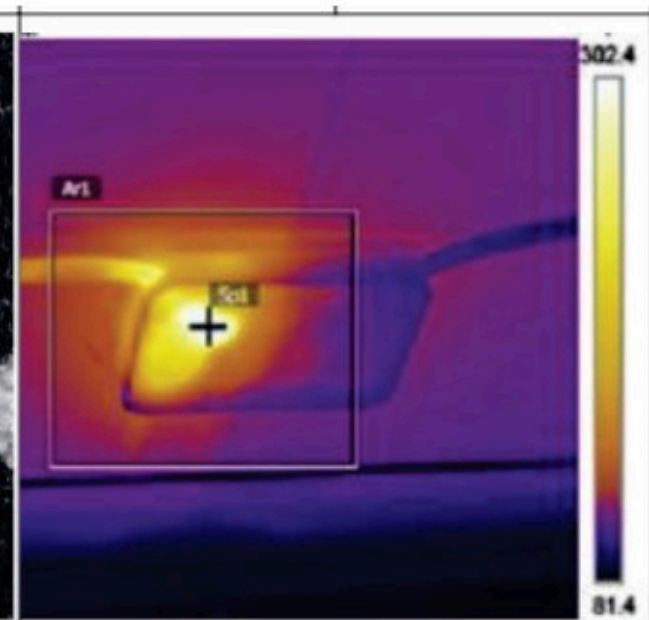
IR imaging of a hotspot Jbox due to loose electric connection inside [Yang19].
