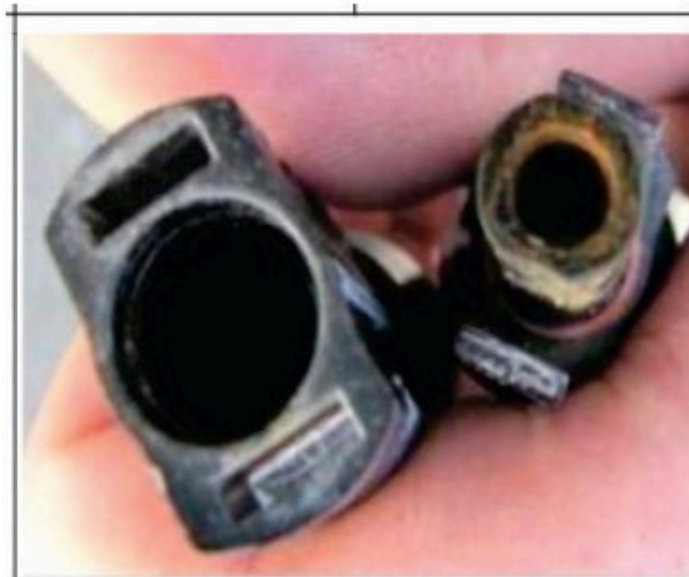
Corroded connector due to cross-mating [By the courtesy of Stäubli].

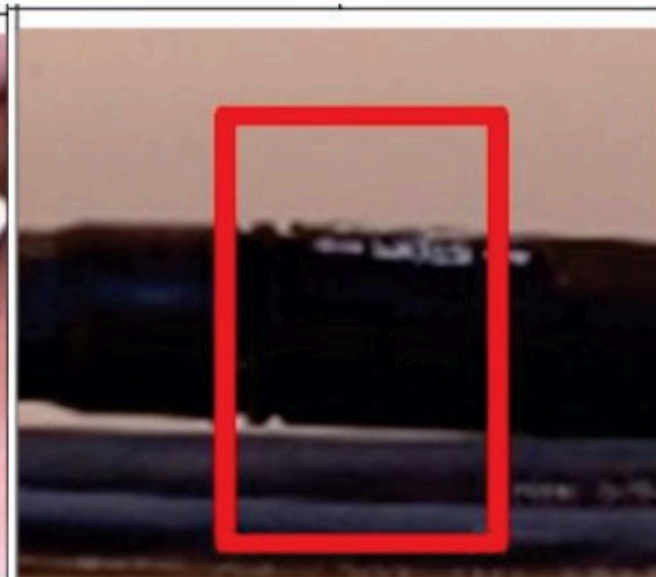
Not fully inserted or interlocked connector [Yang19].

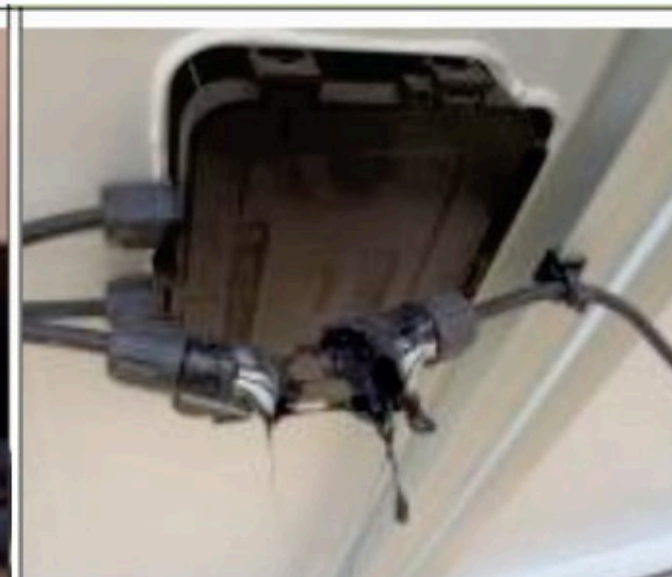
Burned connector [Köntges17].

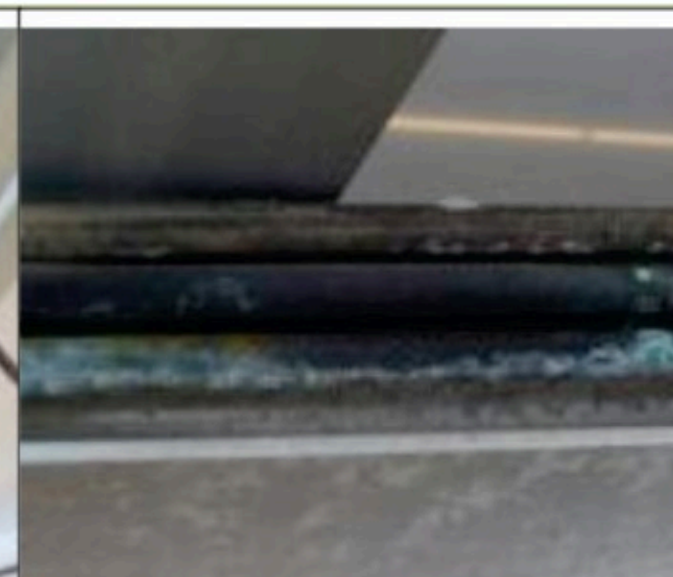
Corroded Cable [Köntges17].

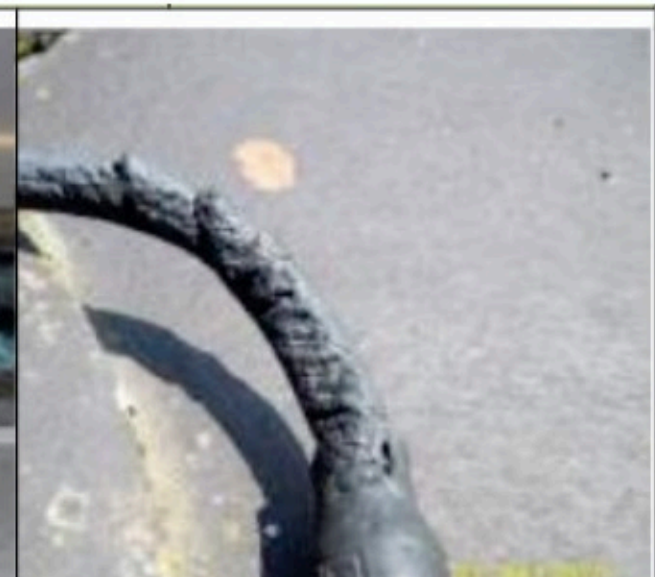
Animal bite on cable [Köntges17].
