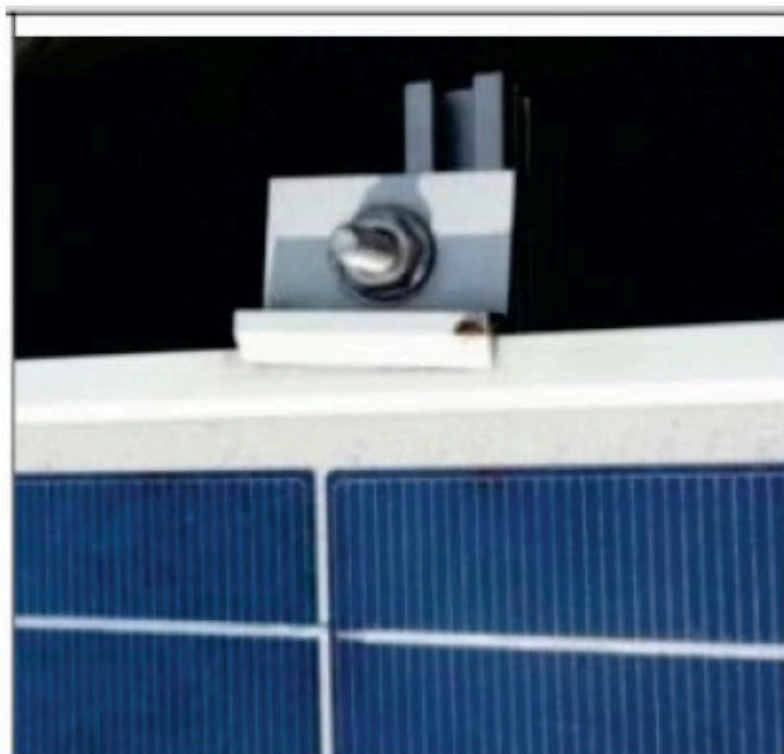
Improper installation of clamp [By courtesy of SUPSI PVLab].

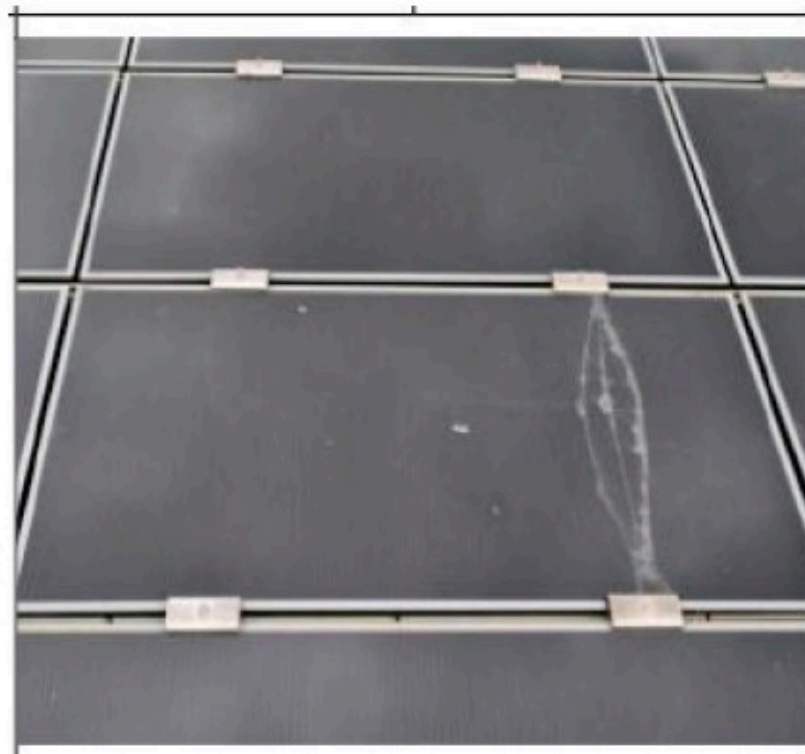
Glass breakage caused by poor clamp design [Moser17]. (see also PVFS 1-8)

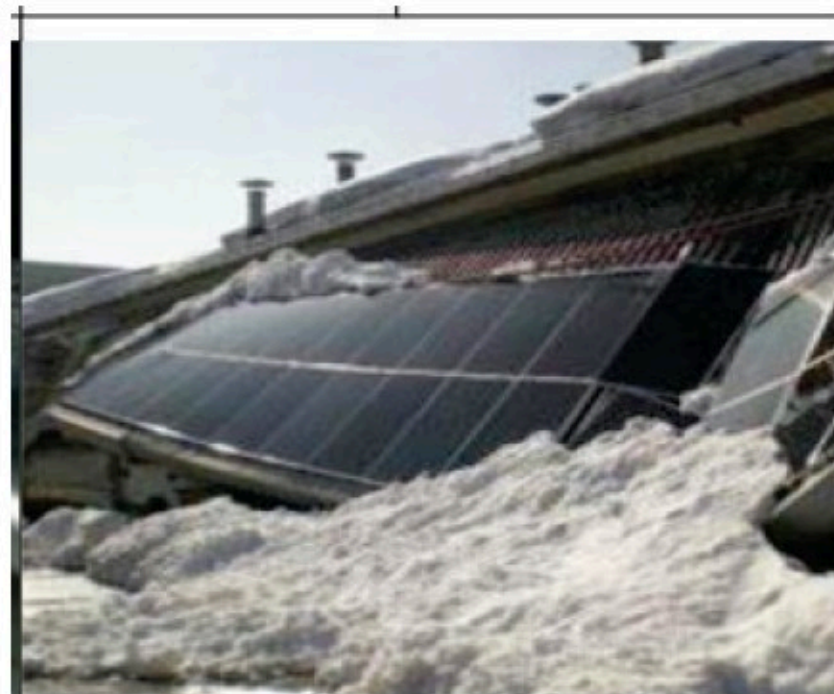
Undersized mounting structure for local snow load conditions [Köntges16].

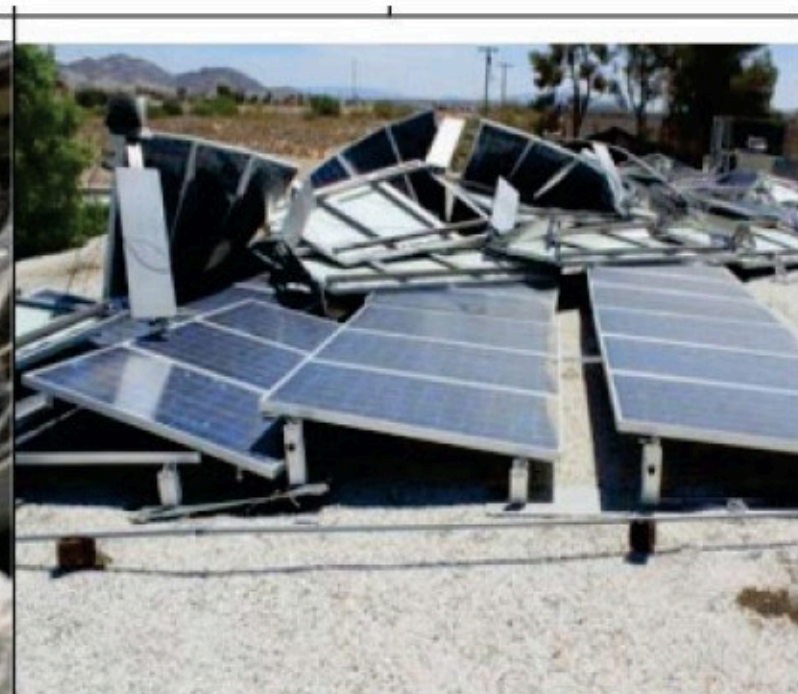
Undersized mounting structure for local wind conditions [India13].
