# AMT Encoder Mounting Troubleshooting Guide

Applicable series: AMT11, AMT11A, AMT20, AMT21, AMT22, AMT23, AMT31

## DAMAGE TO ENCODER PCB DUE TO IMPROPER MOUNTING

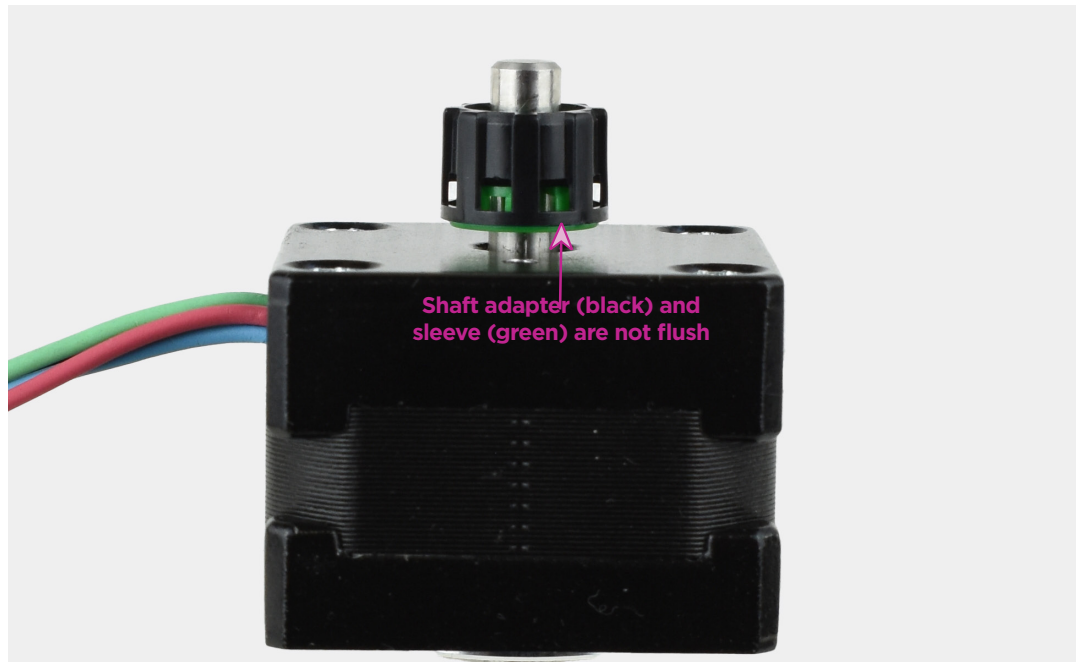
**Figure 4**

Improperly mounted shaft adapter and sleeve. The green shaft sleeve and black shaft adapter should be completely flush when properly mounted.

When mounting the shaft sleeve and shaft adapter, ensure that Tool A is utilized as a spacer that defines the proper distance to the mounting surface. Next, use Tool C to press the shaft adapter over the sleeve until the shaft adapter is completely flush with Tool A.

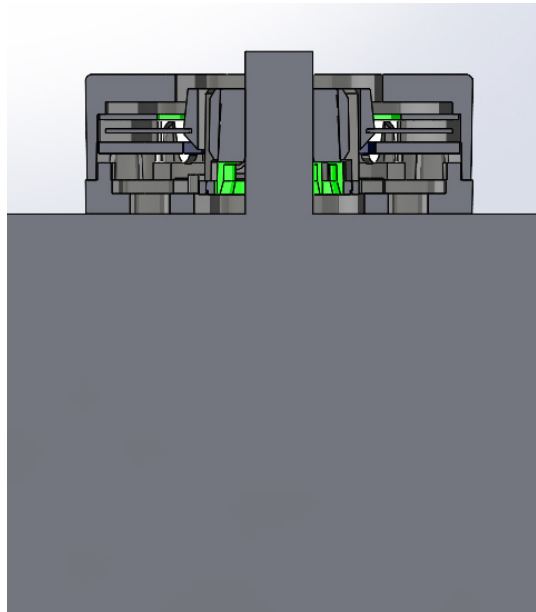
**Figure 10**

Properly installed encoder with internal rotor and shaft adapter now flush and properly seated within the encoder assembly. Once Tool C is used, the rotor PCB should be properly seated between the transmitter and receiver PCBs. The image on the right further shows the proper air gap and that there should be no physical contact within the encoder.
