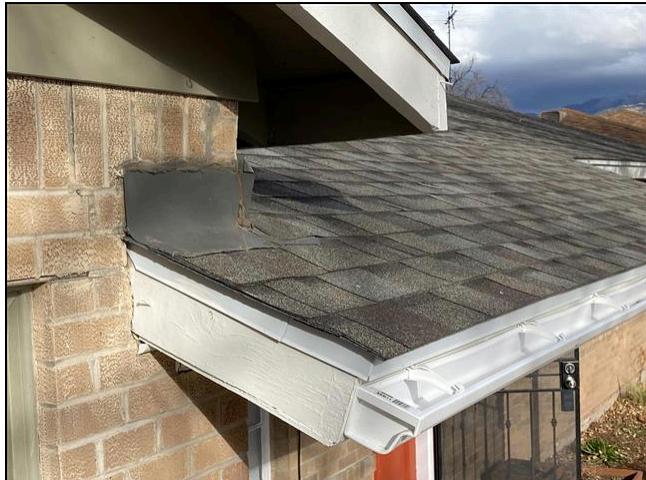
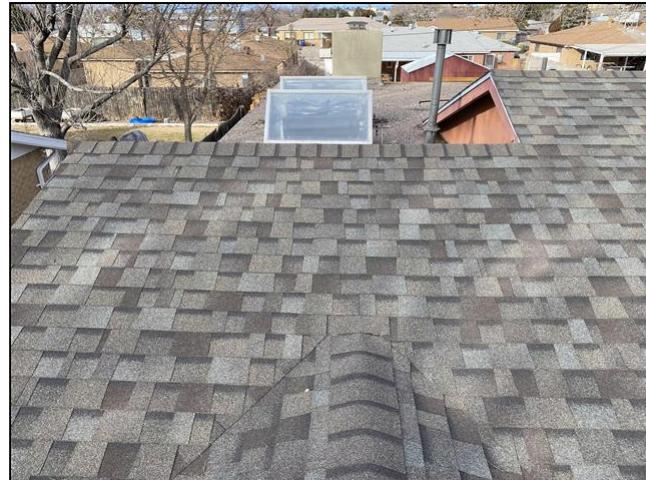
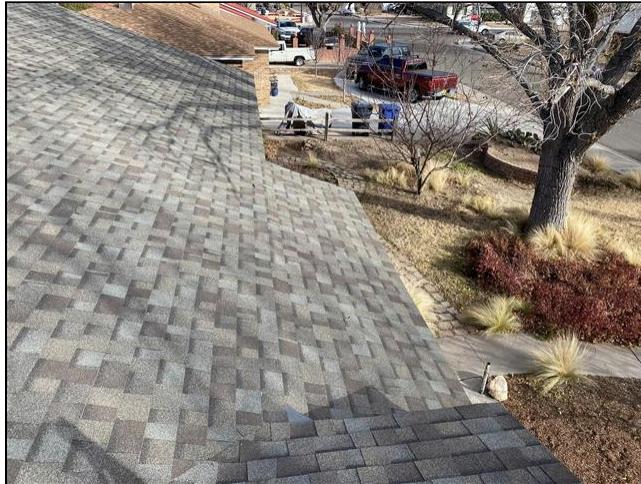
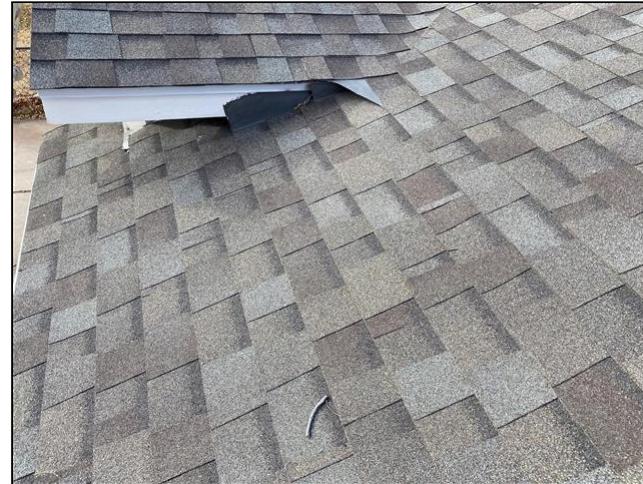
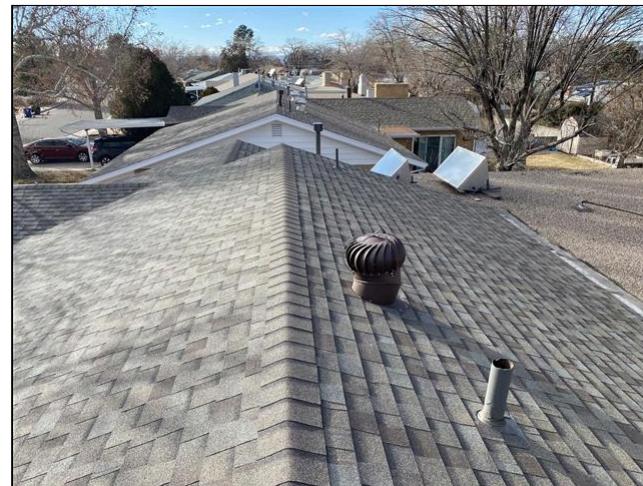
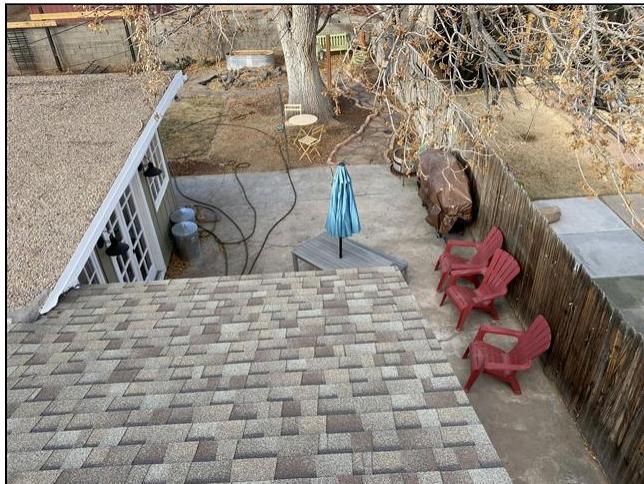
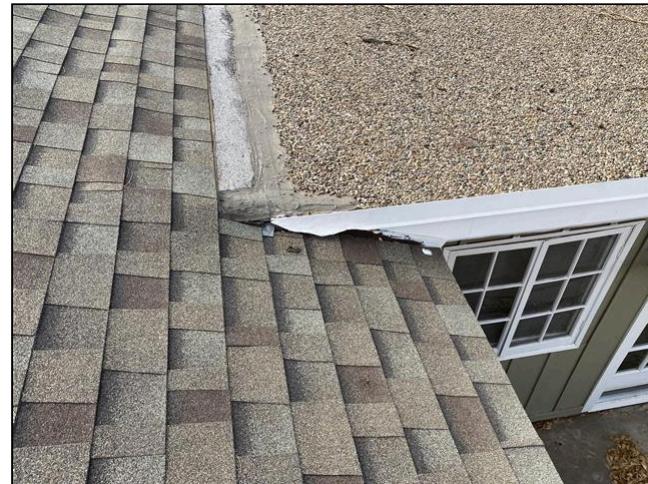
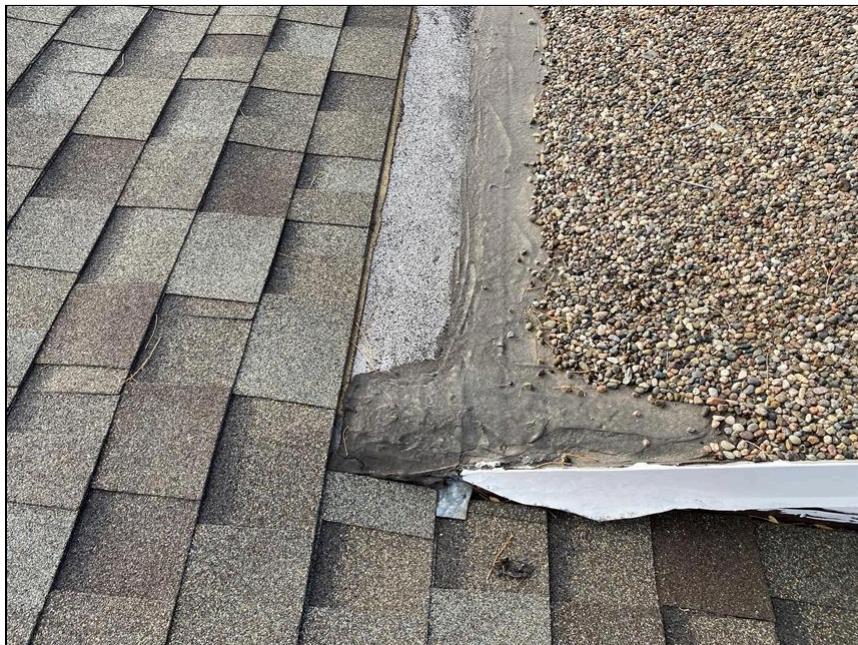
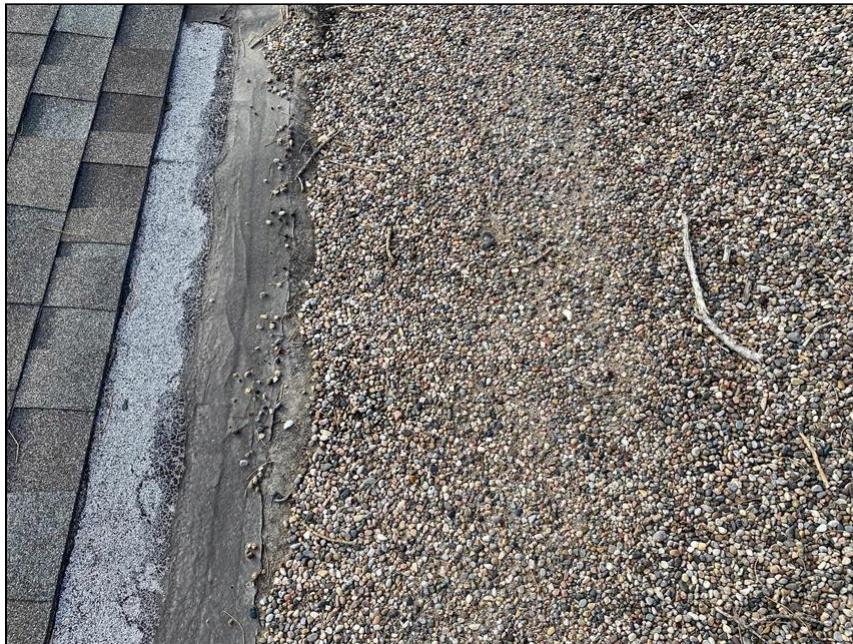
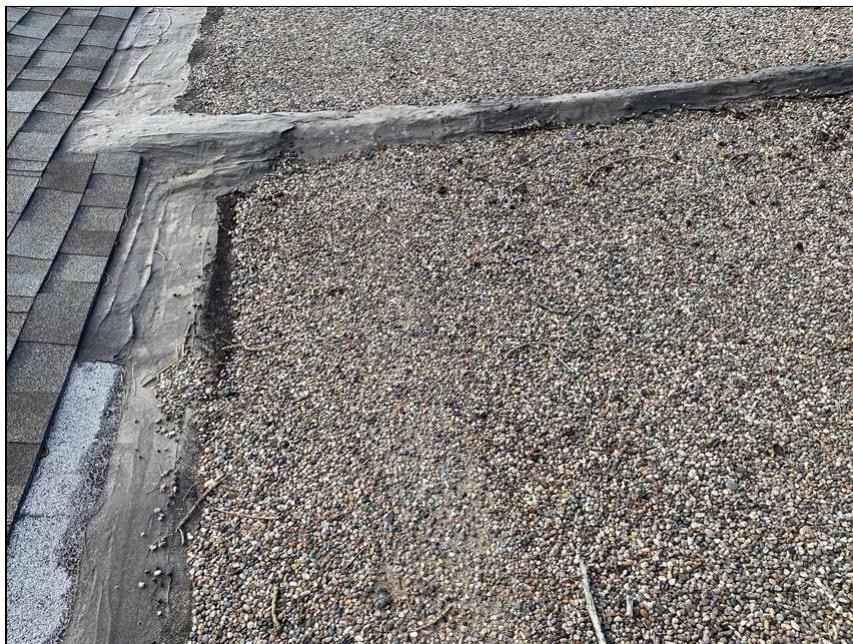
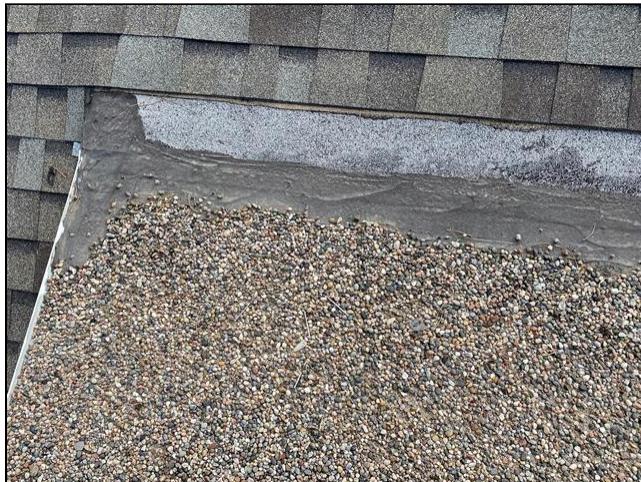
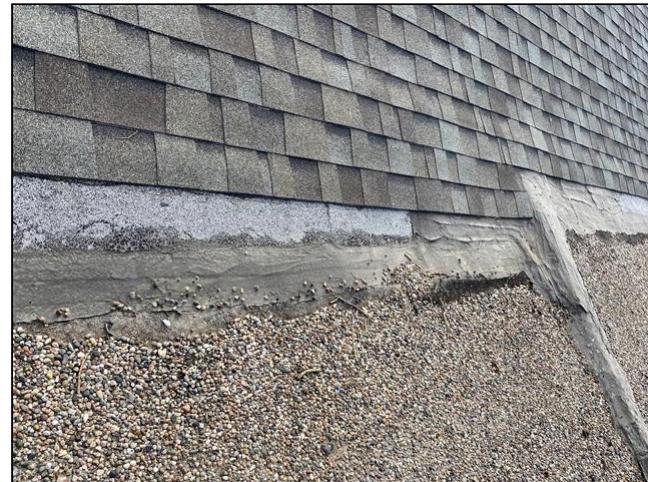
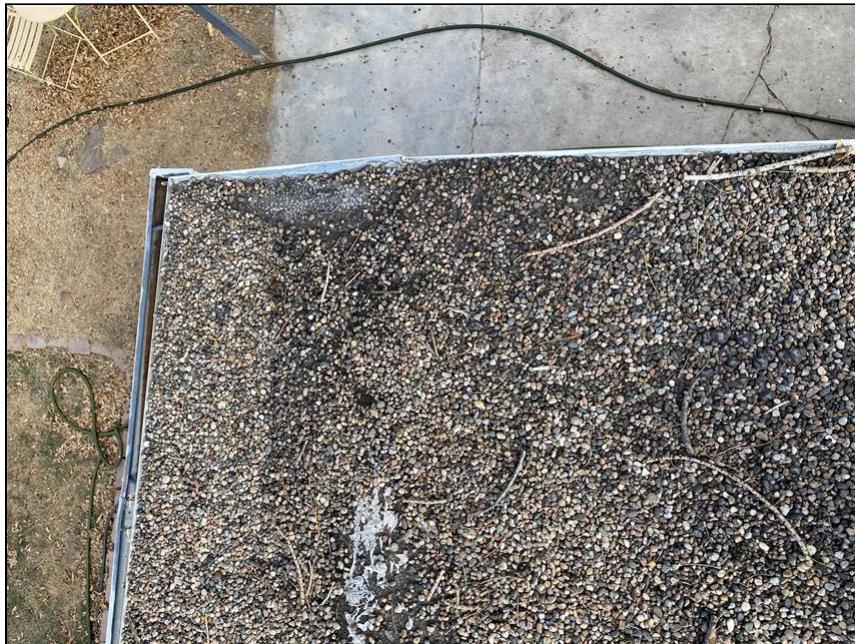
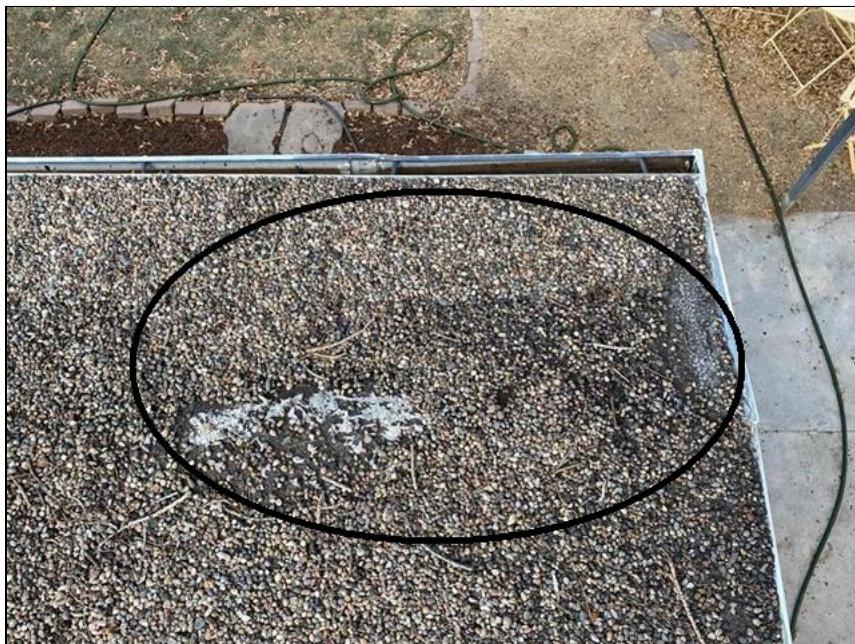
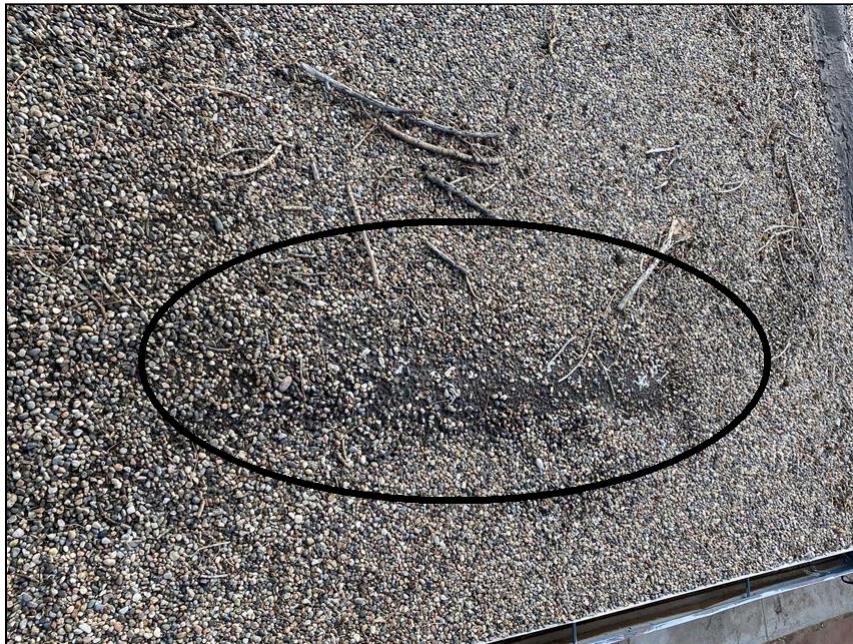
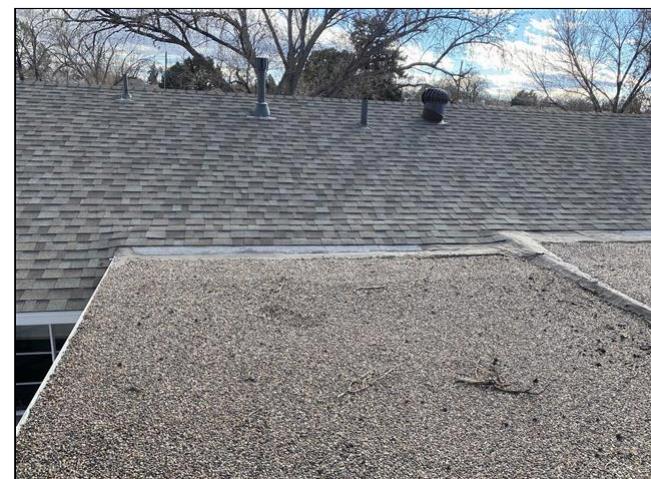
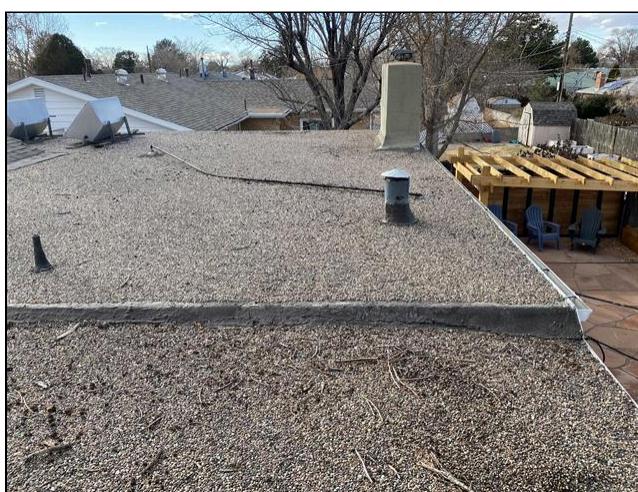
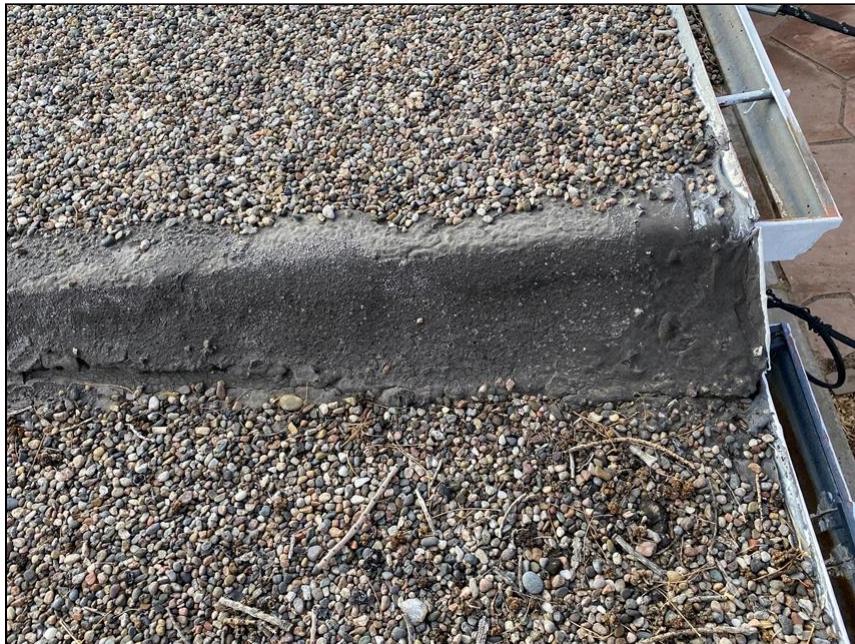
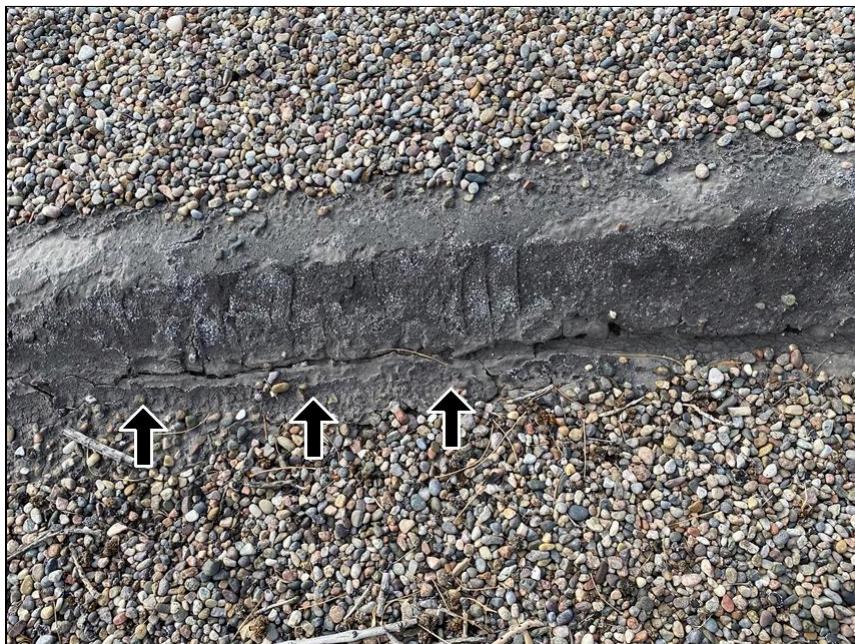
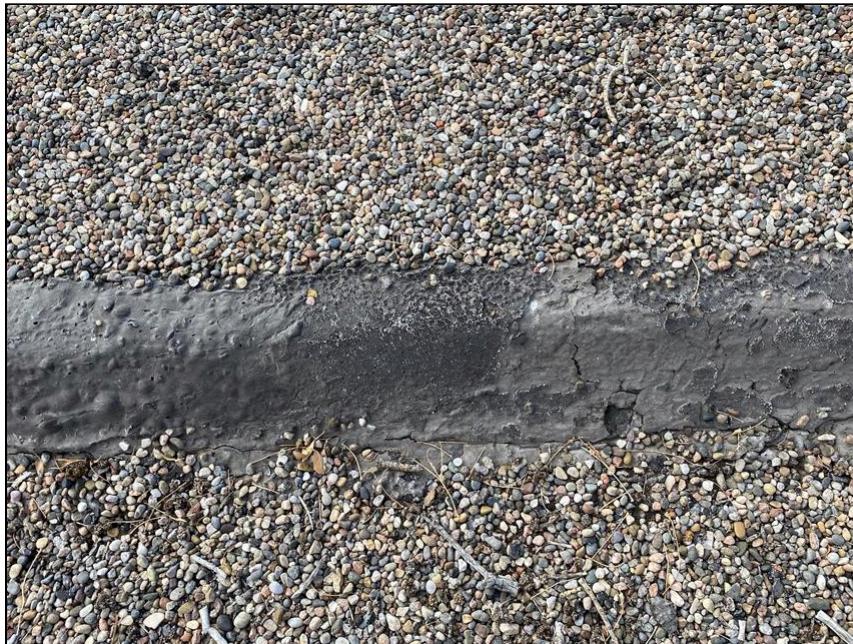
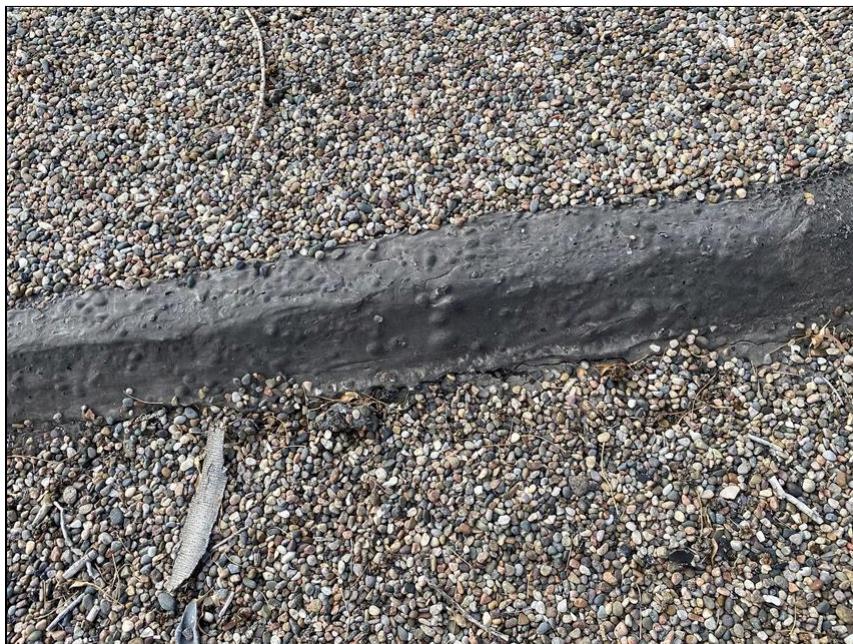
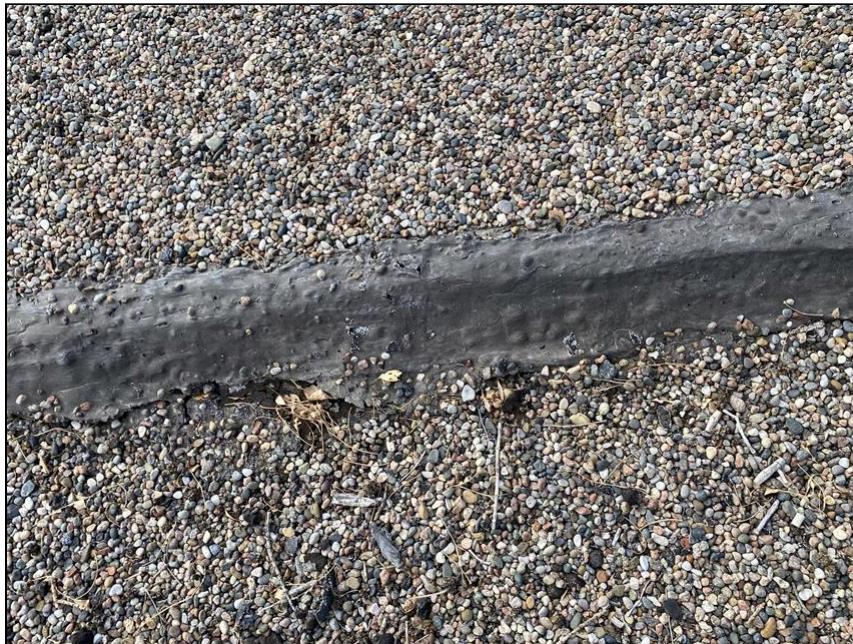
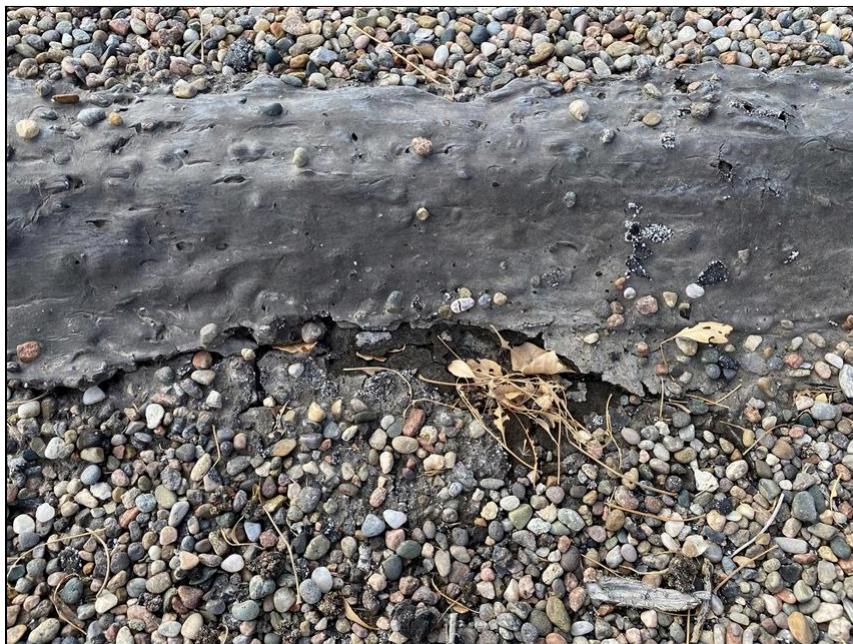
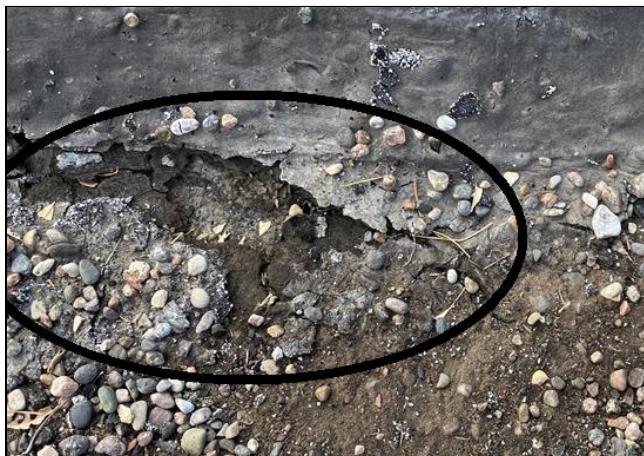
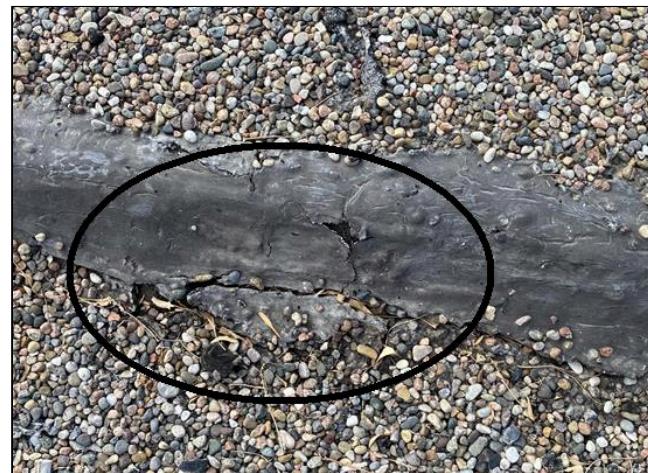
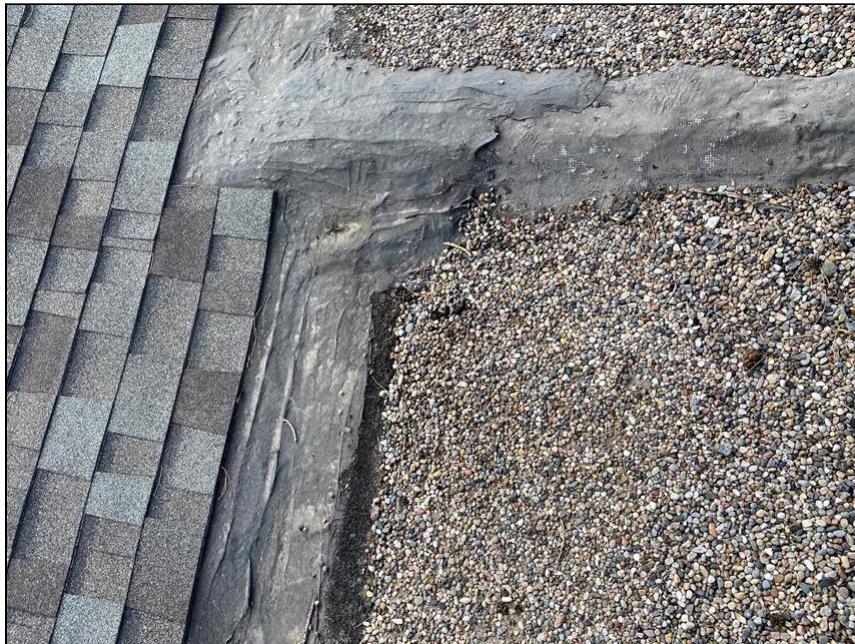
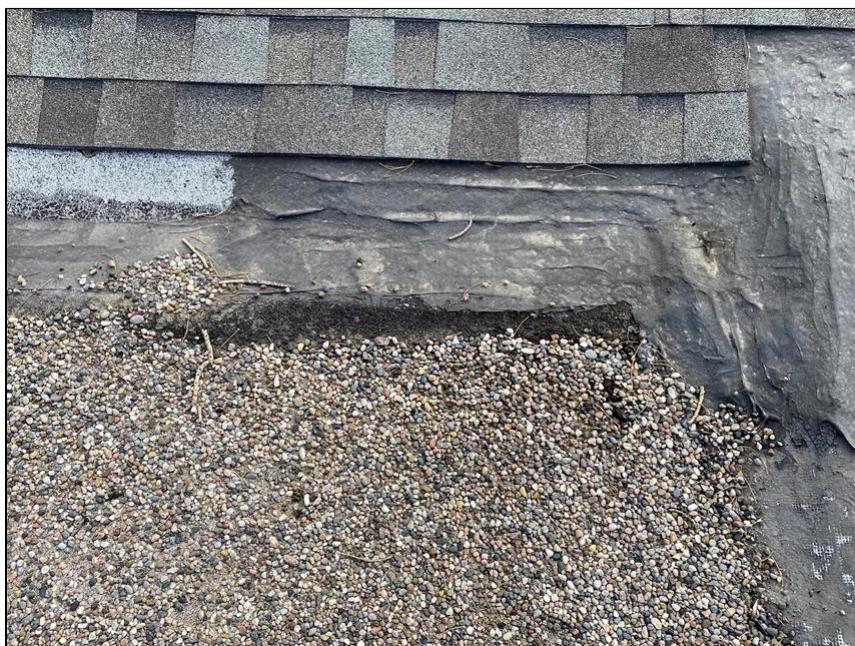
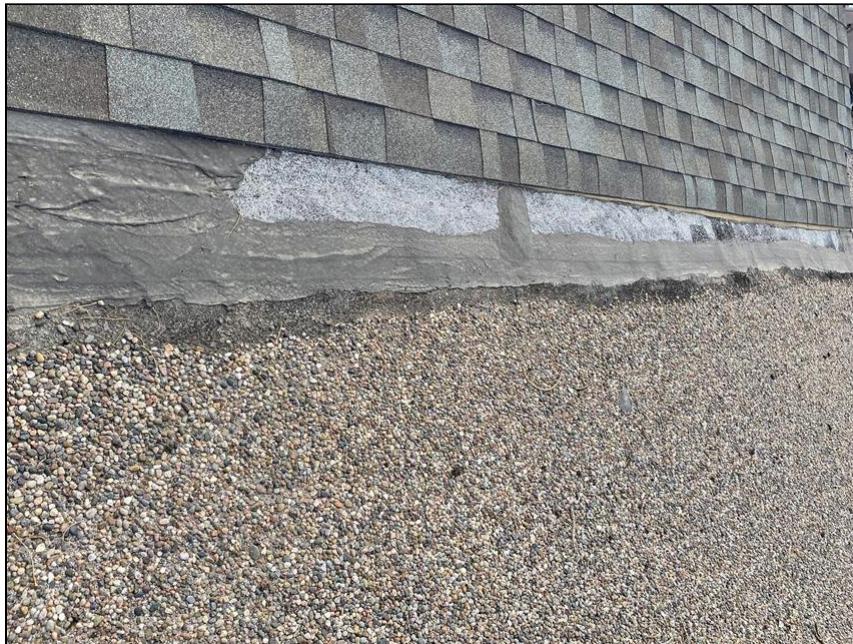
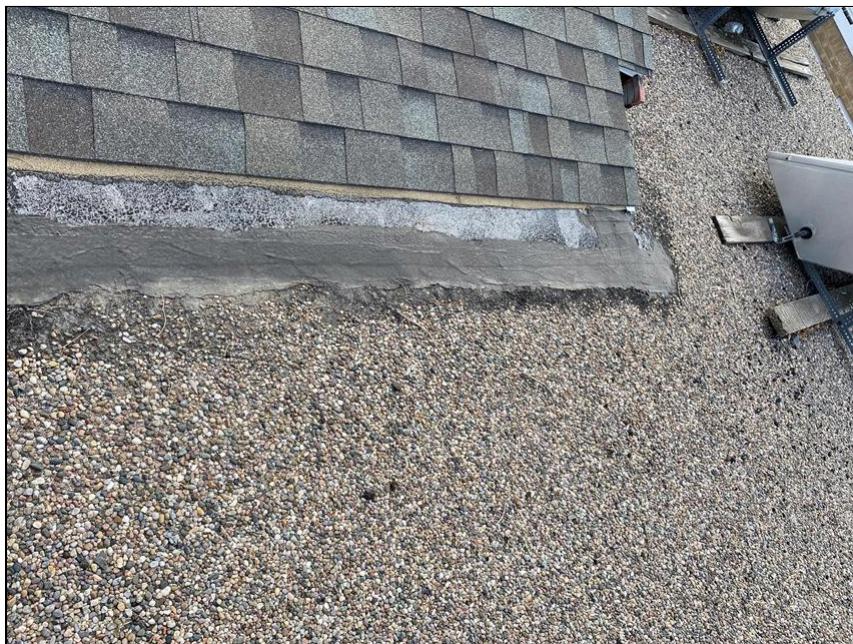
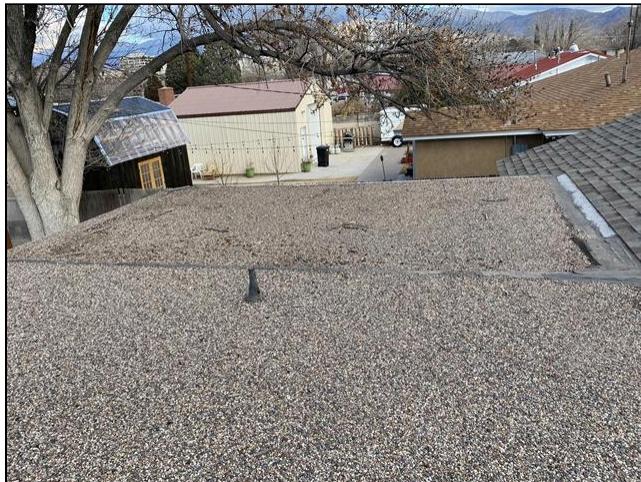
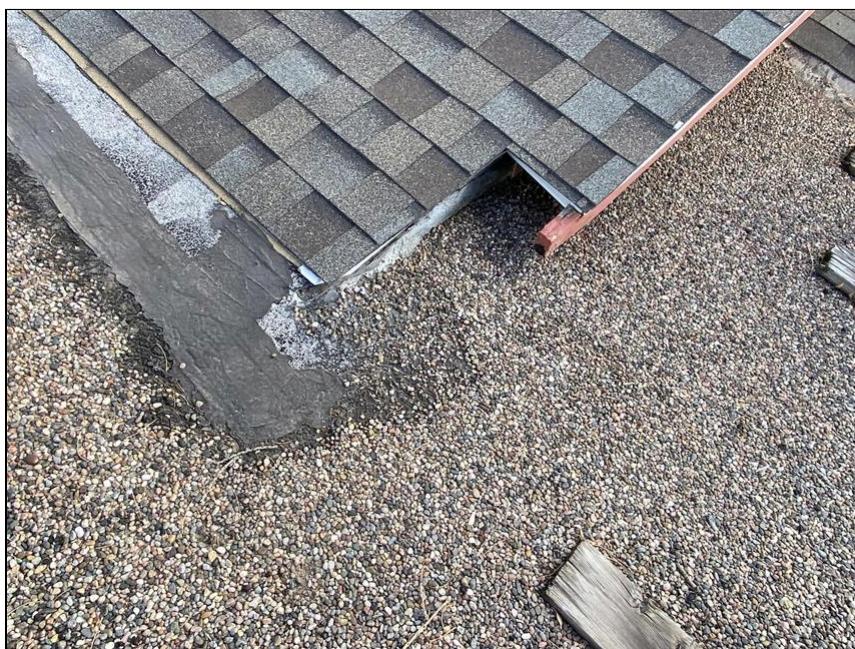
The rear NE enclosed patio room roof covering is old and the life of covering is past the latter stages of life. While it could last a year or so, some areas may need patching with tar as leaks develop.

The roof has various surface wear with some degranulated worn parapet side walls at outer perimeter/tie-ins to other surrounding roof sections.

The tar and gravel roof areas has various gravel erosion with some bare areas observed which should be monitored/maintained, i.e. bare areas re-graveled over time as needed.

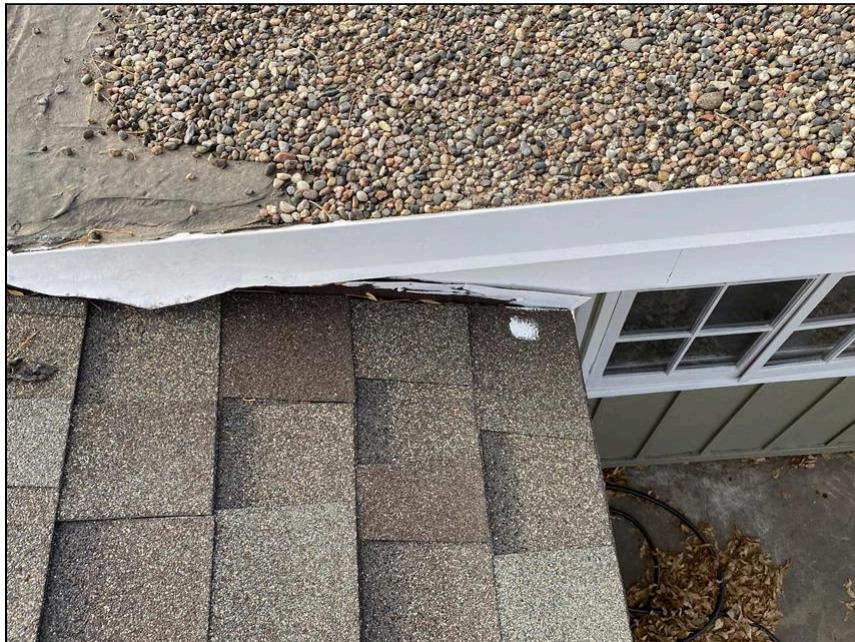
1.1 Item 1(Picture)

1.1 Tar and gravel roof has split gas line penetrations observed at NW area of rear roof.

Tar and gravel roof has various split gable/corner tie-in flashings observed.

Recommend resealing any and all split flashings as needed by qualified person or reputable licensed roof contractor.

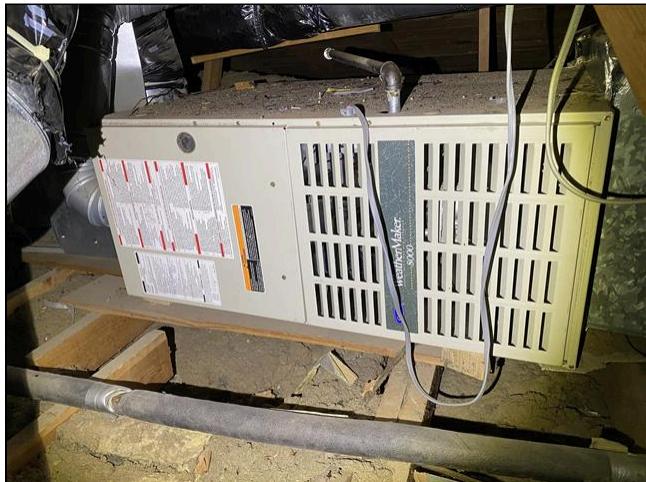
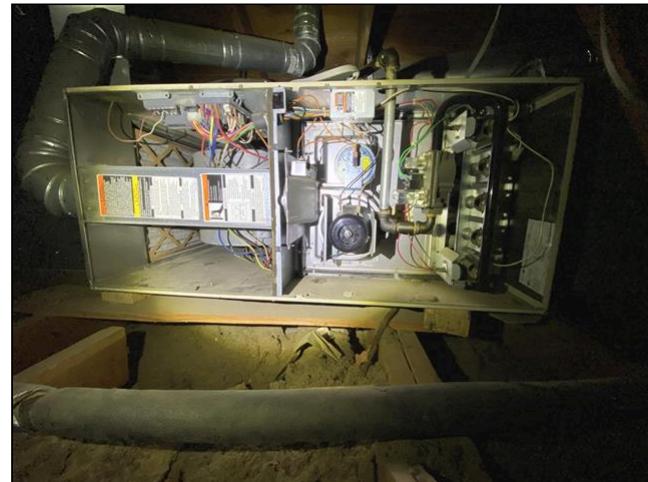
2.0 (1) The Carrier brand gas fired forced air furnace was located in attic.

This unit is approximately 21-22 +/- years old and has a heating capacity rated at 115,000 BTU's. The average operating life expectancy for most natural gas forced air furnaces is 20-25 years. The furnace was found to be functional at time of inspection.

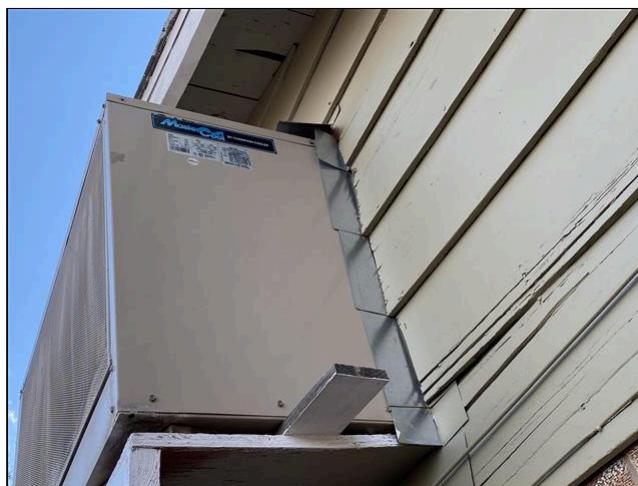
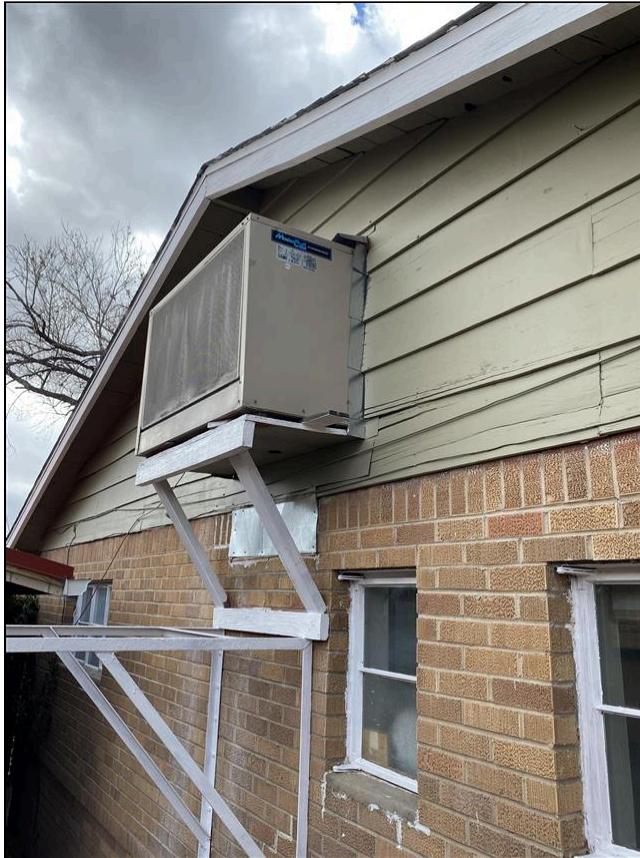
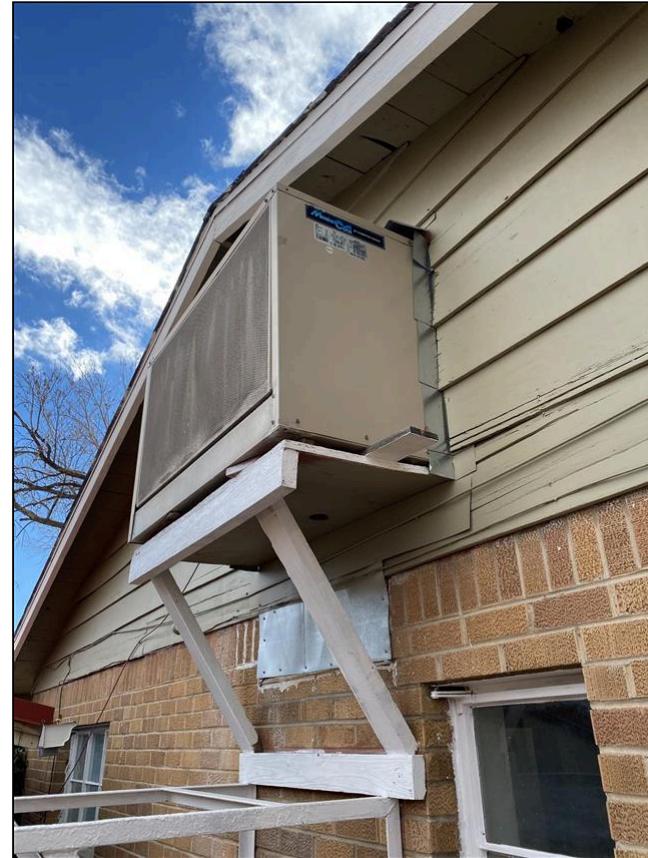
Evaporative cooler is installed in a non-standard manner, unit is installed in a manner that obstructs the side access panels from physically being able to be removed for service at interior, i.e. oiling left and right blower shaft pillow bushings, blower and motor pulley/belt adjustments, etc.

Overall recommend contacting reputable licensed HVAC technician for further evaluation and/or remedy/ repair unit in a manner that allows for normal operation and accessibility to unit rather than having to remove part of pad and entering unit from E exterior side which is non-standard and limited for proper maintenance of unit.

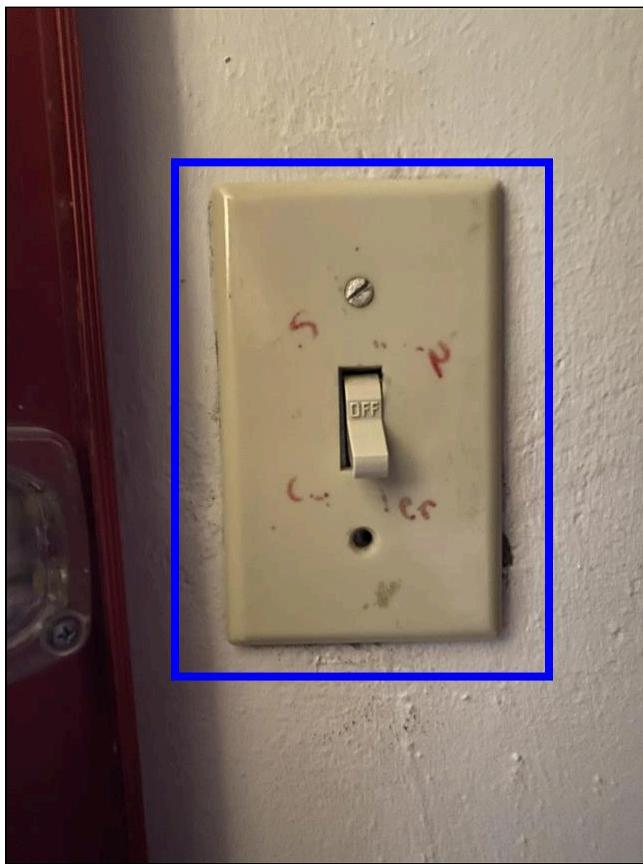
3.1 Item 1(Picture)

3.1 Evaporative cooler control switch located at hallway S coat closet E wall.

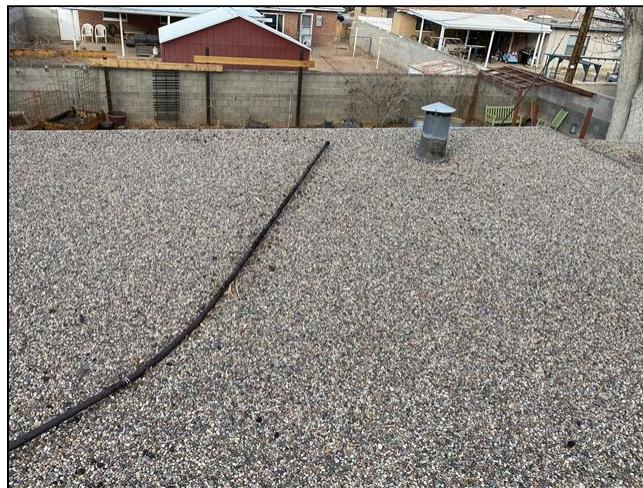
4.5 Item 1(Picture)

4.5 (1) Gas line on roof at NW area has no supports present below gas line which appears to be visibly bowed and without supports can cause tension on coupling connections.

Recommend installing some appropriate supports below gas line where routed on roof as needed.

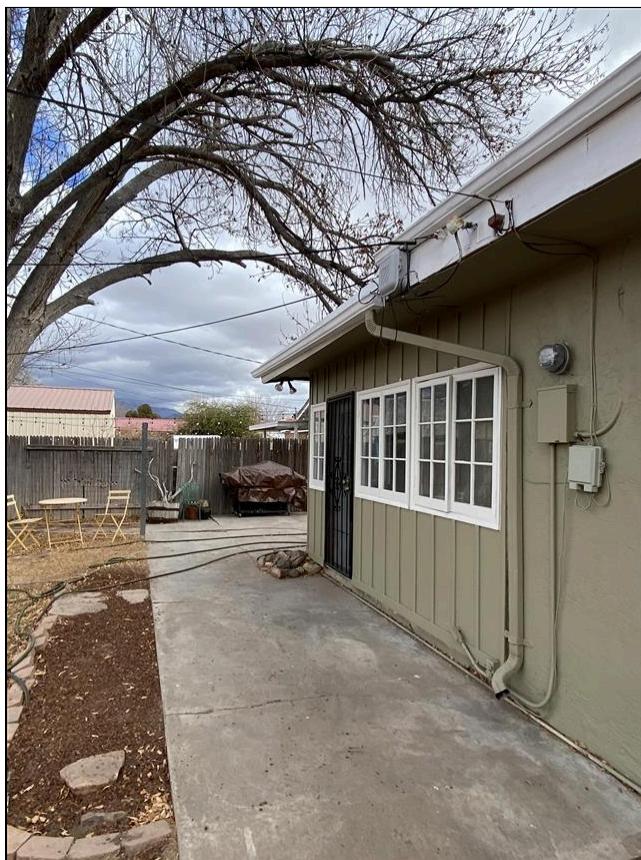
5.0 Item 5(Picture)

(2) Electrical service conductors clearance (outside) from ground is lower than 12 feet and may need correcting for safety. Opinions by licensed electricians on acceptable service entrance height varies between safe and unsafe. Inspector recommends contacting reputable licensed electrician for further information/evaluation and/or repairs as needed.

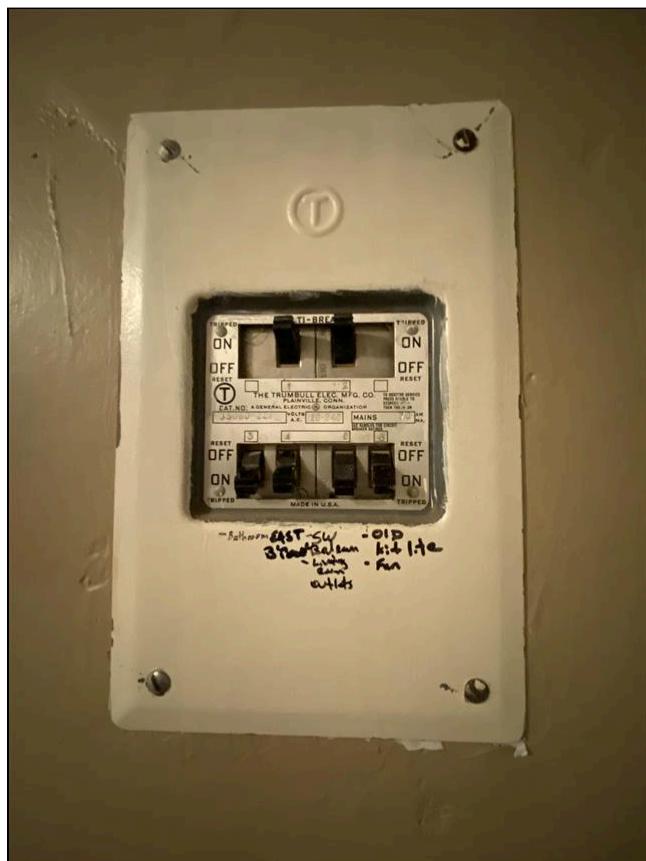
5.1 Item 1(Picture)

5.1 Problem(s) discovered in sub distribution panel/breaker box at laundry N wall right side such as circuits are not legibly labeled/identified, double lugged wiring at lead lugs on left and right sides, and any other problems that an electrician may discover while performing repairs need correcting. Recommend a licensed electrician inspect further and correct as needed.

Problem(s) discovered in main distribution panel/breaker box at rear N exterior at meter service entrance such as breakers are different brands, doubled wiring at upper right and lower left circuit breakers, double lugged wiring at lead lugs on left and right sides, panel breakers not fully identified/labeled, circuit wiring installed through panel box with no romex collar connector in place at lower right and any other problems that an electrician may discover while performing repairs need correcting. Recommend a licensed electrician inspect further and correct as needed.

Subject home has a Federal Pacific main distribution panel/breaker box at rear exterior meter service entrance area which is legal, but there is a possibility that the circuit breakers may not trip when shorted possibly causing an electrical hazard. Opinions by licensed electricians on this panel varies between safe and unsafe. Inspector recommends consult a licensed electrician for an opinion and correct if necessary. Further information regarding these panels can be obtained from the Consumer Products Safety Commission at: <http://www.inspect-ny.com/fpe/CPSC.htm>.

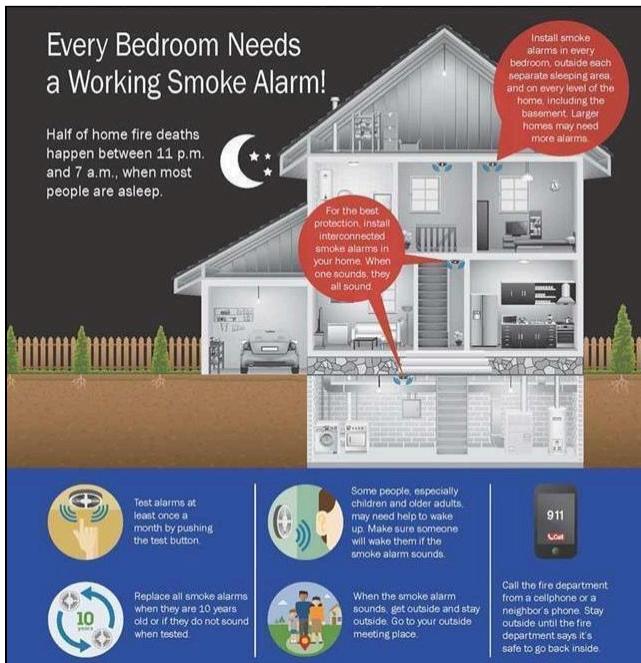
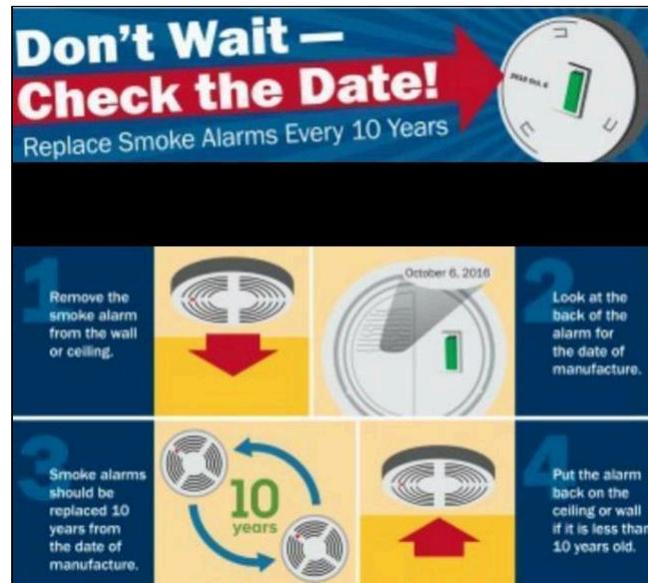
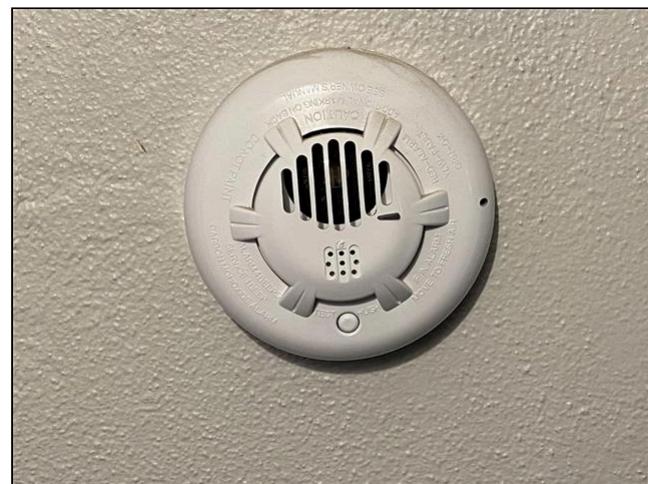
5.8 Item 1(Picture)

5.8 Smoke detector(s) should be tested on a regular basis. The battery (if any) should be replaced with a new one every six months, and tested on a monthly basis thereafter. Smoke detector(s) should be installed and maintained in compliance with the manufacturer's recommendations.

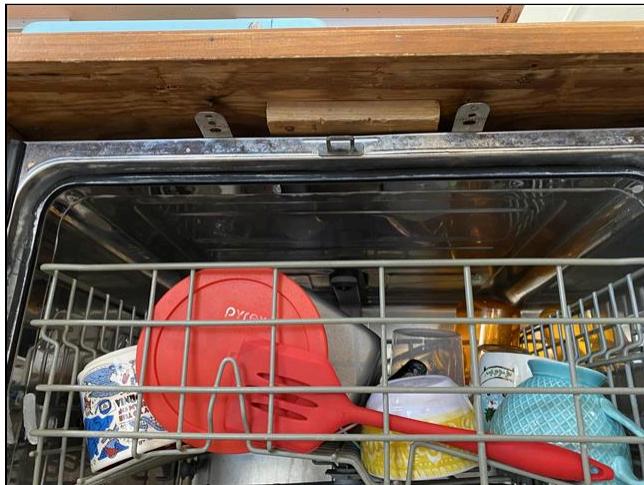
6.3 Item 1(Picture)

6.3 (1) Dishwasher operation functional at time of inspection though unit does not appear to be physically attached to counter top or cabinet sides.

(2) Note: Dishwasher door/front is dented at the lower right area.

Note: Kitchen tile floor is tiled up to but not underneath dishwasher which may make for difficult removal for any potential future repairs or replacement of unit.

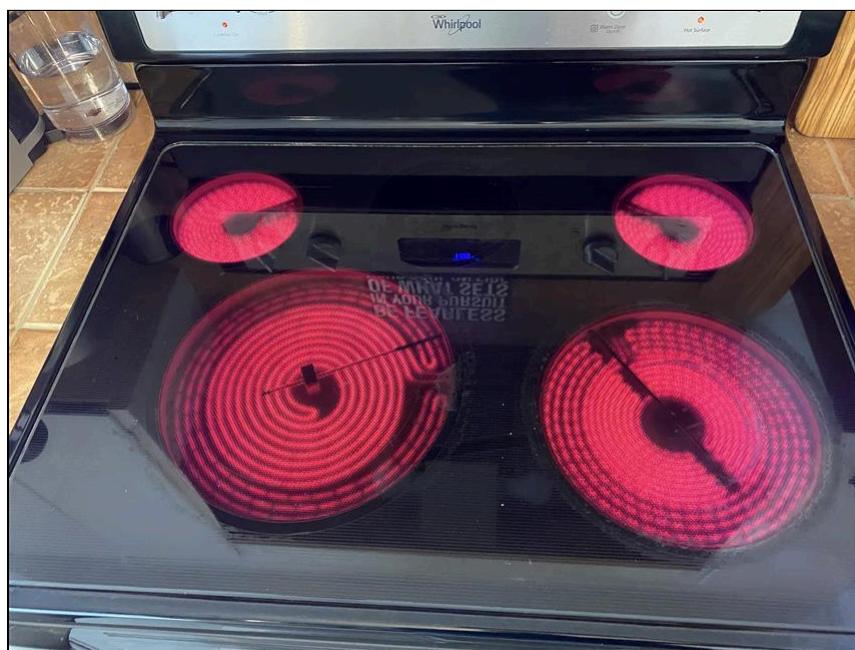
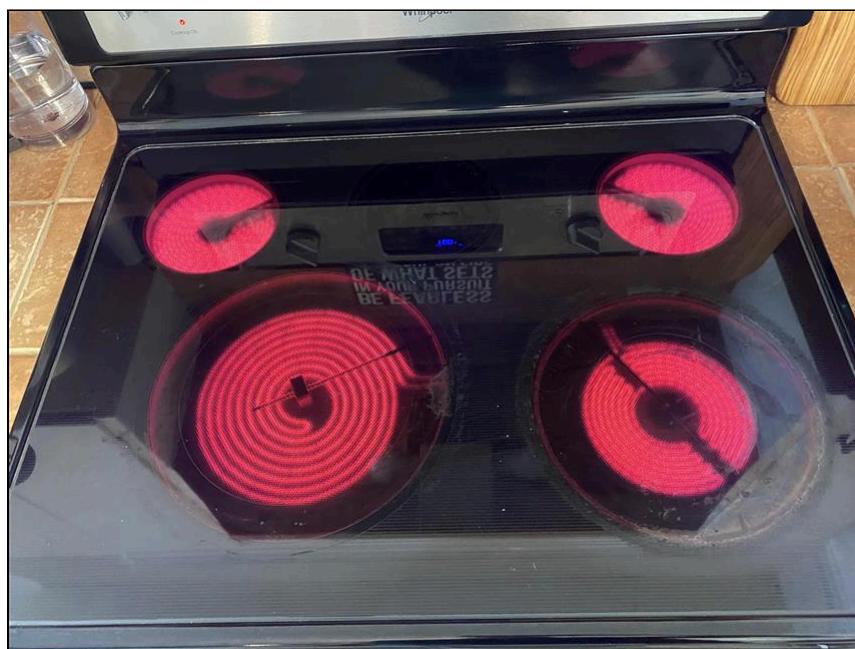
6.4 Item 1(Picture)

6.4 (1) Electric 4 smooth top burner stove with right front and left front dual burner element size feature, operation functional at time of inspection.

Note: Kitchen tile floor is tiled up to but not underneath stove which may make for difficult removal for any potential future repairs or replacement of unit.

Note: Stove has no anti-tip bracket observed behind unit.

Note: This appliance can be tipped over as there is no anti-tip bracket present. For safety, inspector recommends that an appropriate anti-tip bracket be installed. Please refer to the manufacturer's installation manual (if available) regarding these safety brackets.
