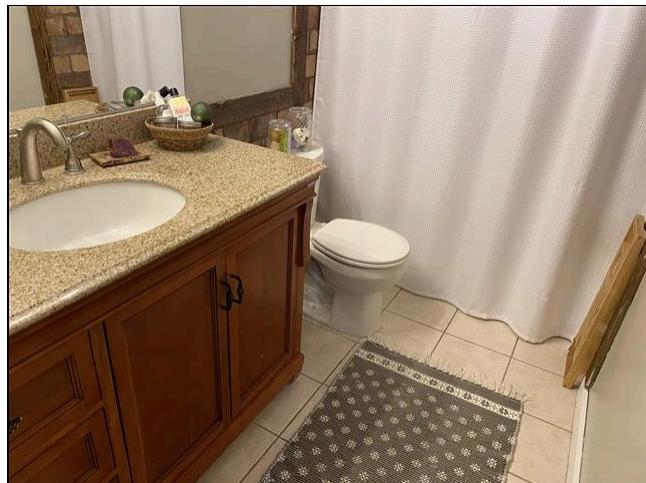
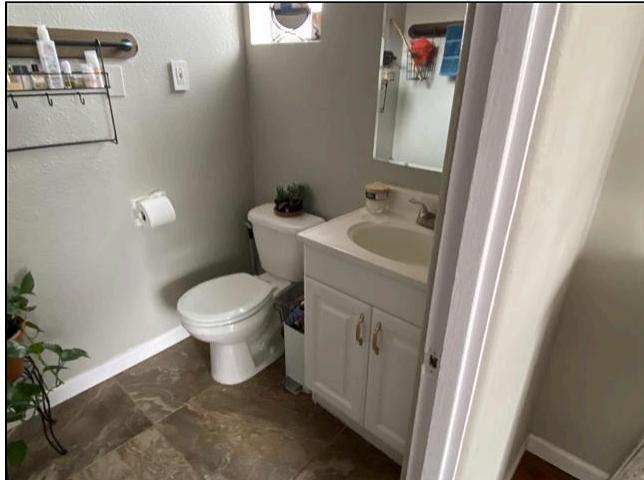
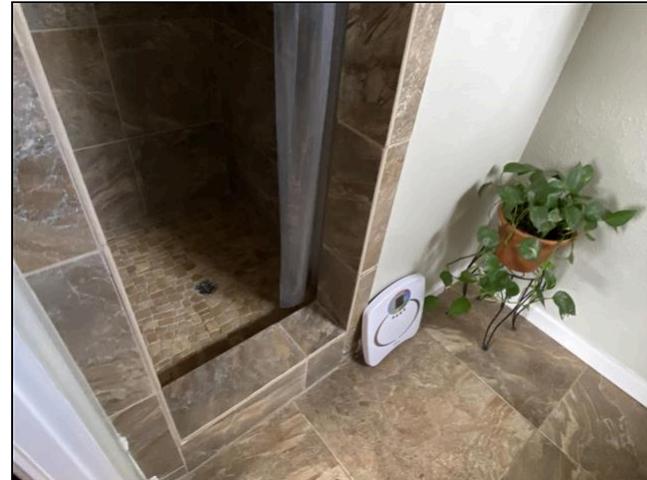
Hall full bath S entry floor transition has raised lip/offsets, potential trip hazard.

Hall full bath tile flooring has cracked grout joint(s) observed at the N end near where meets base of tub.

Master 3/4 bath S entry floor transition is loose/not fully secure, potential trip hazard.

Master 3/4 bath vanity cabinet doors are delaminating at various seam areas.

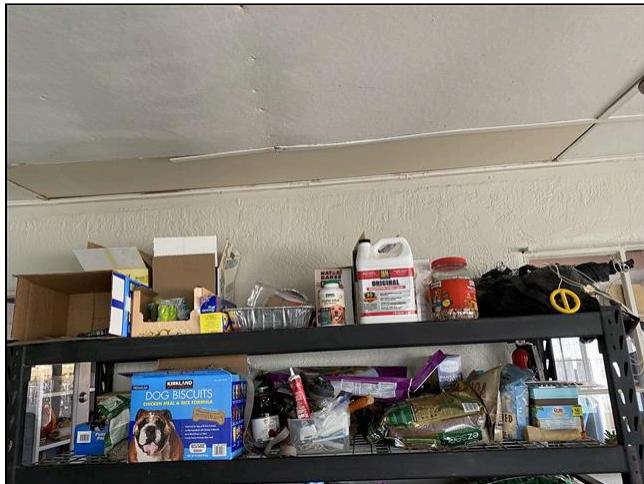
8.0 Item 1(Picture)

SW bedroom ceiling has cracked seam joint/blemish observed.

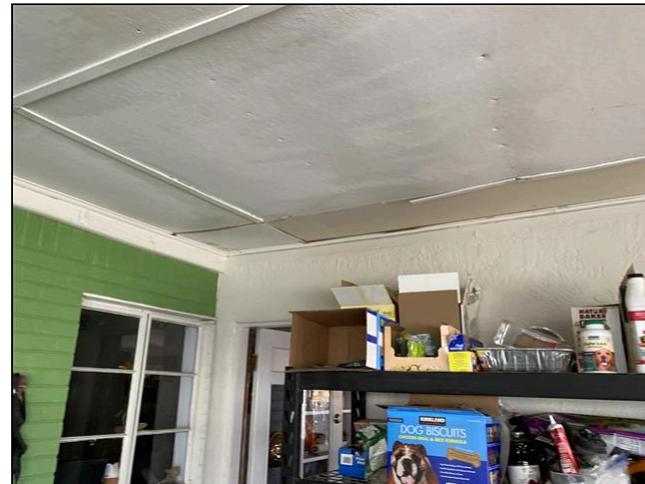
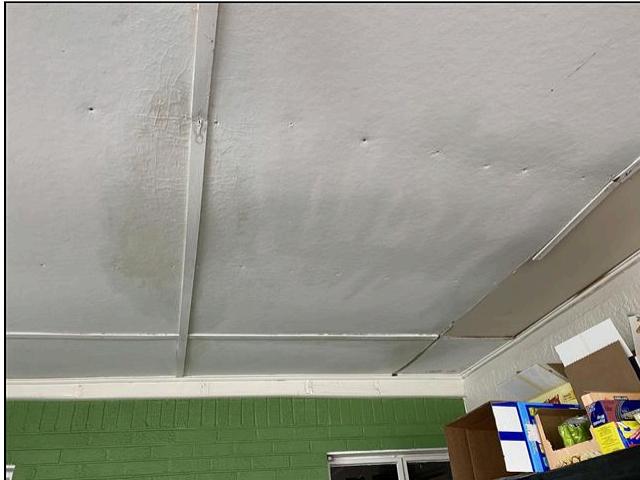
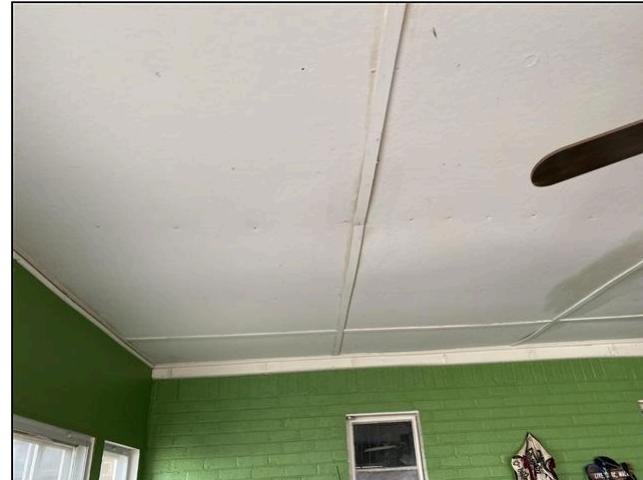
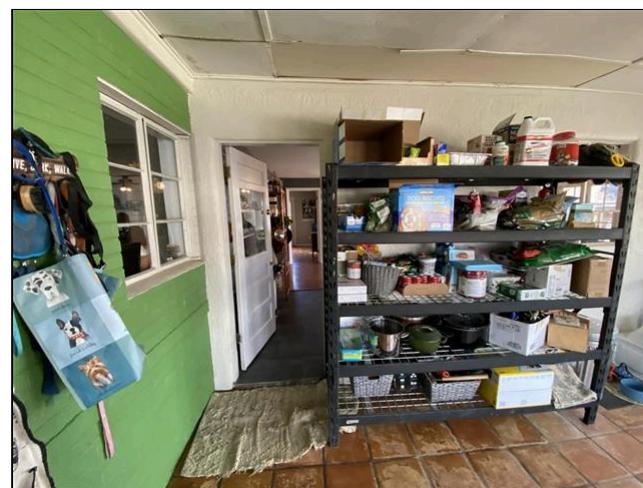
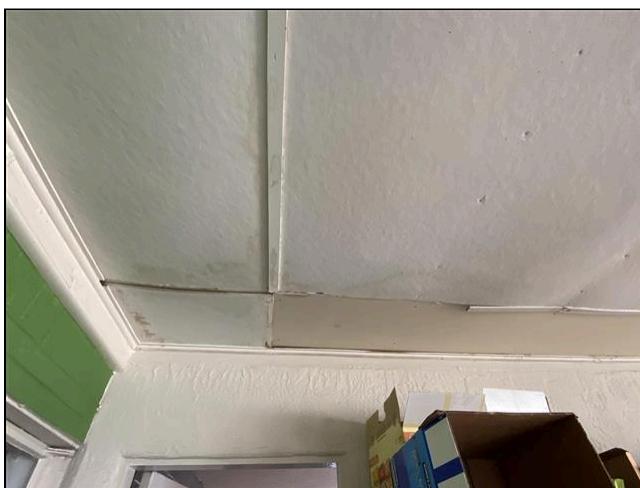
Kitchen ceiling has hole observed at the E end (just S of kitchen ceiling light fixture), unknown cause/source/purpose.

NE sun room ceiling has various moisture stains/blemishes observed at various areas.

NW bedroom/study ceiling has patched texture/blemishes observed at the NE area of ceiling, unknown cause/source/purpose.

Middle office/study ceiling has various patched texture/blemishes observed at the N end of ceiling, unknown cause/source/purpose.

Hall ceiling has cracked/chipped texture/finish observed at the middle area of ceiling.

Hall full bath ceiling has various patched texture/blemishes observed at the N end/outer perimeter areas of ceiling above tiled shower/tub enclosure, unknown cause/source/purpose.

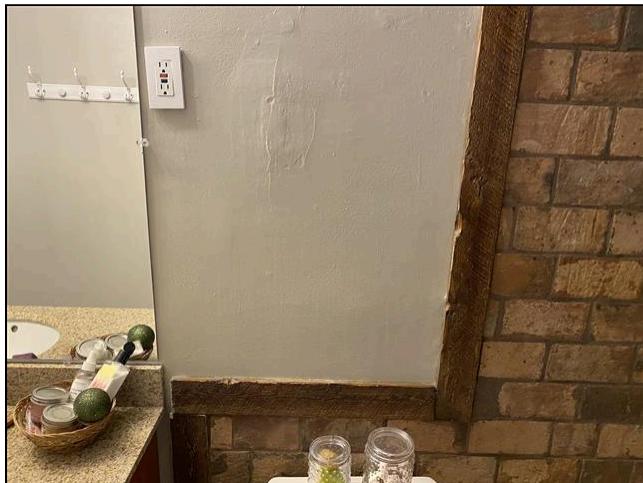
8.1 Item 1(Picture)

Hall S wall has patched texture/blemish observed at upper area of wall near where meets ceiling.

SW bedroom E wall has gouge observed at the N end/middle area of wall, possibly from contact with N entry door knob.

Hall full bath N wall has various patched/texture blemishes observed.

Master 3/4 bath N wall has various mismatched texture/blemishes observed.

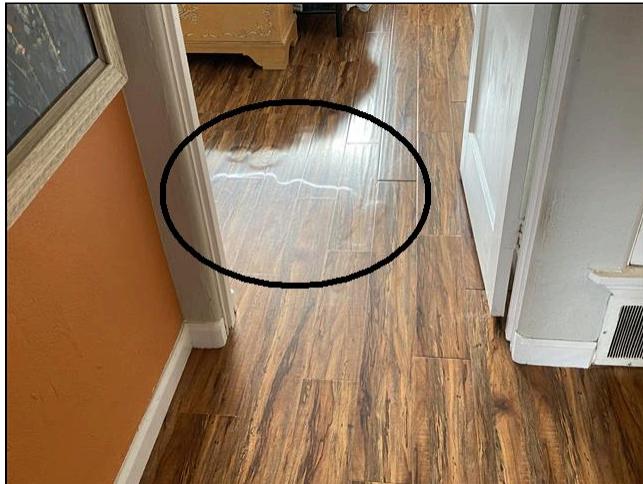
8.2 Item 1(Picture)

NE sunroom floor has low spot/gap observed at the E end near where meets E exterior double entry door frame threshold at interior side, potential trip hazard.

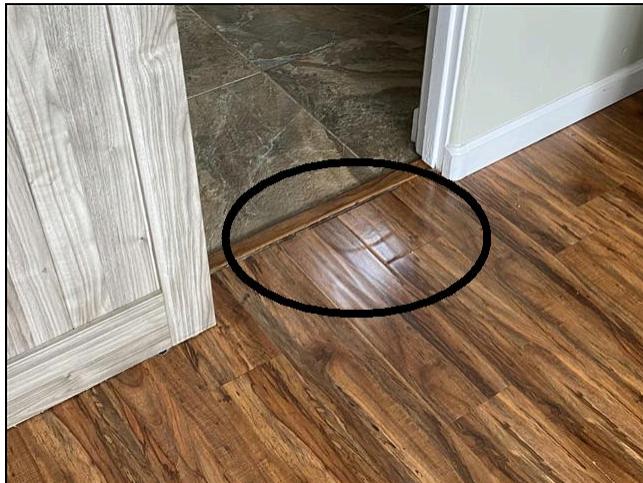
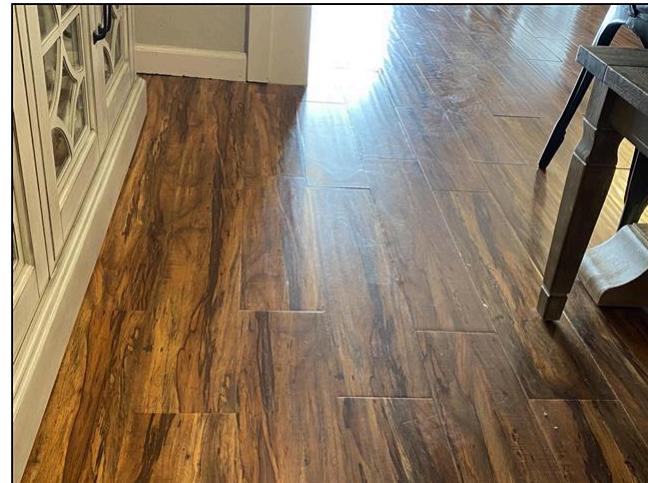
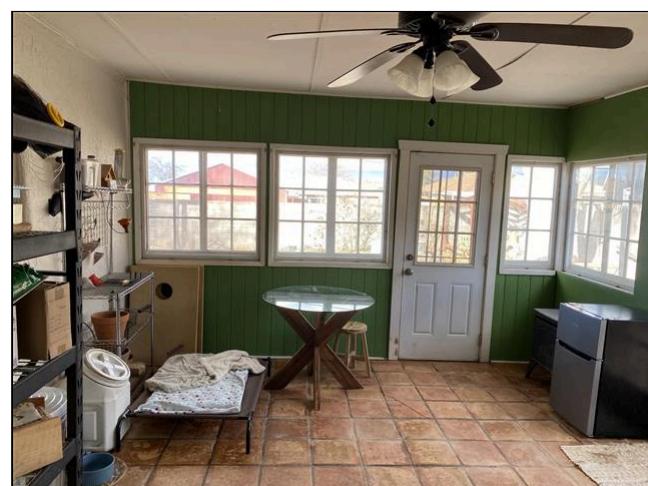
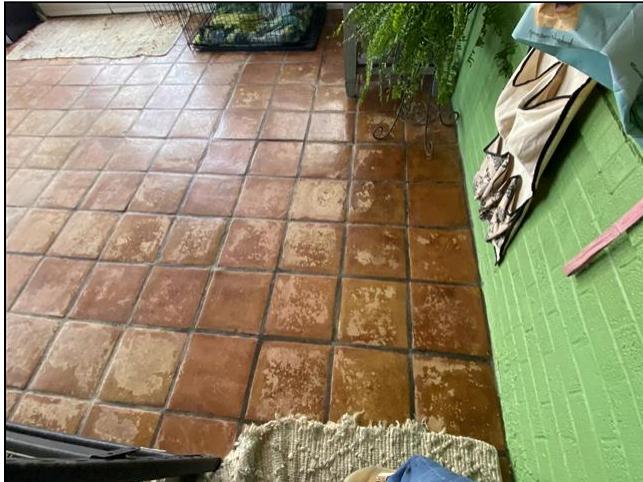
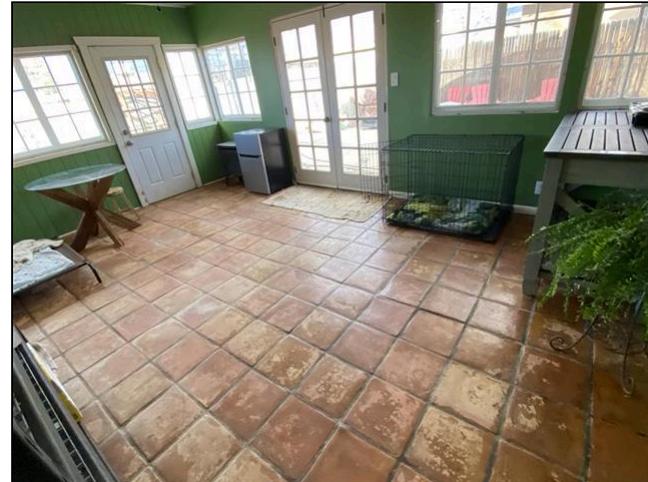
Wood/laminate flooring is blistered/swollen at various areas throughout home (possibly from moisture damage) to include the following but not limited to kitchen/dining areas and SE master bedroom.

Wood/laminate flooring has various gaps observed at seams areas where pieces of flooring appears to have shifted loose throughout home.

Laundry E entry floor transition has raised lip/offset observed, potential trip hazard.

NE sunroom W entry/step has overhang observed, potential trip hazard.

NE sunroom has various cracked saltillo floor tiles observed at the N end of floor.

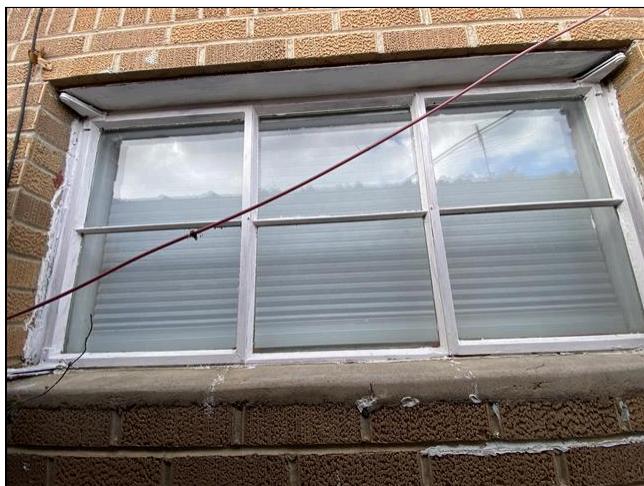
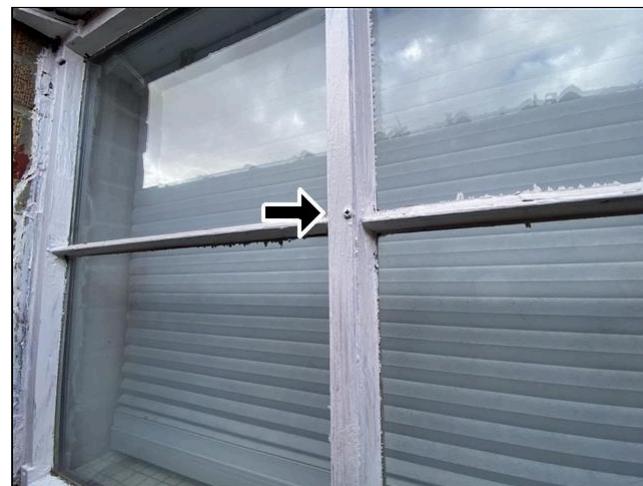
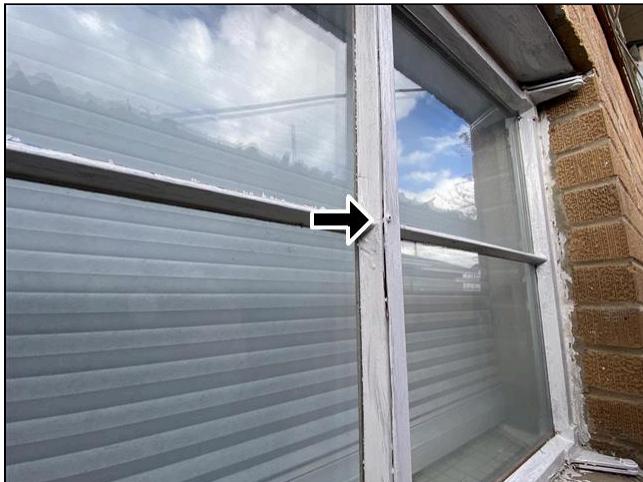
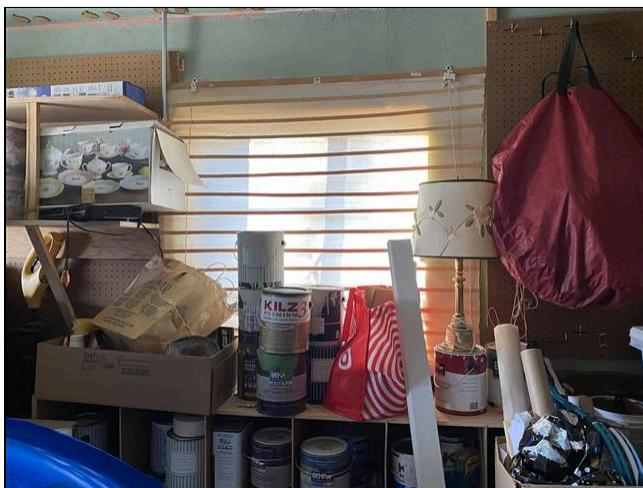
Various windows at NE sunroom have interior storm windows in place, windows cannot be opened in present condition.

NE bedroom E window is missing various hardware and is screwed shut at exterior side, windows inoperable in present condition.

NE bedroom N right window crank appears to be stripped, window cannot be opened in present condition.

SE master bedroom E window is missing various hardware and is screwed shut at exterior side, windows inoperable in present condition.

Various exterior casement windows on E side of home are inoperable with screws observed securing windows shut on exterior.

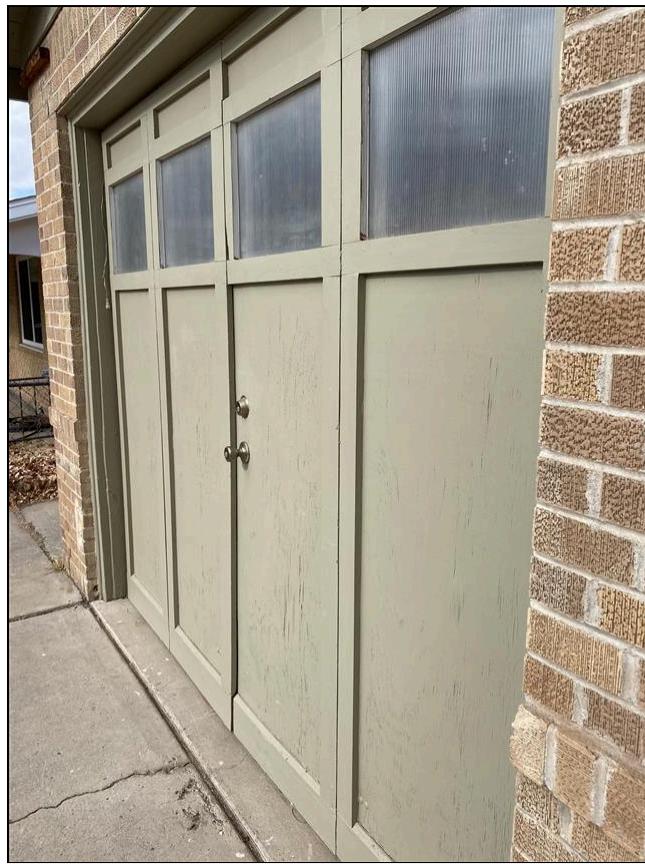
9.0 Item 1(Picture)

Custom manual bi-fold man doors in place of standard overhead door, operation appears functional though doors bind when opening/closing at time of inspection.

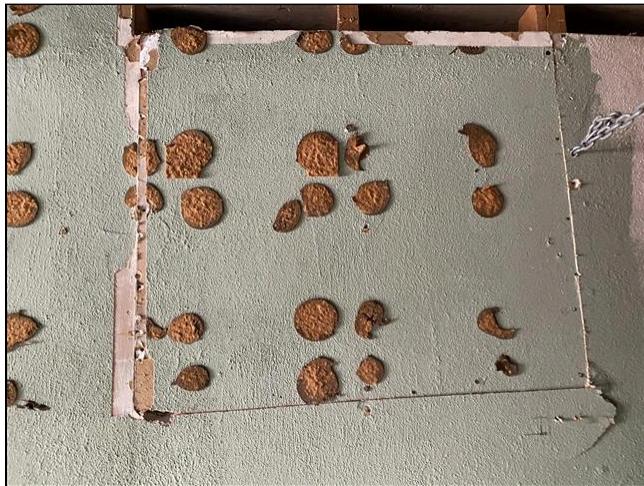
9.1 Item 1(Picture)

Garage ceiling has various moisture stains observed in several areas throughout.

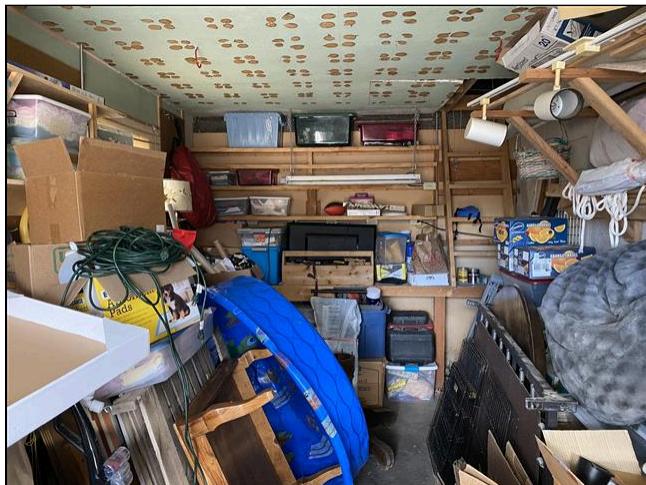
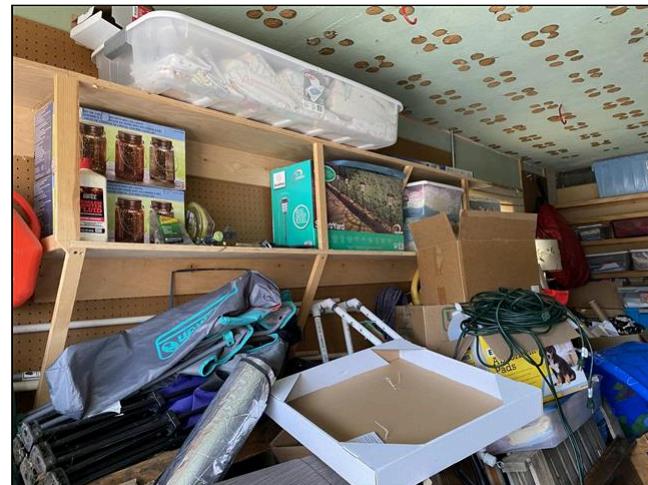
9.5 Item 1(Picture)

9.5 Garage area has extremely limited access observed at time of inspection, i.e. storage, boxes, etc. Not all related item areas of garage inspected at time of inspection due to limited access.

Recommend inspecting garage interior upon final walk-through for any potential concerns which may have been concealed with storage/boxes, etc. at time of initial inspection.

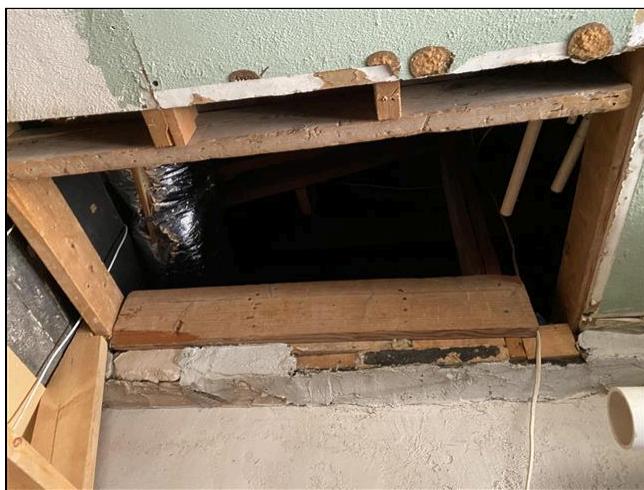
10.0 Item 1(Picture)

Attic access found open and has no fire rated cover in place, this is considered a fire wall breach and should be remedied properly for safety.

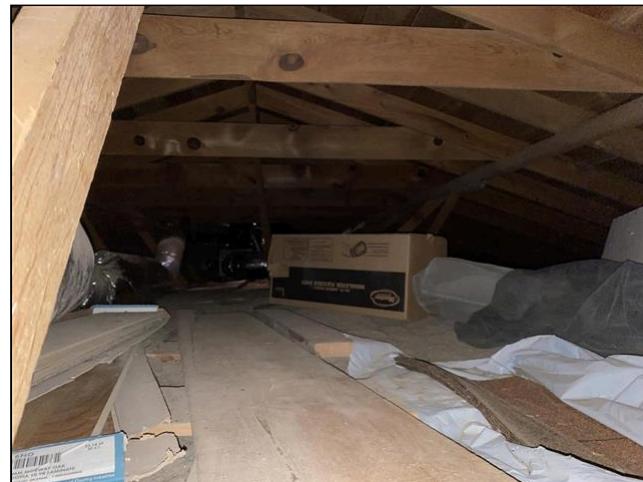
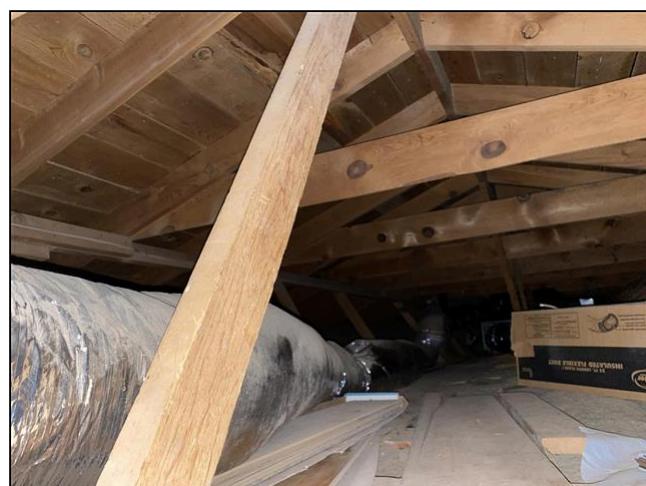
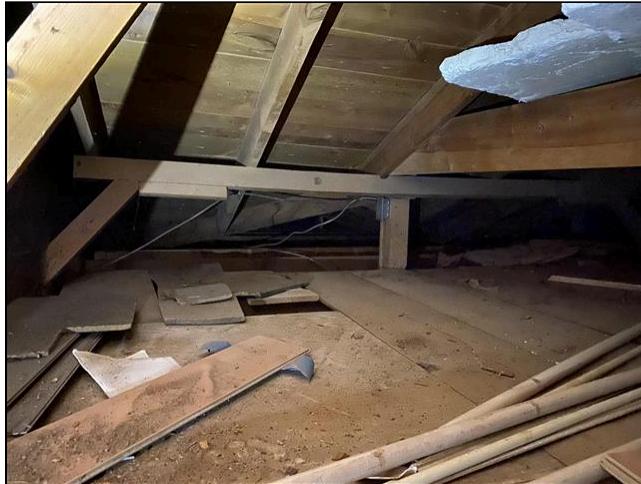
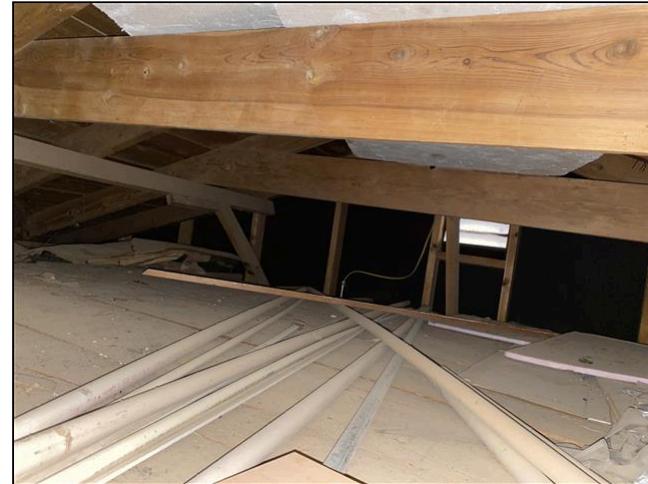
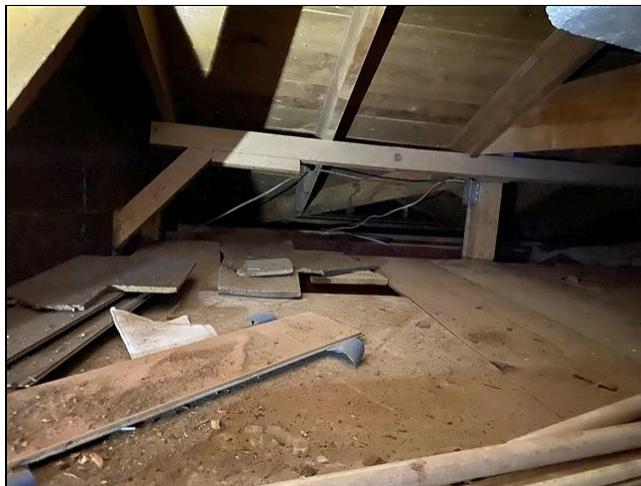
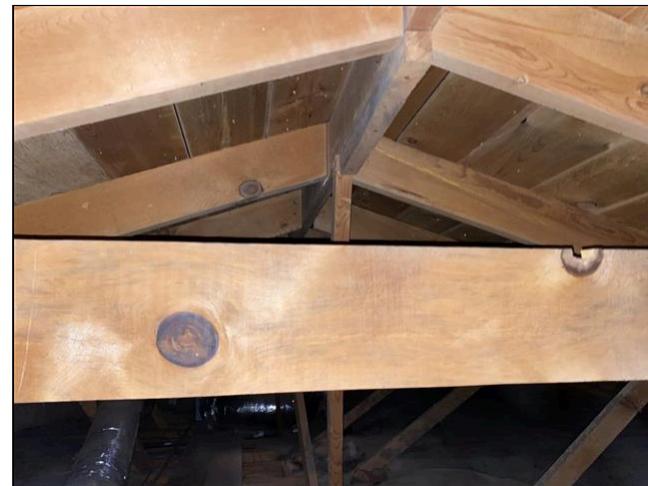
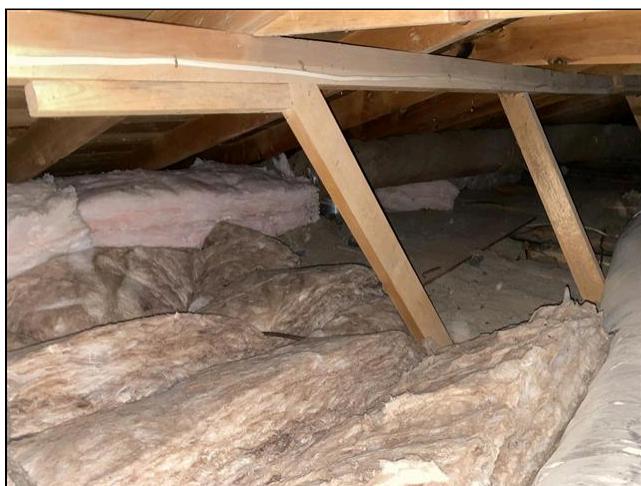
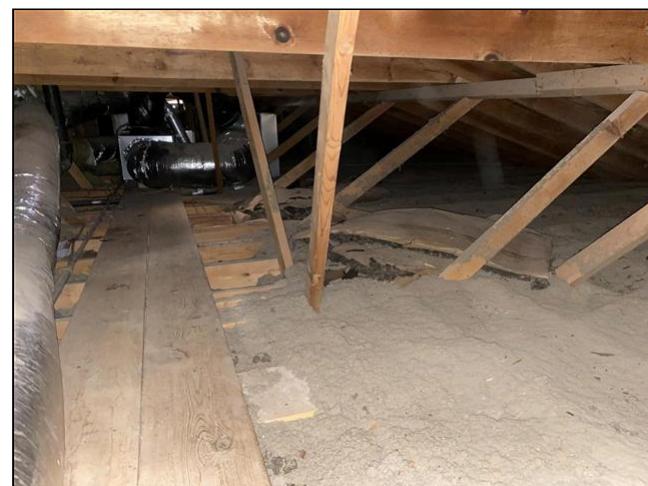
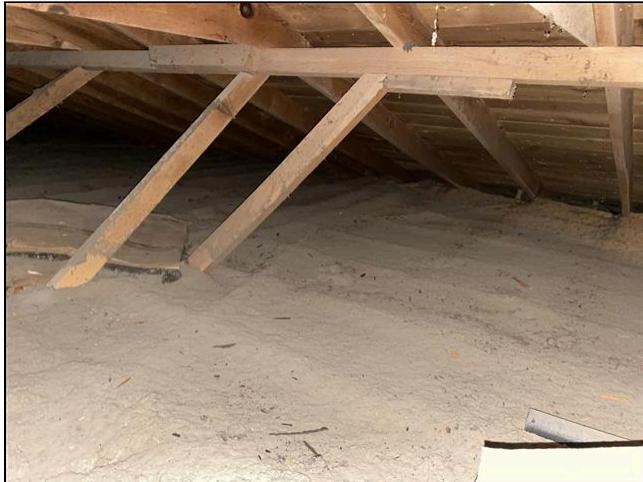
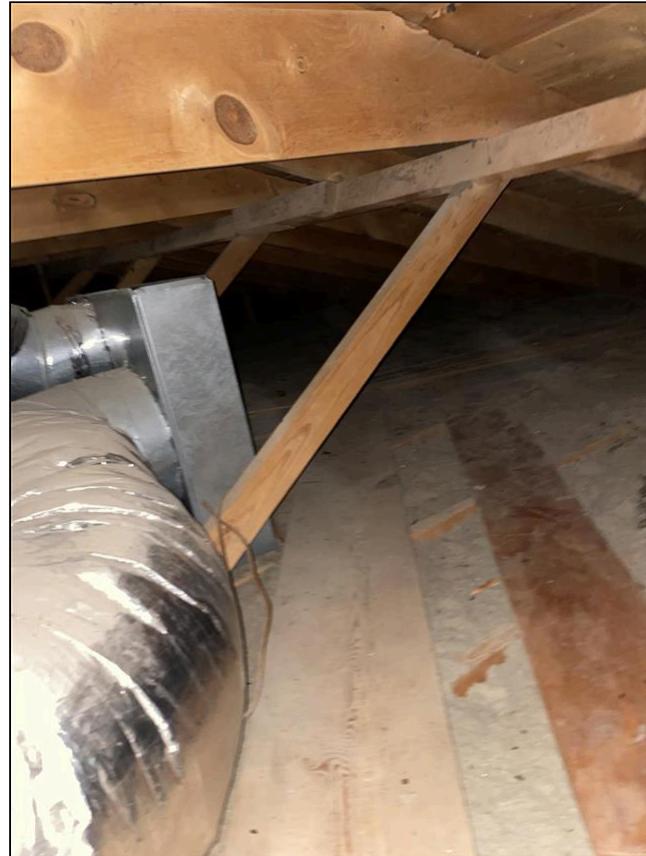
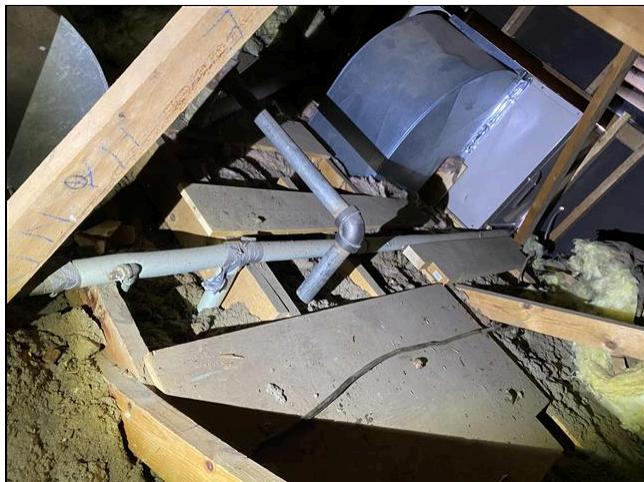
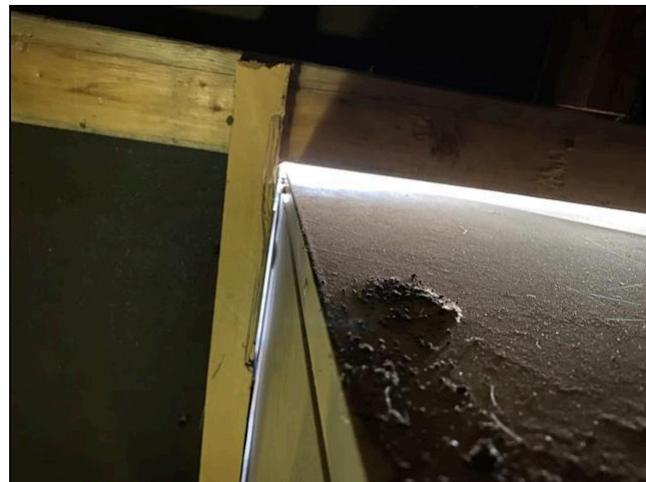
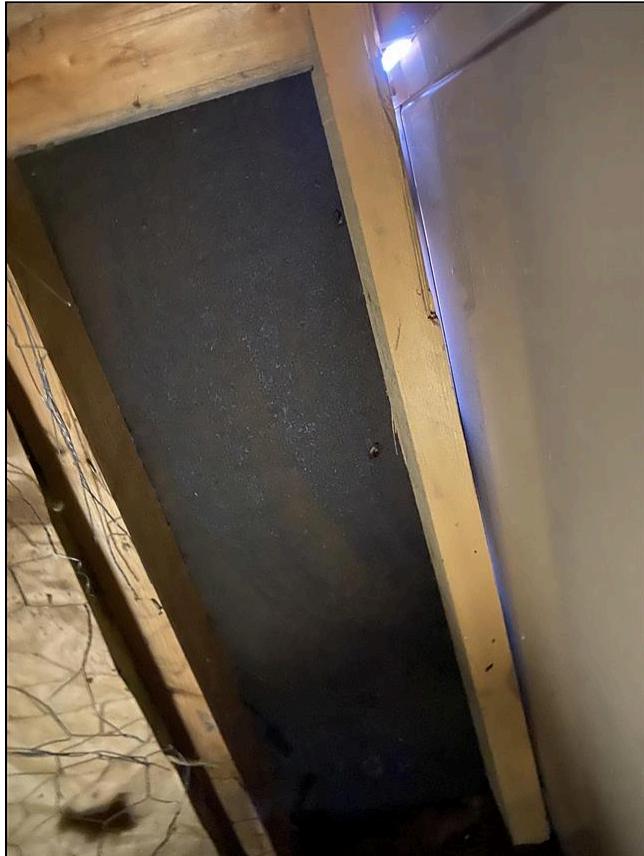
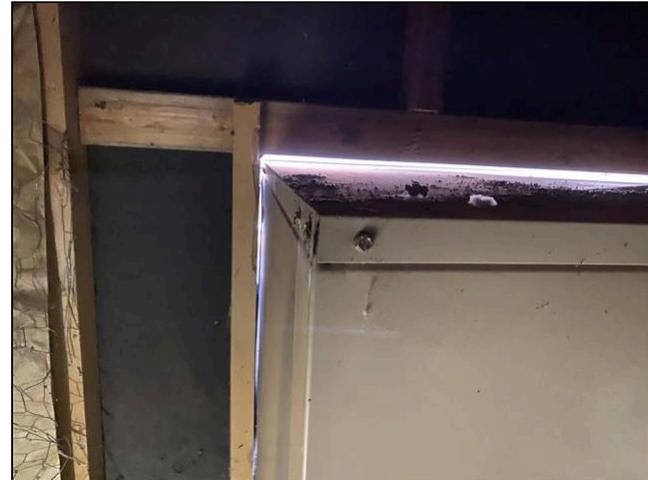
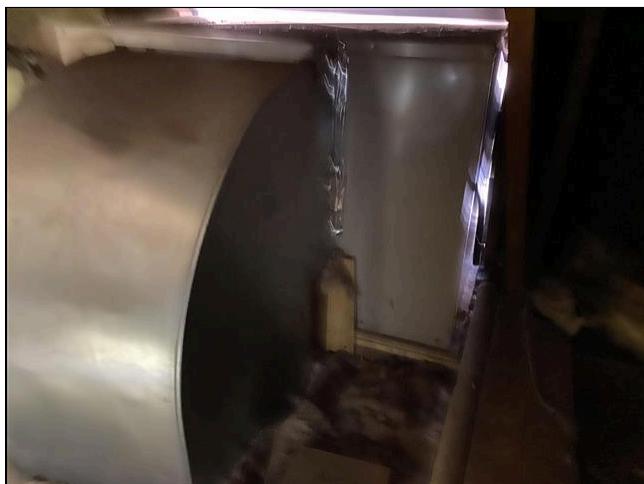
10.1 Attic access observed at garage upper E wall and garage partially open ceiling areas.

Attic has 2x6 wooden rafters with 2x4 wooden purling supports, wooden collar ties and 1x wood plank decking observed.

Attic has various open gaps observed at E end area surrounding the evaporative cooler shell where installed between the upper exterior divider walls in non-standard manner. Open gaps at subject area are considered conditions conducive to potential pest/moisture intrusion if left in present condition over prolonged period of time.

Due to configuration of framed members limited access observed in attic areas and it is not possible to inspect all areas of attic. There is no visible active moisture in attic at the time of inspection. The absence of visible indications of active moisture is not necessarily conclusive evidence that the roof is free from leaks.

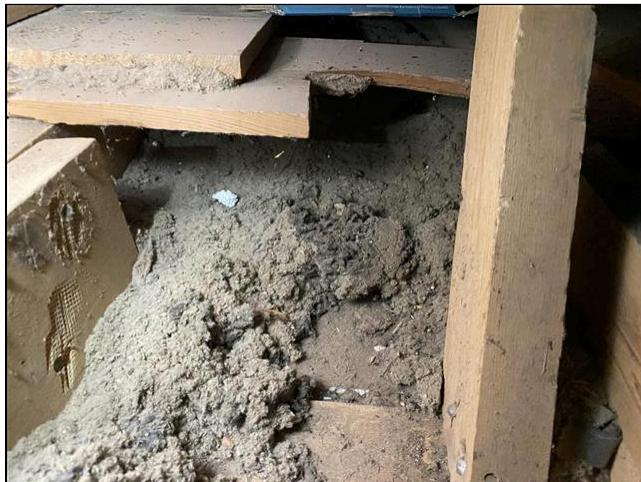
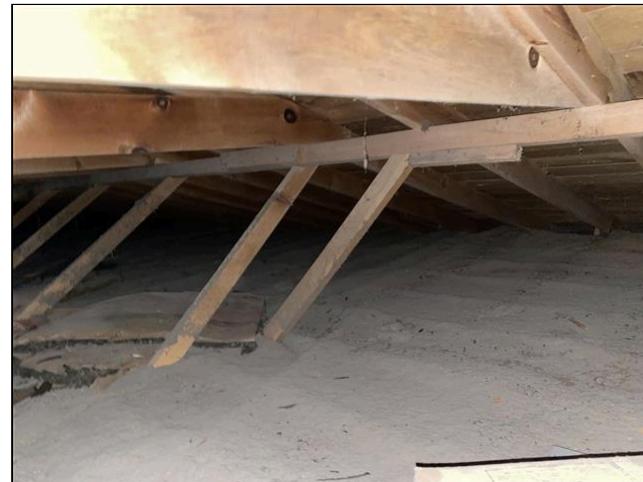
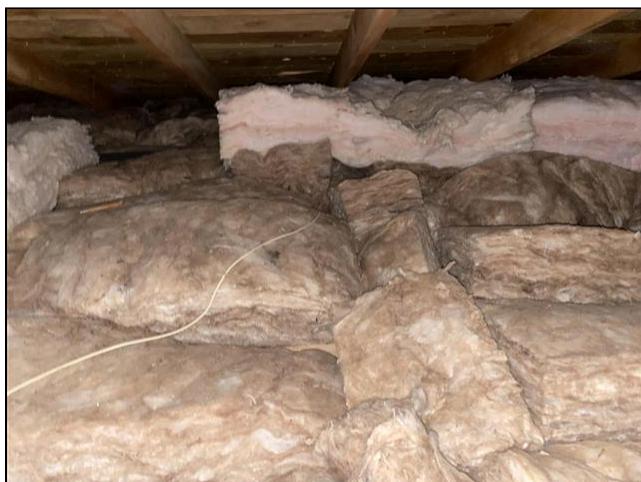
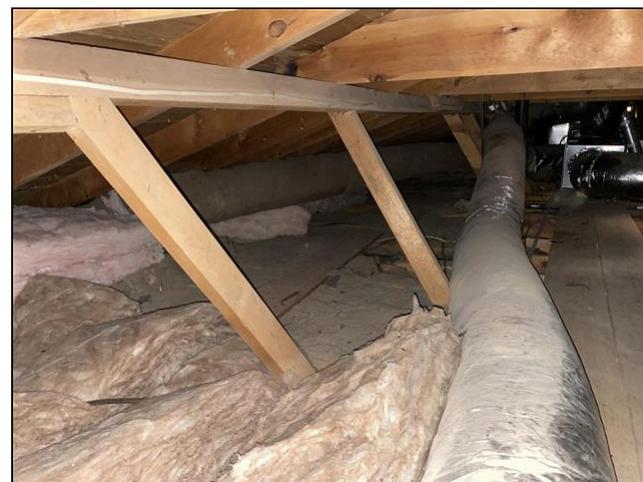
10.2 Attic has (aged) blown and some batt insulation observed in place at most areas throughout excluding garage attic area which has no insulation, typical of most construction.

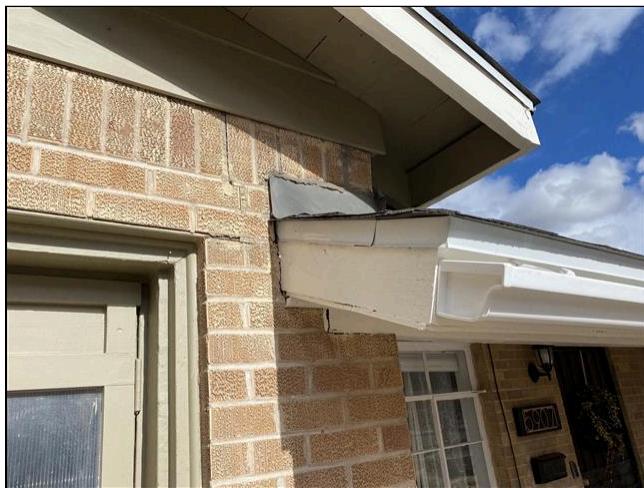
11.0 Item 1(Picture)

Wooden and masonite finishes soffit eaves/overhangs at rear N side of subject home has some weathering and some soffit areas have open gaps observed where meets front fascias.

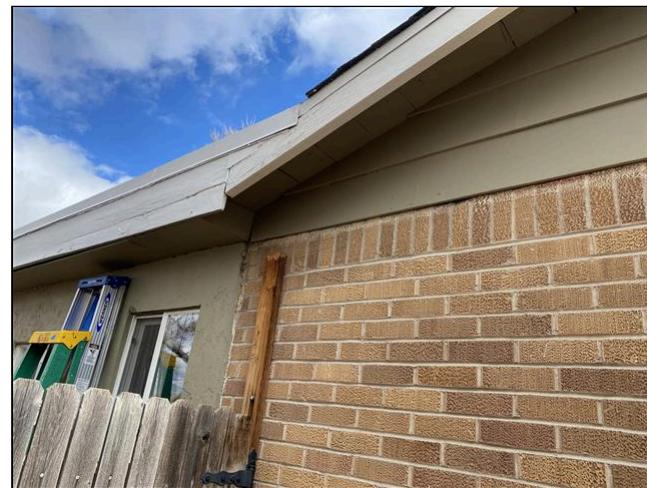
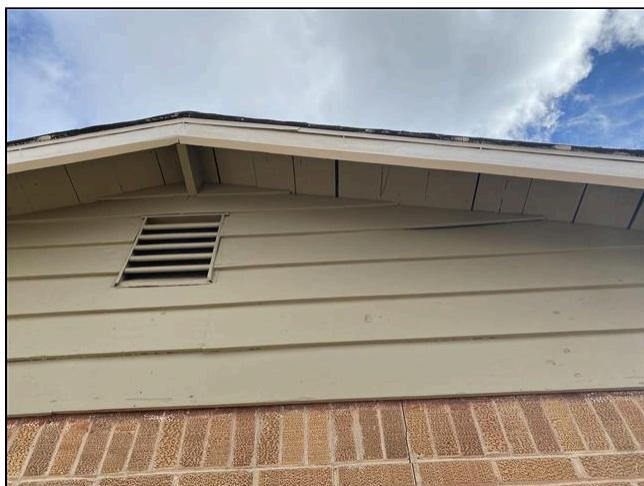
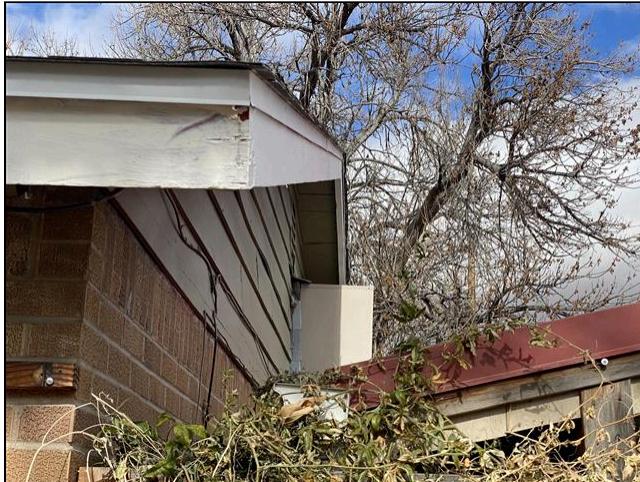
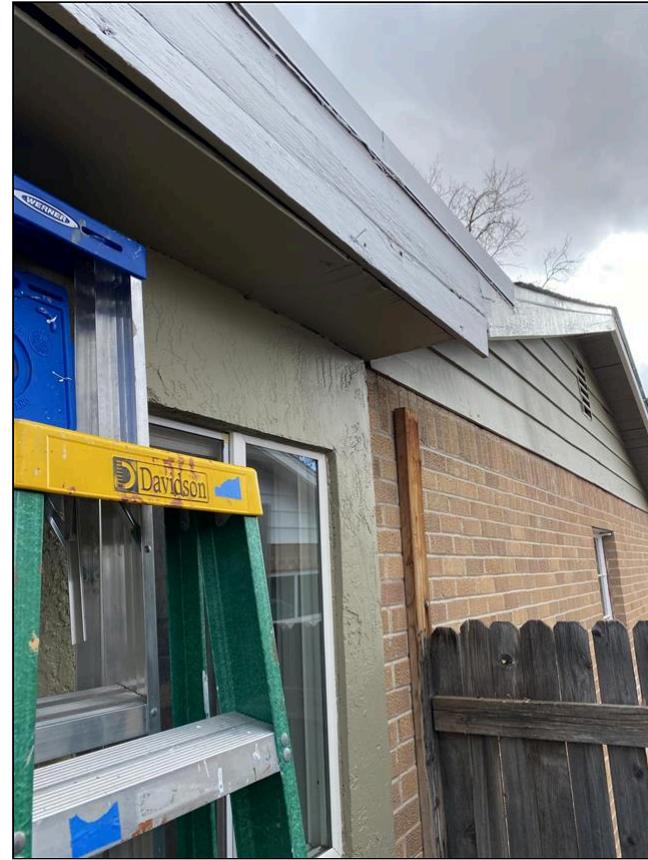
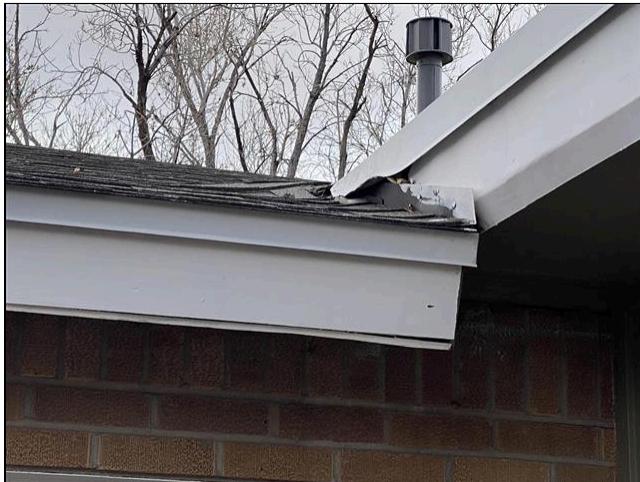
11.0 Wooden fascias with open wooden soffit eaves/overhangs with some cracked/weathering observed.

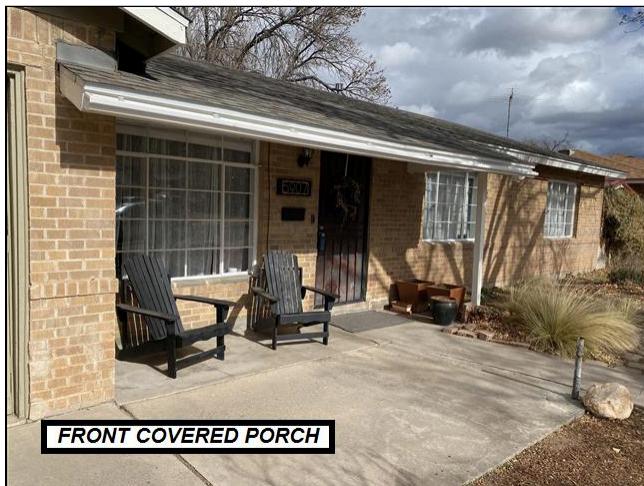
11.1 Item 1(Picture)

Front covered porch has various cracking present and noticeable crack present at/near front exterior entry which has lip/offset observed, potential trip hazard.

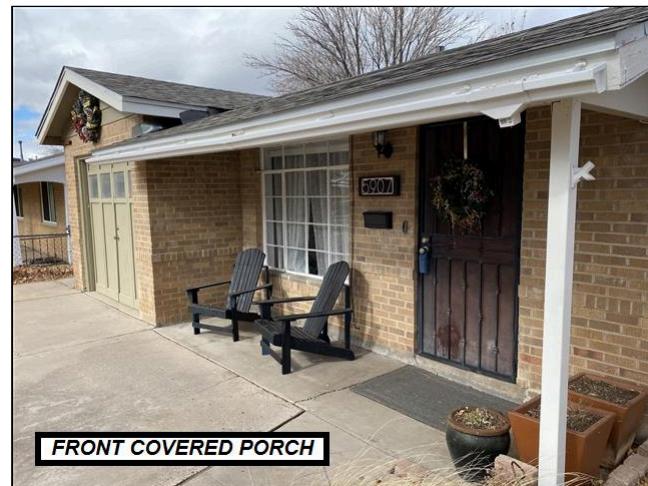
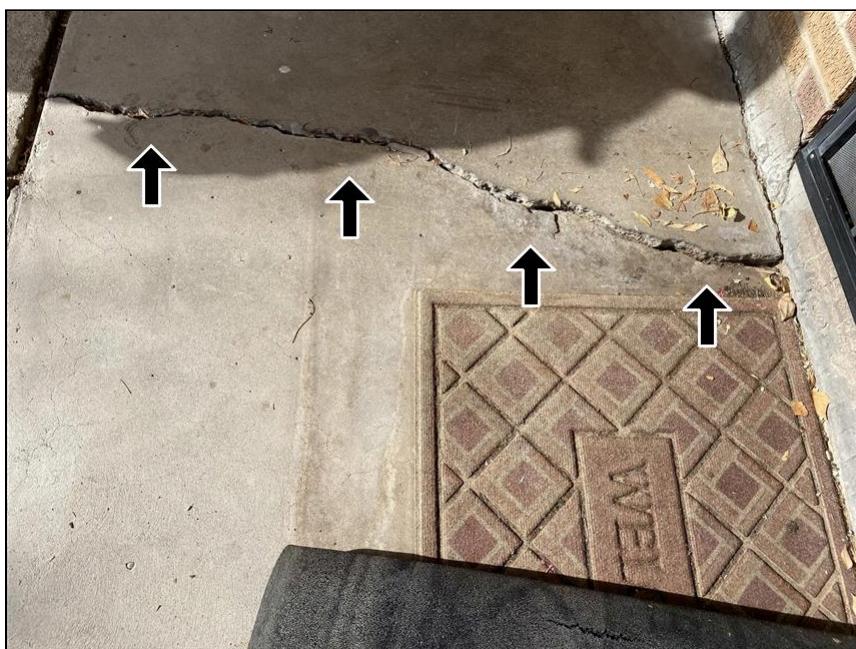
11.1 Front covered porch with concrete walk/floor in place.

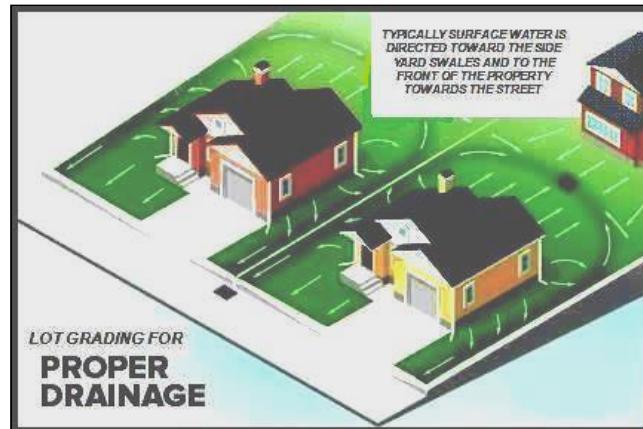
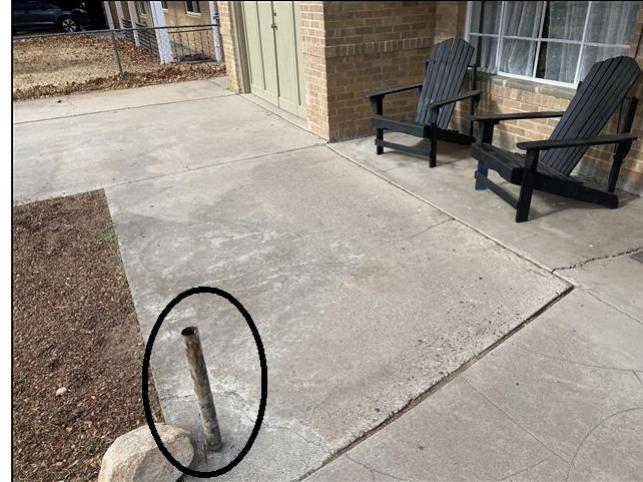
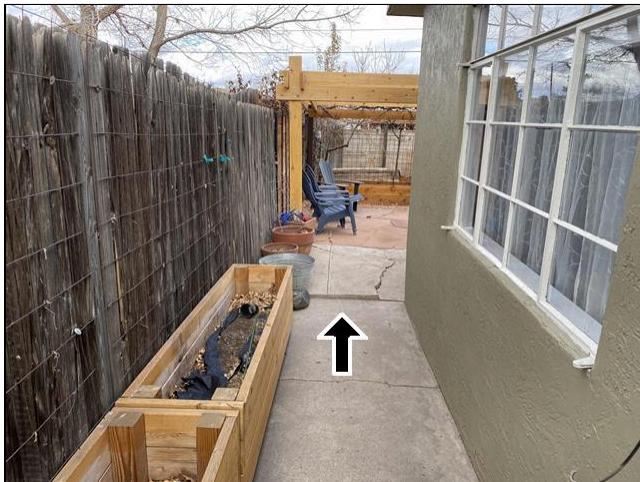
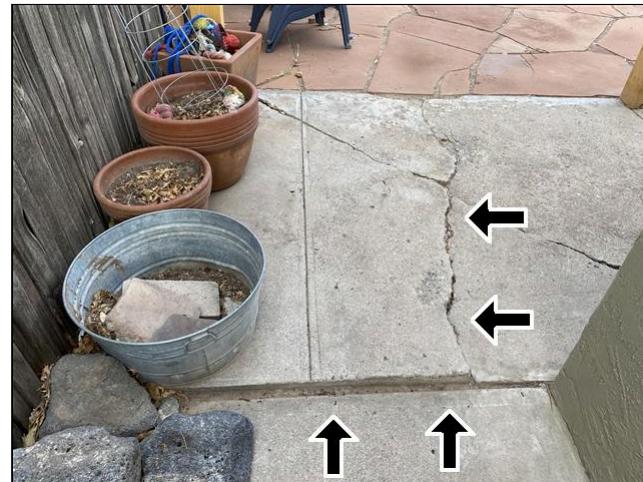
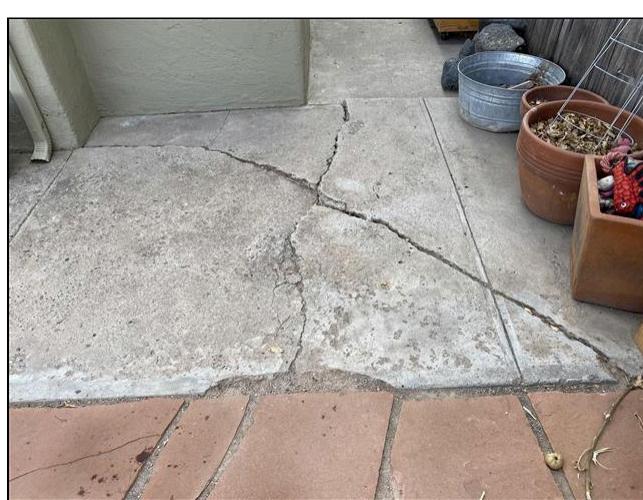
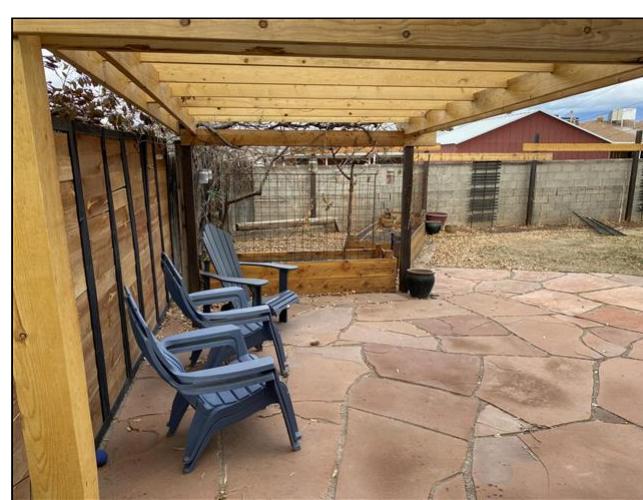
11.2 Concrete walks and drives have moderate cracking and surface wear observed at exterior.

Front exterior concrete walks and drive have various cracks with some chips, surface wear and spalling observed.

Front exterior concrete walk/floor in front of porch area has steel pipe/post sticking up from ground, unknown source/purpose, potential hazard.

Rear W exterior concrete walk has various cracks with lip/offsets observed at NW corner area, potential trip hazard.

Any and all low spots, holes, bushes, trees, vines and vegetation growth, to include bark/wood chips located near structure considered conditions conducive to moisture intrusion and settling if left over prolonged period of time.

Recommend monitoring site drainage during and after heavy rains.

Recommend grading soil to slope away from foundation to avoid any potential negative/poor drainage and ponding near foundation.

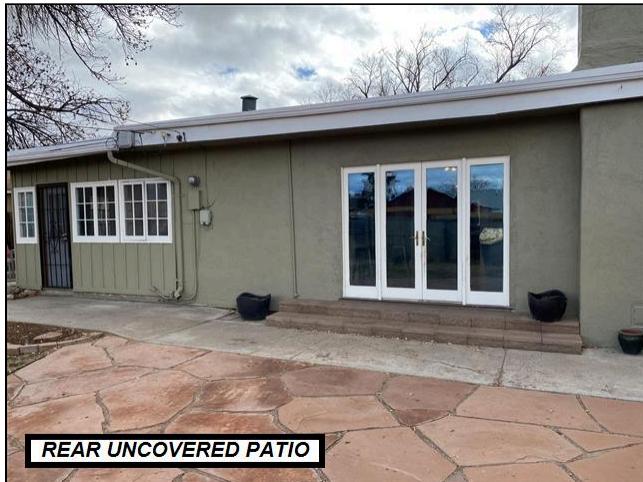
11.2 Item 9(Picture)

Rear uncovered patio outer NE area concrete walk/floor is uneven with various cracks and lip/offsets present, potential trip hazard.

**REAR UNCOVERED PATIO**

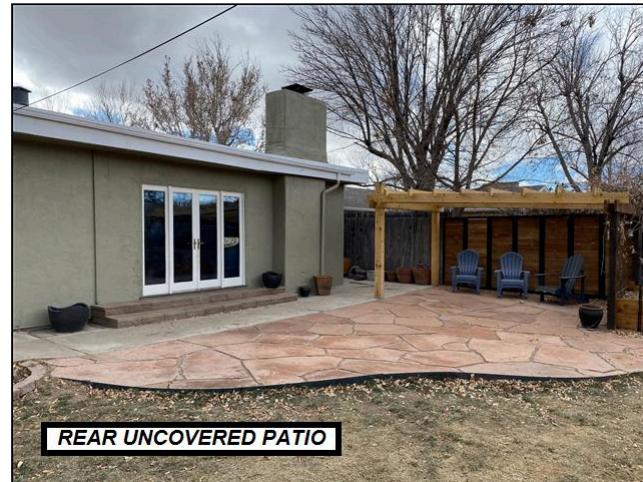
11.2 Item 10(Picture)

Rear outer uncovered patio at NW area has flagstone walk/floor present with some lip/offsets observed, potential trip hazard.

**REAR UNCOVERED PATIO**
