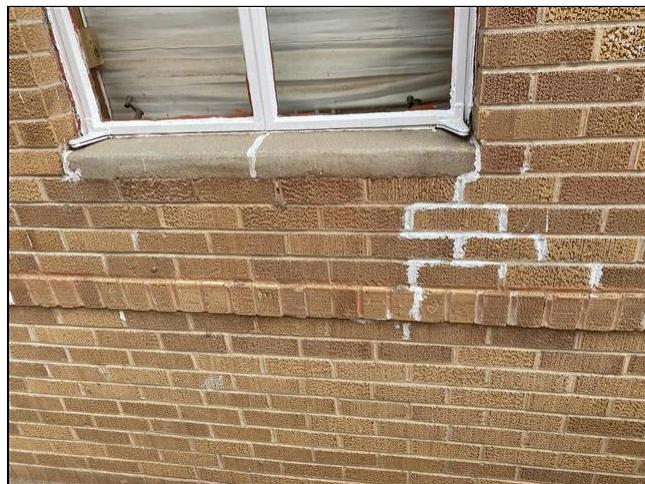
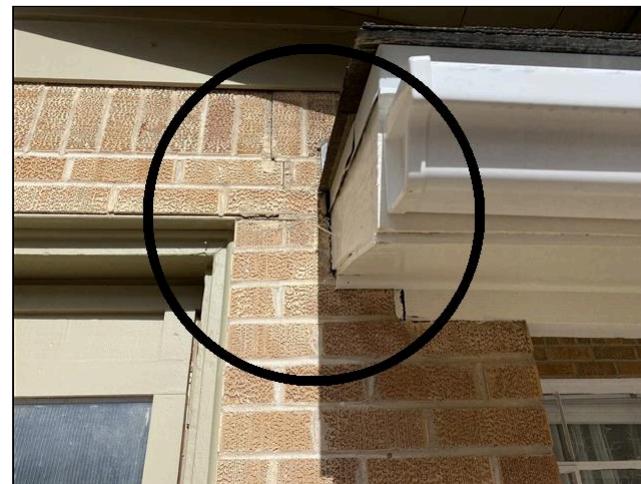
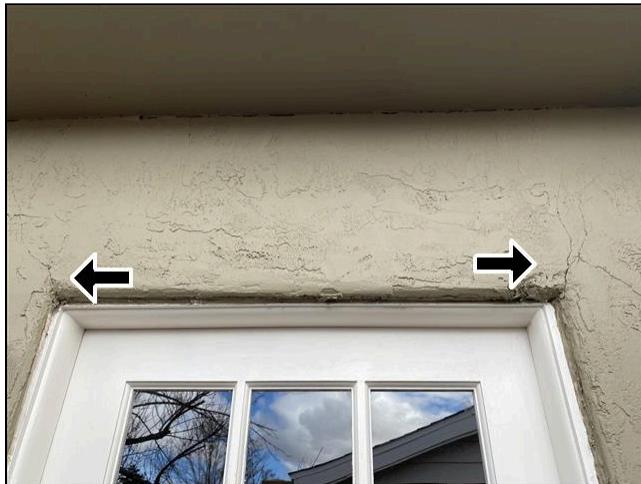
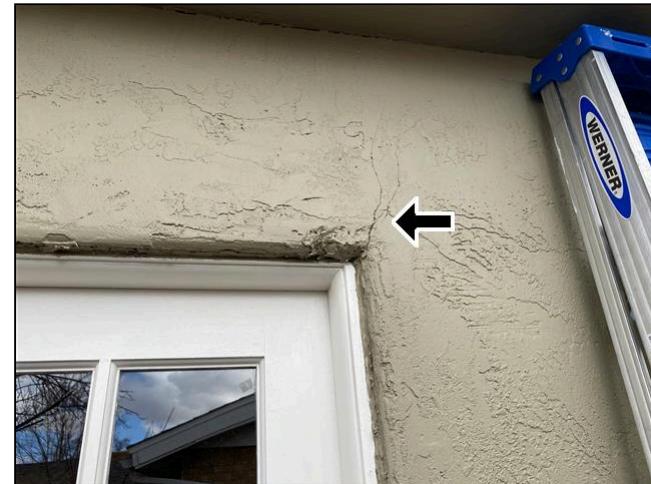
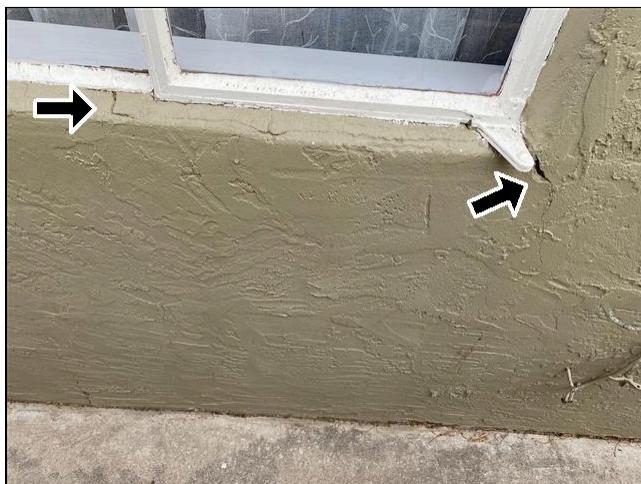
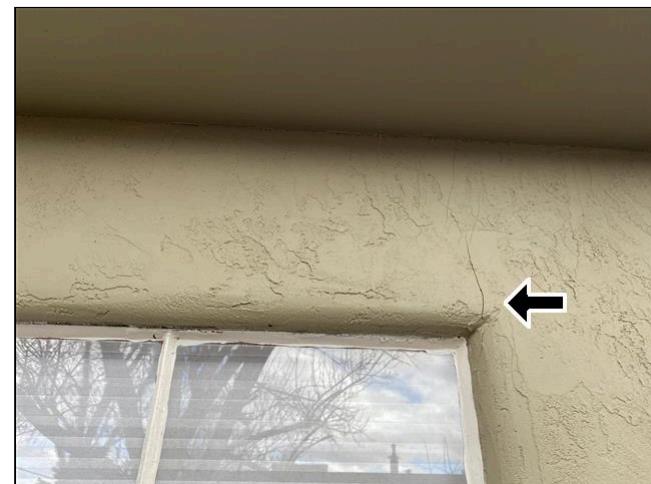
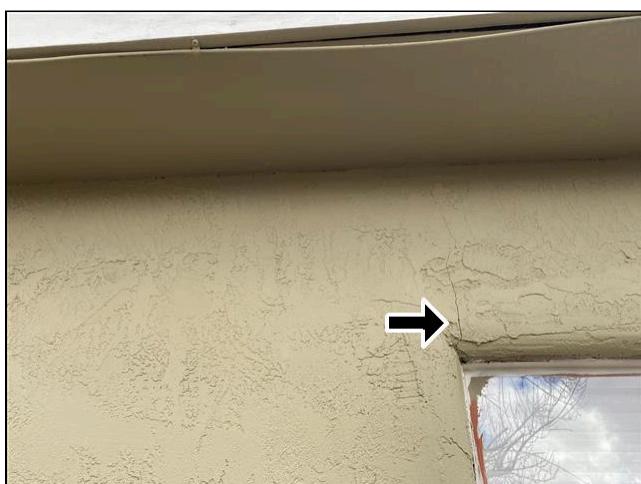
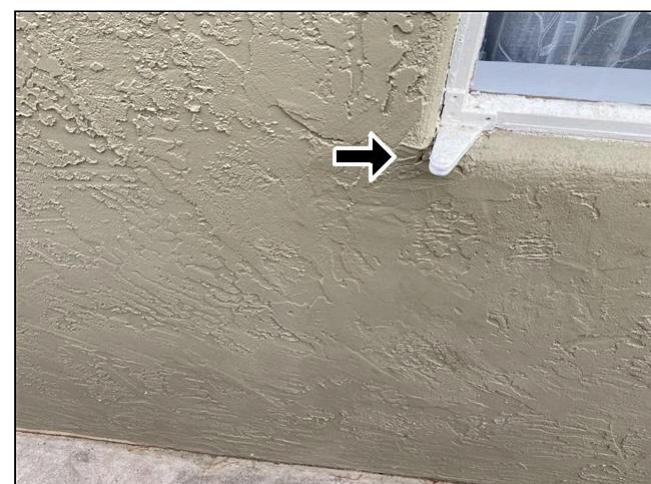
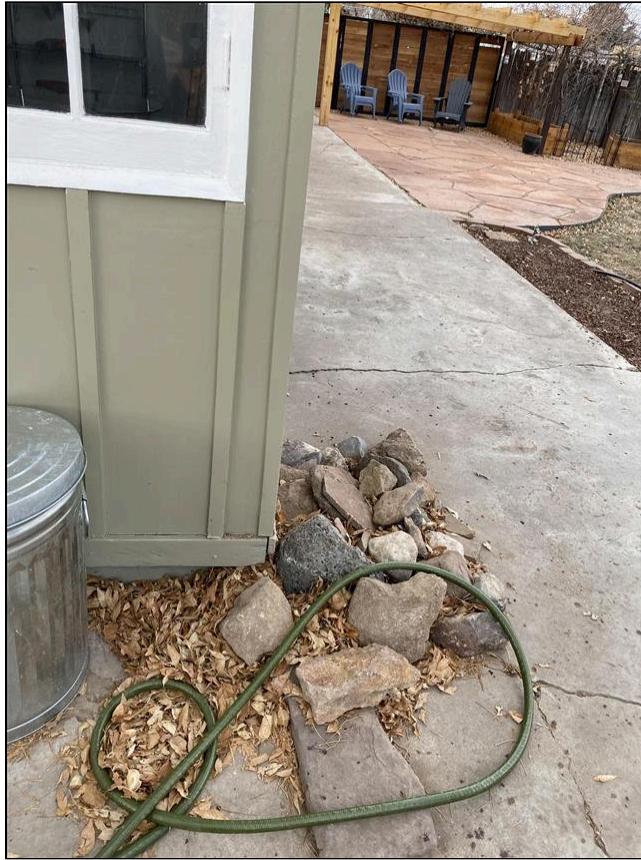
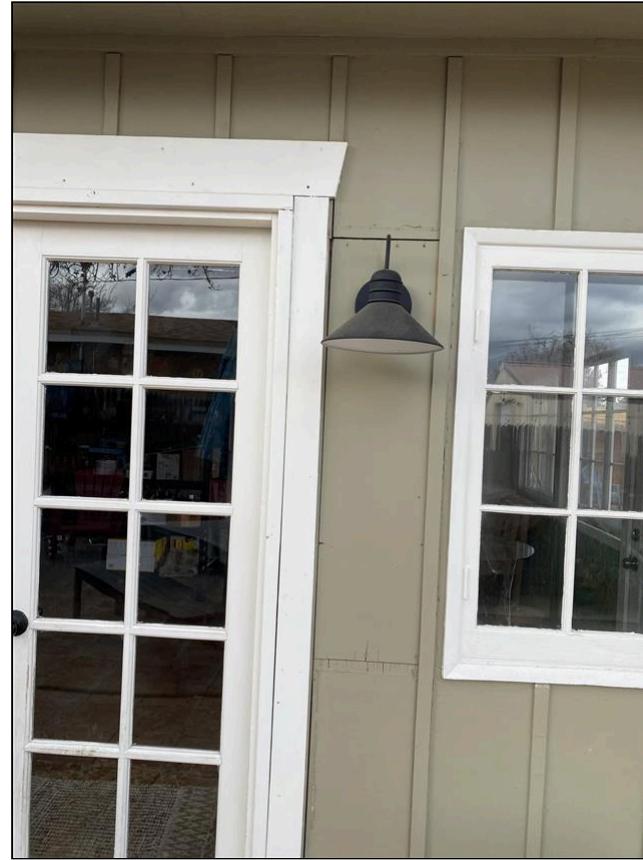
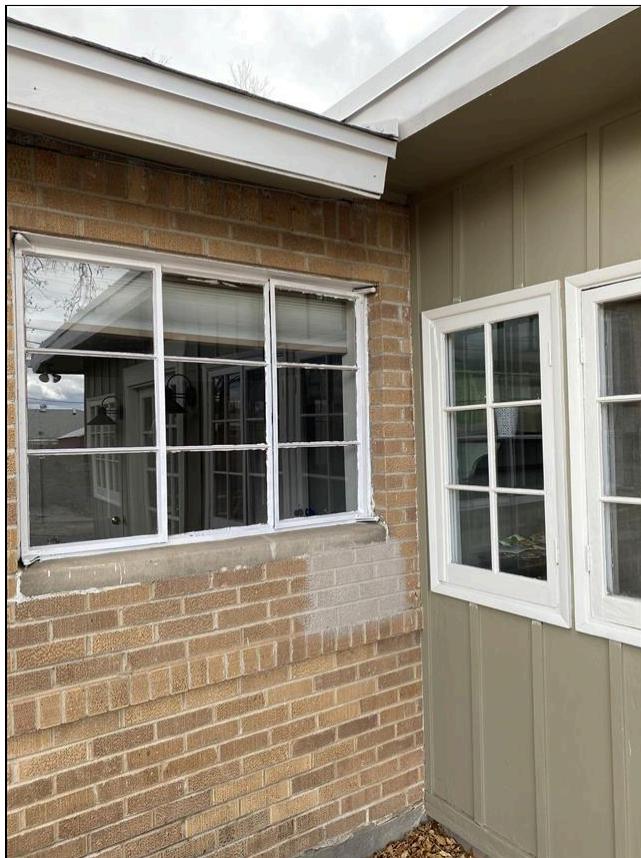
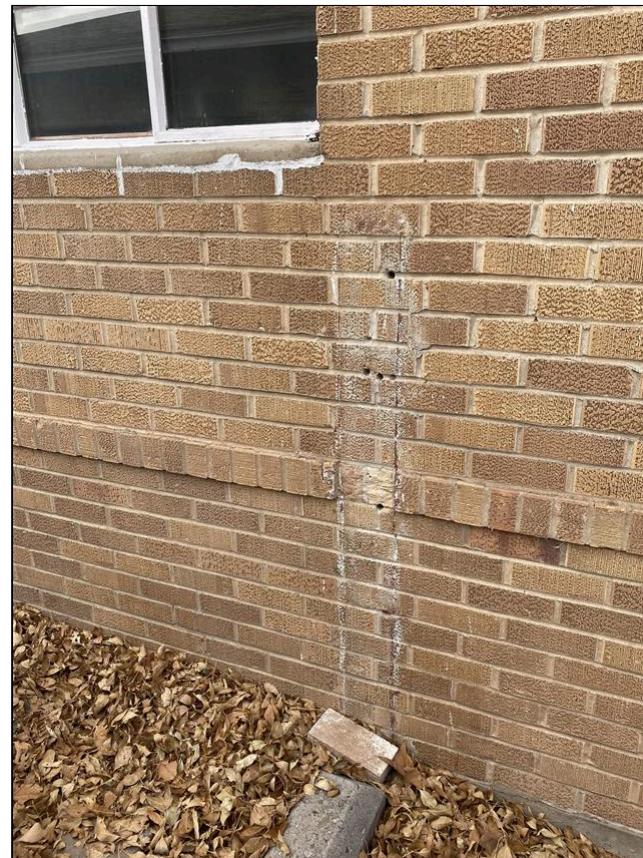
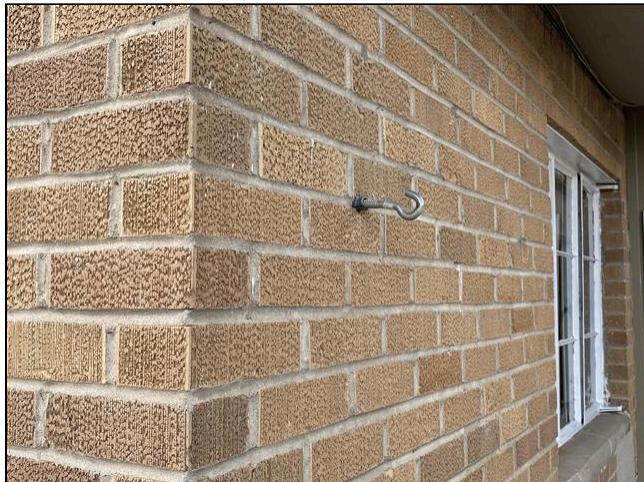
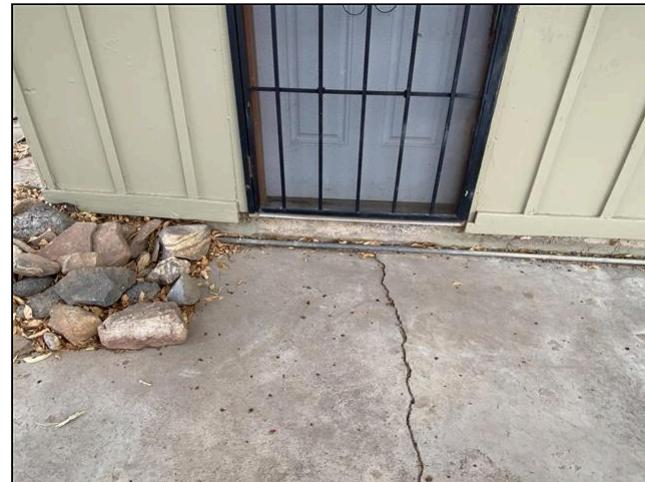
11.3 The subject home has brick, stucco and board & batten siding exterior finish present.

Brick, stucco and board & batten siding exterior has various cracks/chips observed though appears recently repainted in various areas. Cracks should be viewed first hand by potential buyer. The vast majority of cracks should be monitored and maintained over time as needed, however potential buyer may wish to have these areas inspected/evaluated further by a reputable licensed contractor.

Brick exterior has some visible cracked mortar joints observed at front upper E end of garage doorway entry area.

Brick exterior has some cracks with patched mortar joints observed on lower areas of window on side of home.

Stucco exterior has various cracks/chips observed at but not limited to window and door frame corner areas.

Wood lap board siding observed at upper pitched E and W sides of home.

Any unsealed areas to include cracks at window or door frame areas at exterior can permit moisture intrusion, which is the principle cause of deterioration of any surface, unfortunately this type of moisture

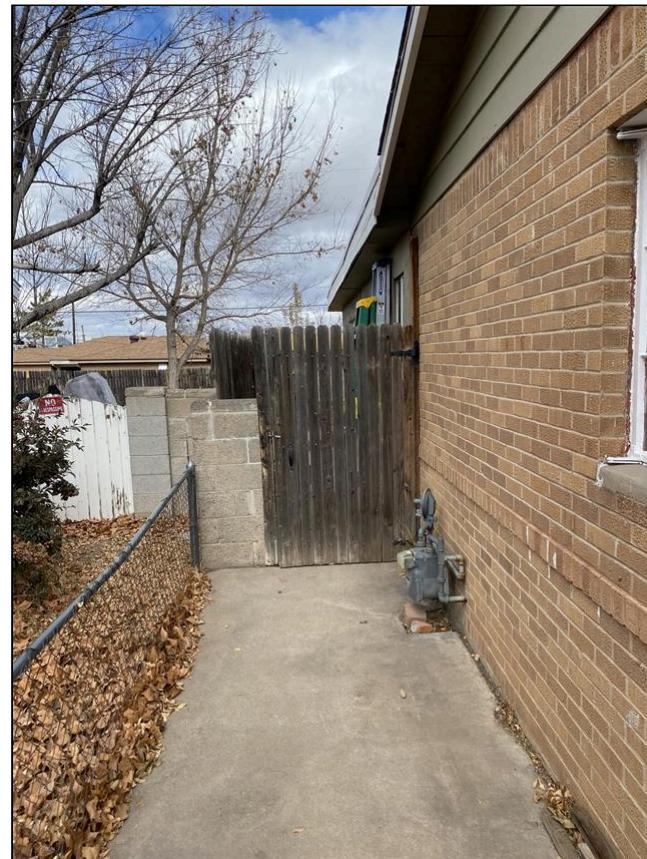
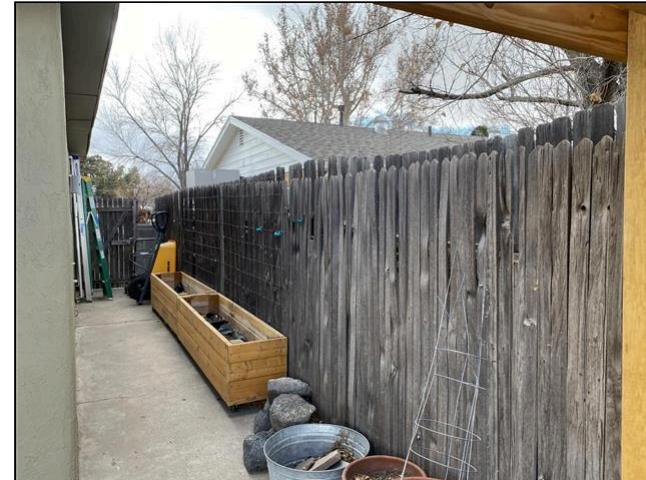
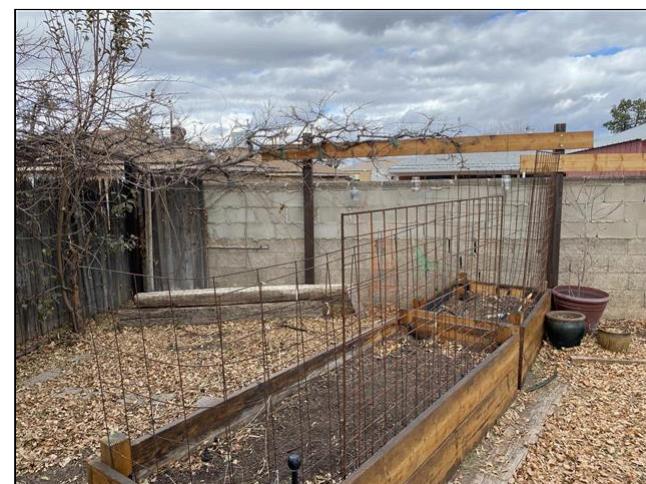
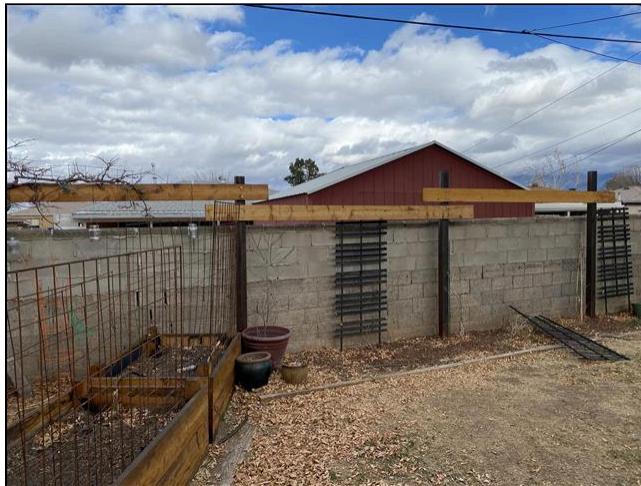
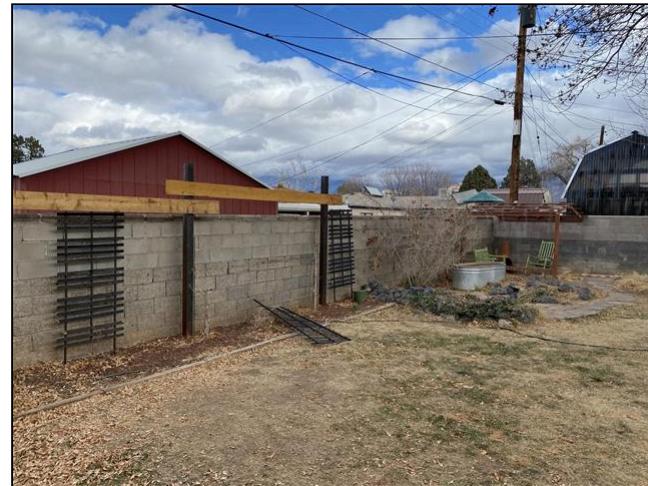
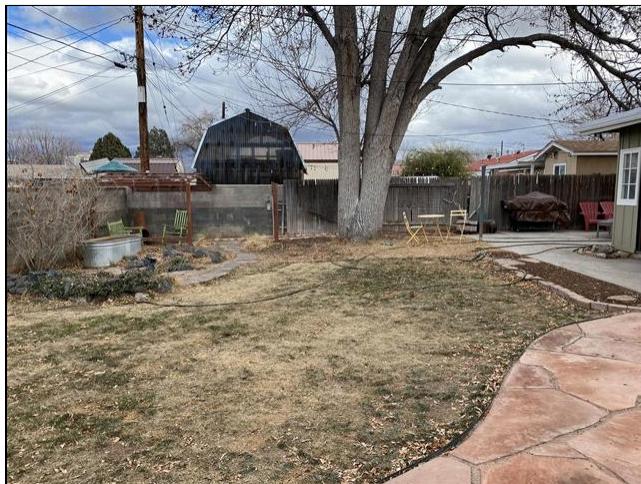
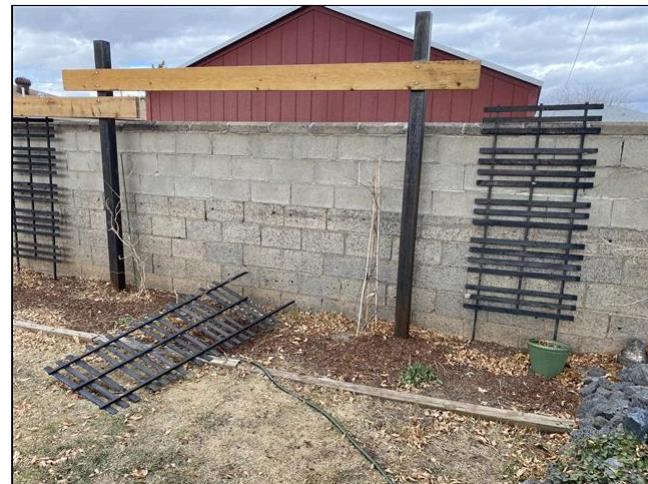
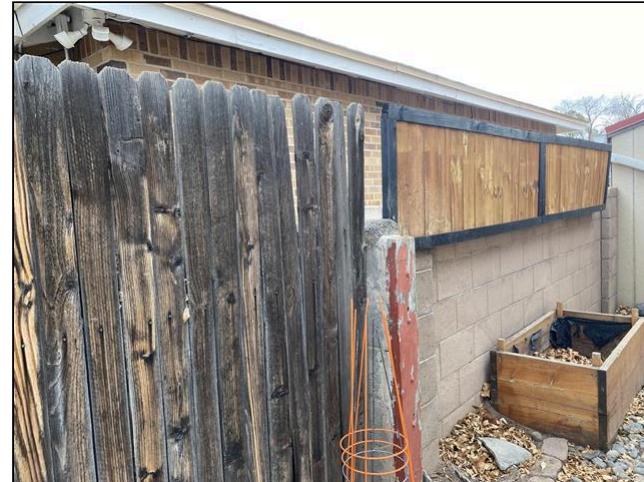
11.4 (1) Wooden front/rear divider gate observed at W side of home with some cracked/weathering observed.

Cinder block divider walls at rear yard outer perimeter of subject property has various cracked/chipped mortar joints observed.

Cinder block divider walls at rear yard outer perimeter of subject property elevated/raised at N side and unstruck mortar joints also known as (weeping mortar), wall also has various chipped mortar joints with some open gaps observed and should be properly filled/sealed.

Wooden divider fencing at rear W side of home has various cracked/weathering and some direct wood/earth contact observed.

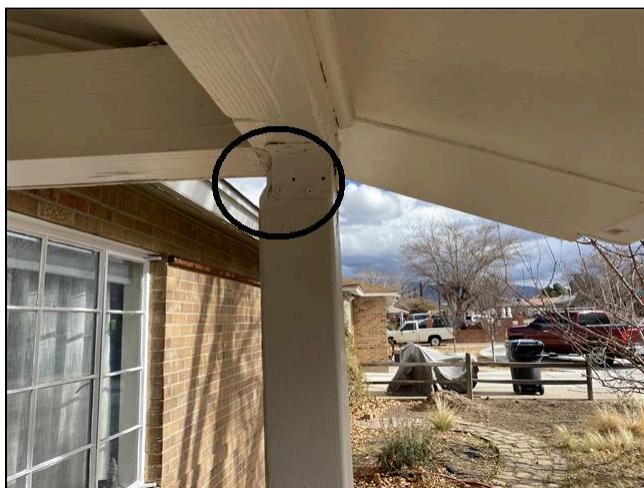
12.1 Item 1(Picture)

12.1 Wooden 4x4 post support observed at front covered porch has chipped blemish observed at top near beam tie-in above.

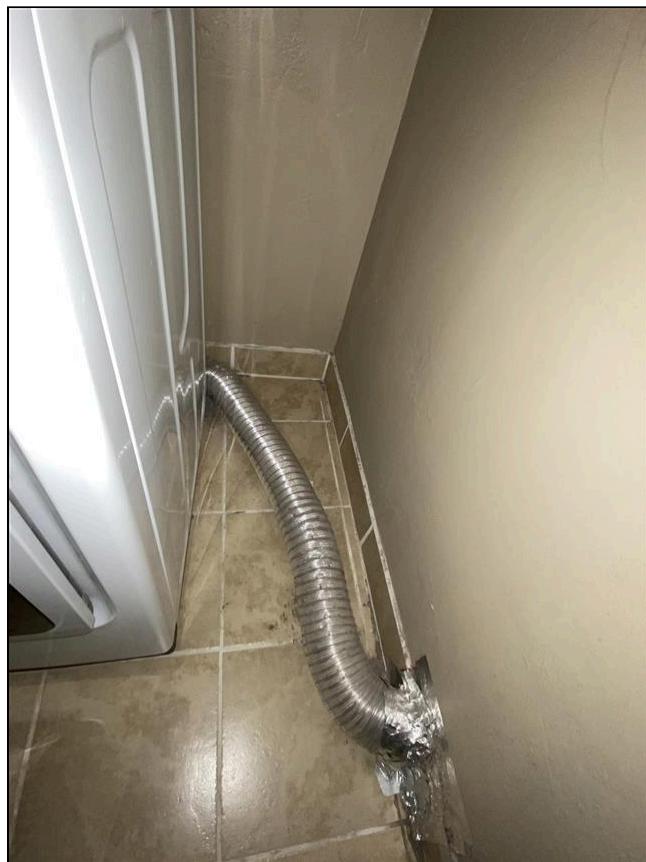
13.0 Item 1(Picture)

13.0 Note: Dryer vents with vertical duct are prone to lint build up.

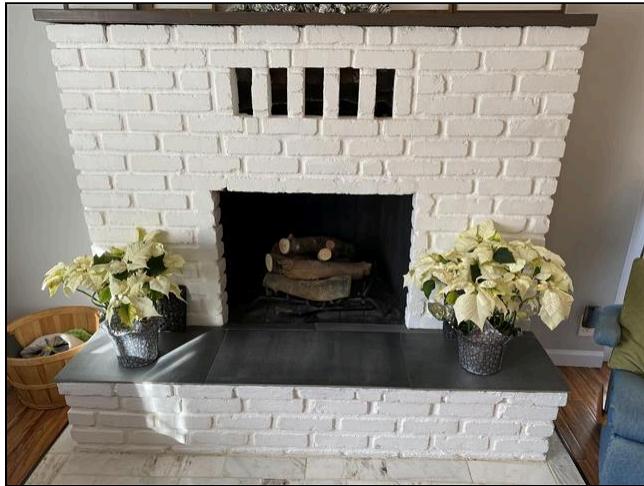
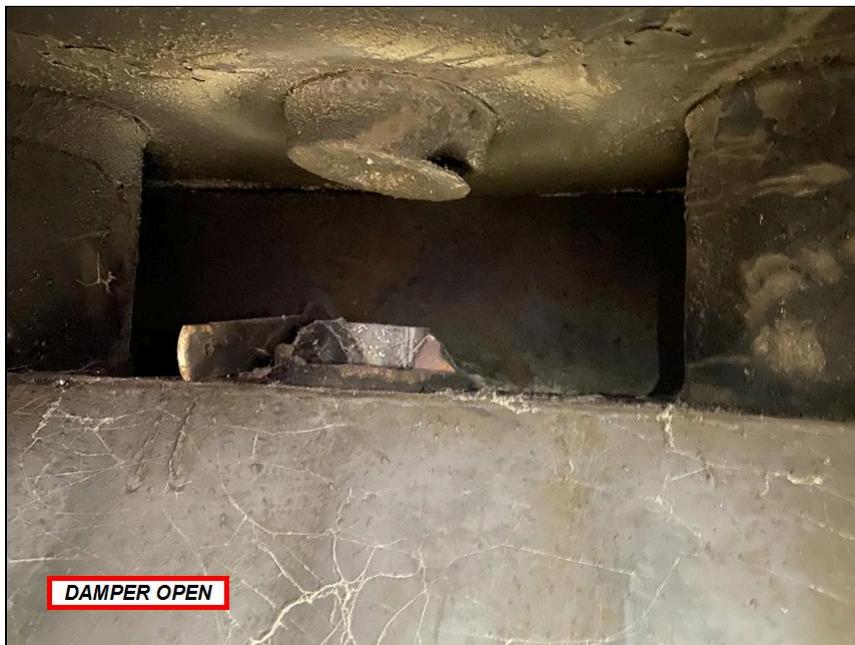
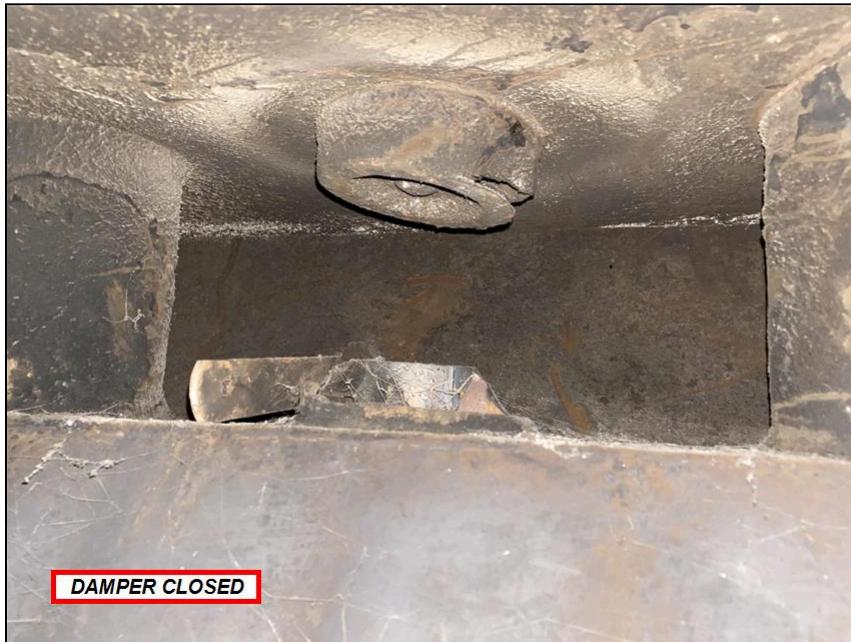
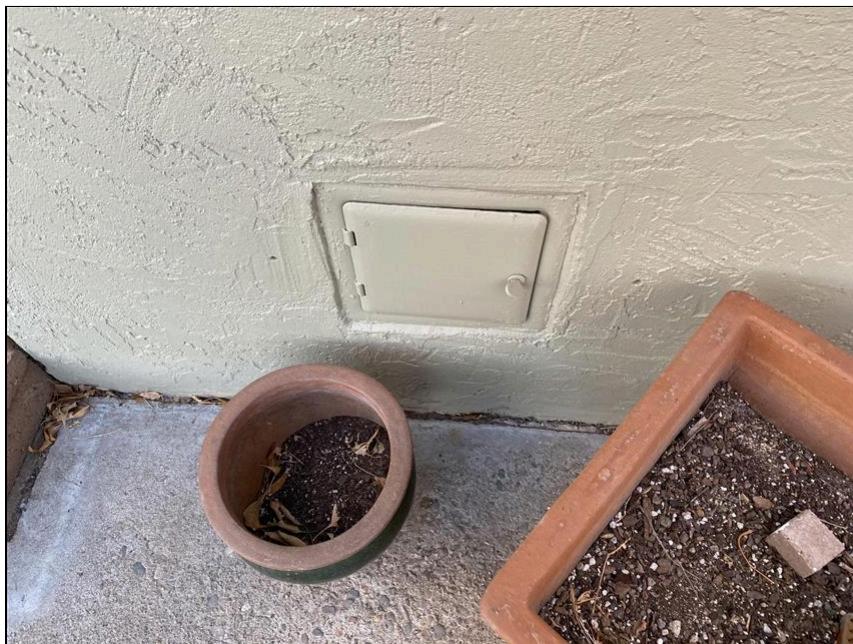
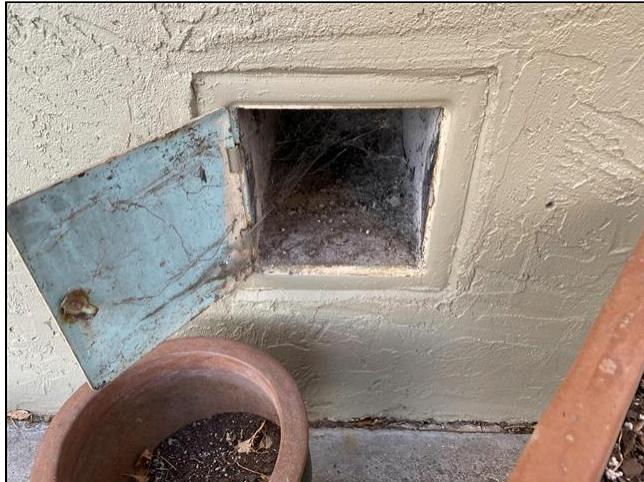
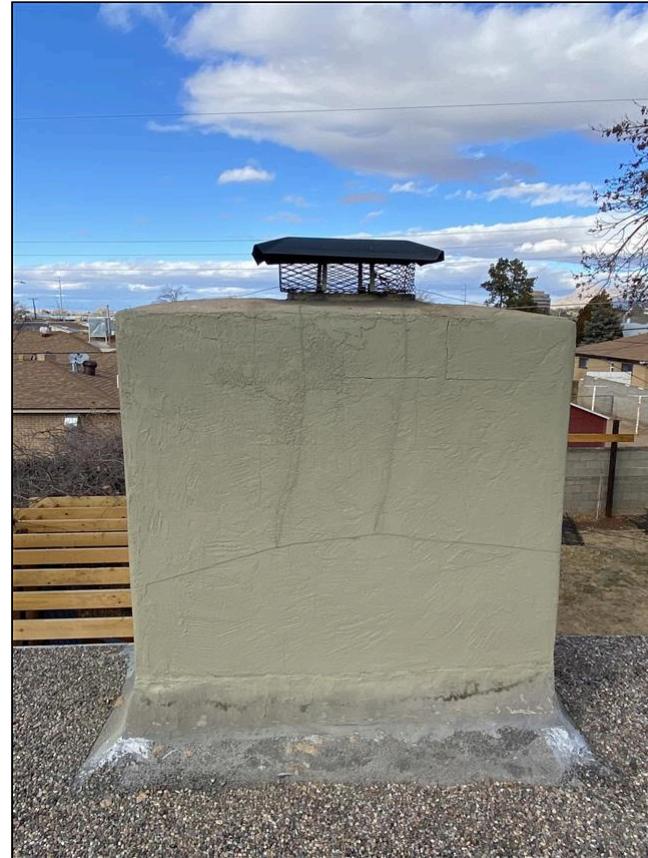
13.1 Solid fuel wood burning fireplace at **NW den/great room N wall** with manufactured metal interior and no front enclosure door cover and no screens in place at time of inspection. For safety reasons, this fireplace and its chimney or pipe to which it is vented should be cleaned and inspected frequently as defects may develop over a short period of time. Fireplace has ash clean out observed at rear lower area of fireplace/chimney. Although not actually tested the fireplace appeared to be functional, however, cleaning may be necessary. Fireplace has no visible gas lines observed. Fireplace has no blower fan. Fireplace/chimney has stucco exterior with masonry flue pipe and metal rain cap and spark screen in place.

occurs, a reputable/qualified chimney sweep professional should be contacted for further evaluation and/or repairs as needed.

Chimney/fireplace interiors/liners and all related items not inspected/evaluated considered beyond scope of this inspection, should further evaluation be required recommend contacting reputable/licensed chimney sweep professional for further evaluation.

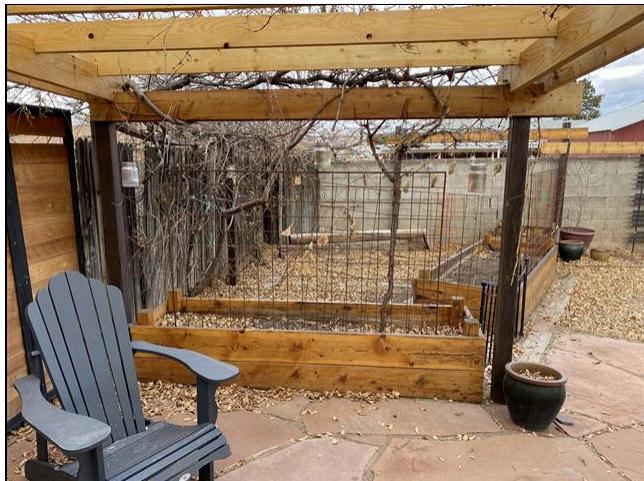
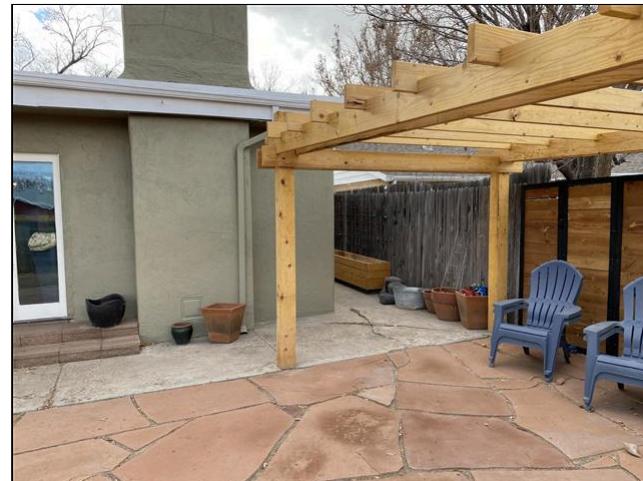
Note: Any and all detached structures to include but not limited to rear E detached storage structure, rear NW detached pergola structure and related items not inspected or evaluated, excluded from and considered beyond scope of this inspection.

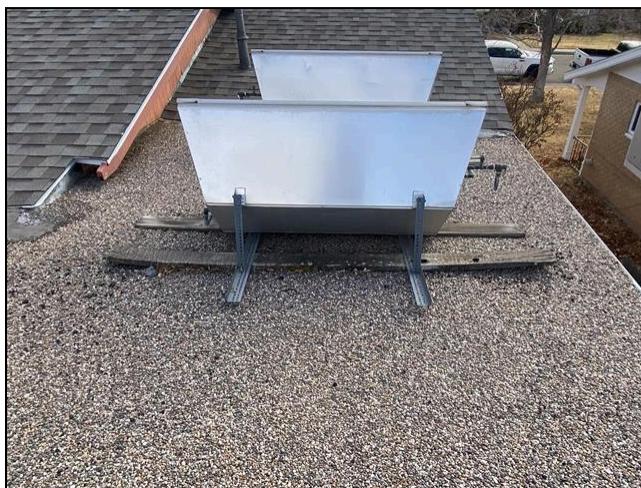
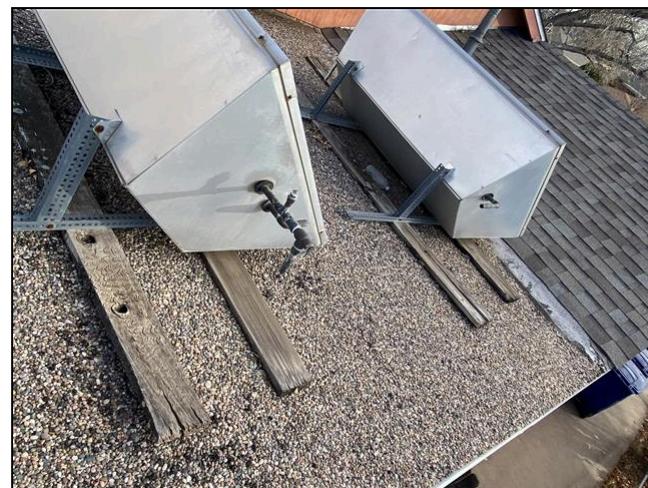
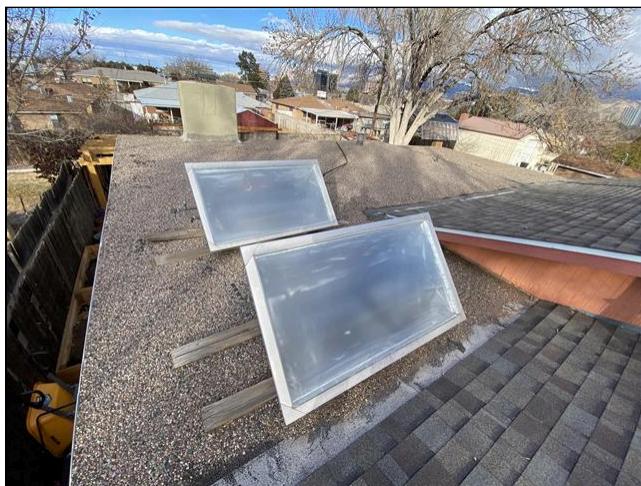
13.3 Solar heating sources and related items are not fully inspected. Typically special testing requirements apply and are excluded from, considered beyond the scope of typical home inspection. (Solar panels at rear NW area of roof appears to be disconnected/abandoned and no longer in use).
