**Regular Visual Termite Inspection Report in accordance with AS 3660.2-2017****H 1120337**

Client: Cardow + Partners. Re: Structure at: WO # 58139-1980

Address: 31 Arkan AVE  
Woolgoolga State: NSW Postcode:

Date of the Inspection: 24/7/26 Invoice No:

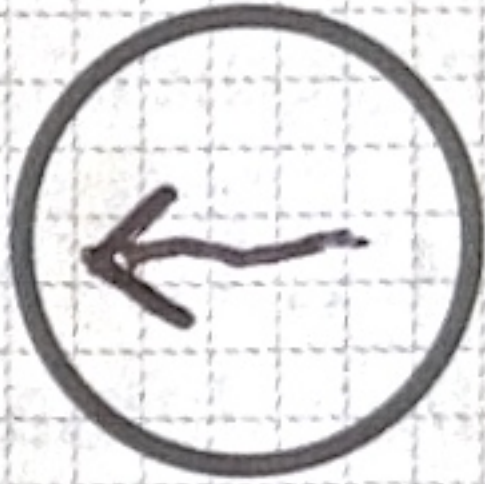
STump - W
