orbit

Volume 30 | Number 1 | 2010

A Technical Publication for
Advancing the Practice of
Operating Asset Condition
Monitoring, Diagnostics, and
Performance Optimization

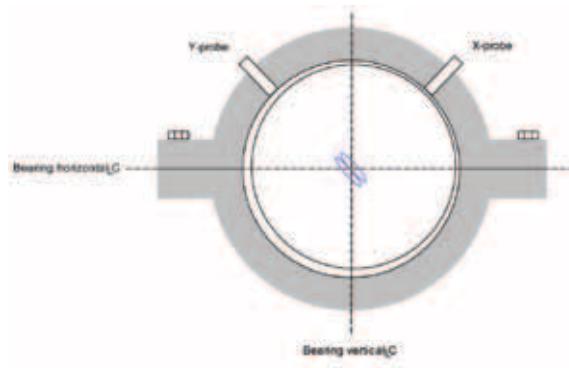
Figure 3C: This orbit again has the same amplitude and frequency (1X) as the orbits of Figures 3A and 3B. However, something is clearly different as shown by the "figure 8" pattern of the orbit. With only an X-probe installed, this change in condition would be missed. Indeed, the monitoring system would detect no change at all between Figures 3A, 3B, and 3C. It is only when a Y-probe is installed that such important changes can be detected.

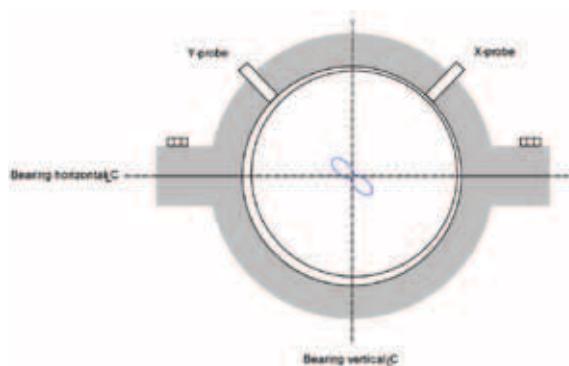
Figure 4: This orbit shows approximately 4 times as much vibration in the X-axis as in the Y-axis. If only amplitude from the X-probe was observed, as would be typical from a radial vibration monitor with only a single probe, such a machinery condition would be missed. Indeed, the X-probe would observe exactly the same vibration amplitude as in Figures 3A, 3B, and 3C.

Consider again the orbit of Figure 4 exhibiting the so-called "figure 8" shape. Depending on where a single transducer was oriented, it may see two vibration peaks per shaft revolution (2X vibration) or one vibration peak per shaft revolution (1X vibration). The malfunctions that exhibit high 1X vibration versus 2X vibration are quite different, and the ability to differentiate such conditions can easily be the difference between a relatively benign change in machinery condition such as imbalance and a serious problem requiring immediate intervention such as a shaft crack, severe misalignment, or a heavy rub.

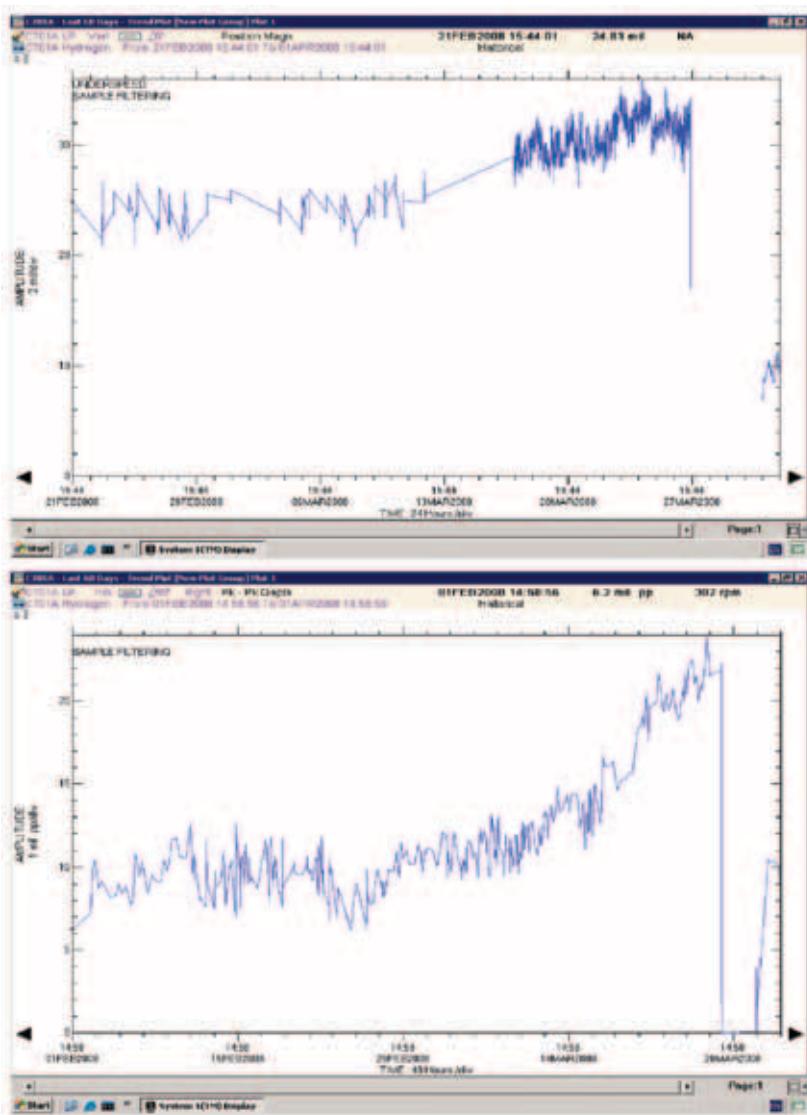
Figure 2: System 1 Trend plot for Rod Position magnitude (top) and horizontal peak-peak displacement (bottom)

Shortly after the overhaul in June 2007, an unusual rod position pattern was observed. The center of the rod position deviated from its normal position and the piston rod position moved with patterns that did not repeat. Eventually the rod position magnitude alarm came in and our Machinery Diagnostics Services (MDS) team was called to review data. Toward the end of February 2008 operations reported hearing a slight knock on the first stage. The plant engineers reviewed all the data and the rod position probe mounting, and concluded that the rod movement was real. Since the amplitude change occurred in both horizontal and vertical directions and the probe mounting was not impaired visibly, the malfunction of the probes themselves was ruled out as the cause for the rod position movement pattern change (Figure 2).

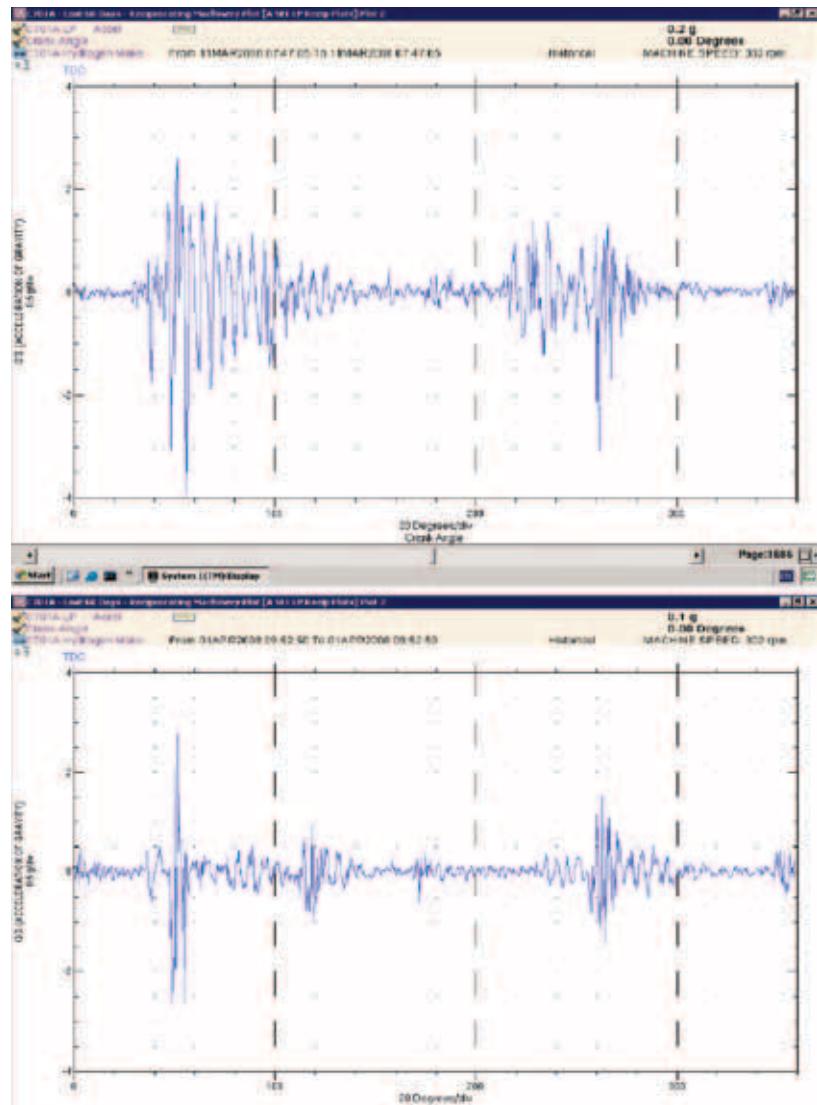
Figure 3: System 1 plots for crosshead acceleration versus Crank Angle, before (top)/after (bottom) repair. The screenshots showed only one stroke cycle, the historical data is stored continuously for every stroke of the compressor.

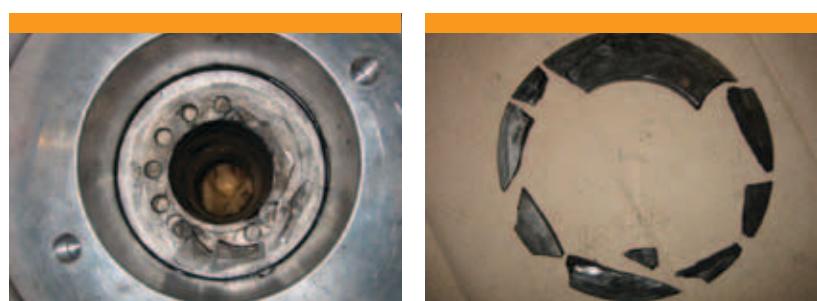
First, the crosshead Superbolt® was inspected and was found to be in good condition. All crosshead and crosshead pin clearances were found to be within specification. Next, the cylinder head was removed, revealing the piston nut damage. The minovar collar was found to be severely deformed and the piston rod had suffered thread damage. The collar and piston assembly were replaced, and the compressor returned to service without production loss.

Figure 4: Minovar Piston Collar Damage

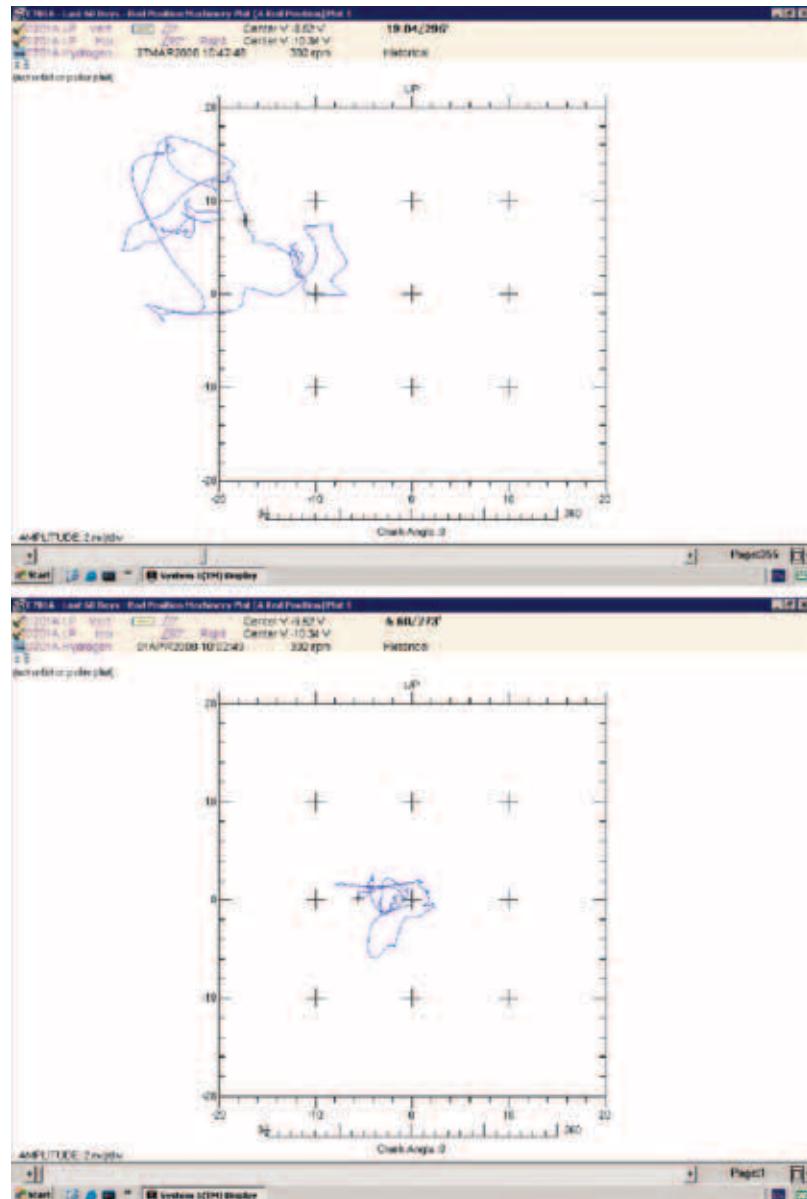
Figure 5: System 1 Rod Position plots before (top) and after (bottom) repair.

After repair, the rod position plot showed rod displacement reduced and rod position moved to the center (Figure 5).

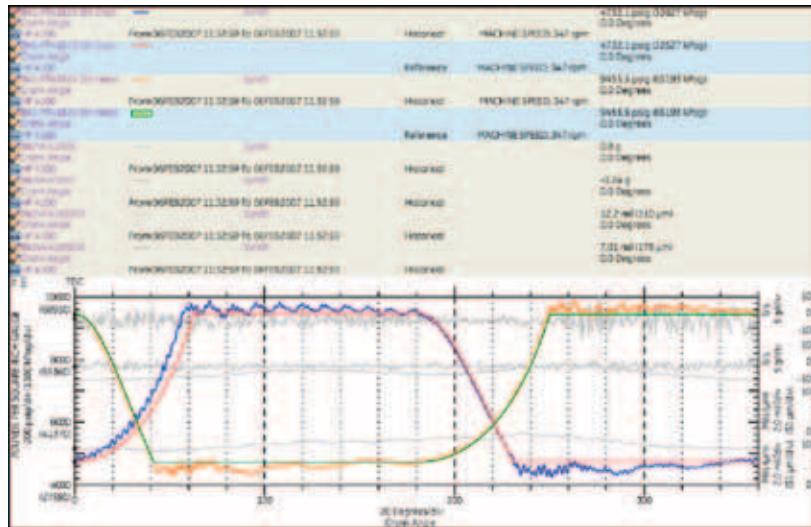
Figure 9: 5th Stage Cylinder Pressure, Cylinder Acceleration, Crosshead Acceleration and Rod Position Versus Crank Angle. 07 Feb 2007 19:06:31

The two plots show that the leak existed prior to the alarm and that the leak seems to be worsening. In order to gauge probable valve life, the diagnostic engineer needed to understand when the leak began. In other words, the diagnostic engineer needed to understand when the

Valve condition deteriorated more rapidly than expected. Figure 9 shows the cylinder pressure, acceleration and rod vibration data seventeen hours after the alarm. The leak in the valve has become so severe that internal cylinder pressure on the crank end never reaches suction pressure. More critical than valve condition, as can be seen in Figure 10, the first reversal occurs at 222° ATDC and the second at 328° ATDC. Degrees of reversal have dropped from the 161° shown in Figure 3 to 106°. Although not yet near OEM limits, the rapid change of rod load and reversal over a seventeen-hour period clearly shows lubrication conditions at the crosshead pin to be deteriorating rapidly.

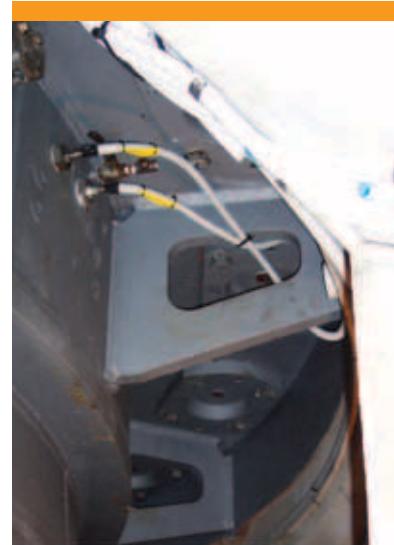
Figure 5 presents an example of redundant dual radial proximity probes mounted through the casing. Depending on the criticality of the hydro-generator, these 'redundant' probes may simply be installed spares with cables connected to a Proximito* sensor. They would not actually be wired to the monitoring system unless the normally connected probe fails.

Figure 5: An example of redundant XY transducer observing shaft in the closed space (only one of XY transducer and its redundancy is visible at the photo)

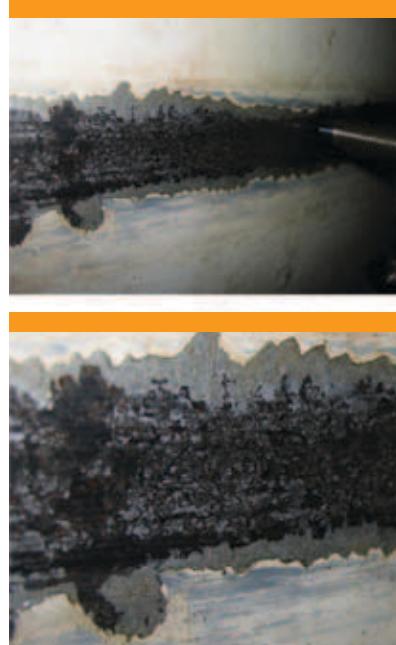
Figure 6: An example of eddy current transducer operating with a 250MW hydro-generator shaft in area close to the guide turbine bearing (upper) and closer view of the shaft surface (lower).

The following is one of XY-eddy current transducers operating with an unprepared shaft area close to the turbine guide bearing. One can see the very bad surface of the shaft (Figure 6). This is actually typical for this rotor section after long periods of operation in corrosive environments. However, even with this corrosion the signal quality can be sufficient to collect reliable data about rotor system dynamics and shaft position in bearings.

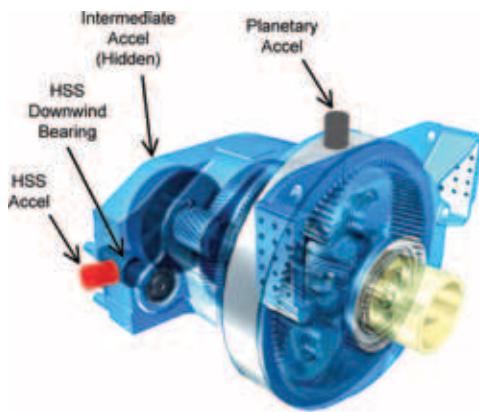
Figure 1: Wind turbine gearbox, viewed from the main rotor side. The high-speed shaft downwind bearing (HSS DW) and accel locations are shown. The high-speed accel location used for this case history is shown in red.

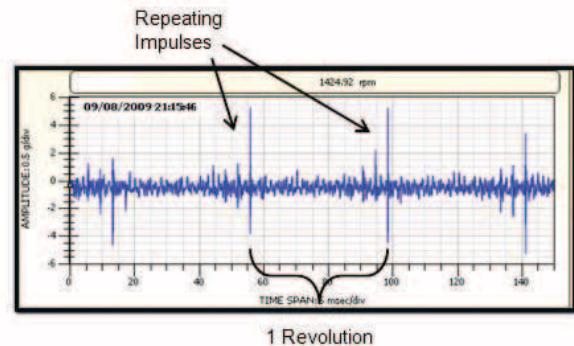
Figure 2: High-speed acceleration waveform from ADAPT.wind software showing periodic impulse patterns. The patterns repeat once every revolution.

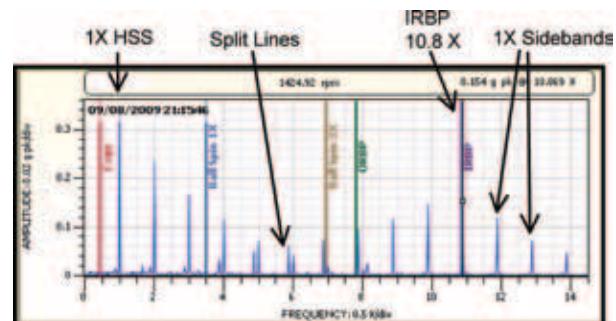
Figure 4: Acceleration envelope spectrum of waveform in Figure 2 (September 2009). The key bearing fault frequency lines are overlaid on the plot. The IRBP fault line is a perfect fit to the data. The split lines show that the two harmonic series are separated. Data processed in ADAPT.wind software.

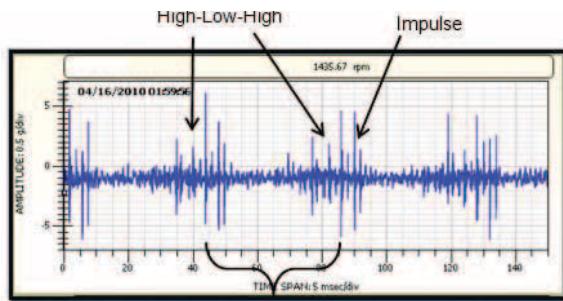
Figure 5: Data from the same bearing as Figure 2, but several months later. The vibration signature has become more complex.

Although the amplitude of vibration remained about 5 g, there were two primary differences between the data in Figure 5 and the data in Figure 2. First, the impulse pattern in Figure 5 shows a repeating high-low-high impulse pattern with each revolution. This differs from the steadily rising amplitude pattern in Figure 2. Secondly, there is another set of lower-amplitude impulses that are offset by less than the element passage period from the larger set. This “double impulse” set appears at the same place every revolution. These changes suggest that more damage has developed on the inner race; the second change suggests that some of the additional damage is smaller than the original damage we observed before.

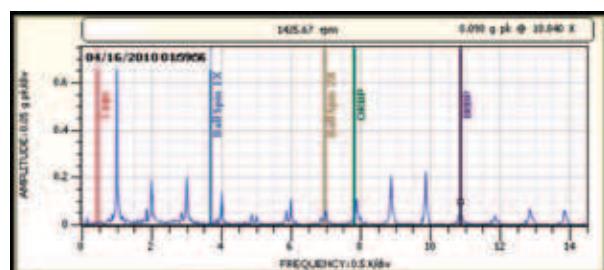
Figure 6: Data from April 2010. Compare to Figure 4. The amplitude of the IRBP line is lower, while the 1X line amplitude is higher.

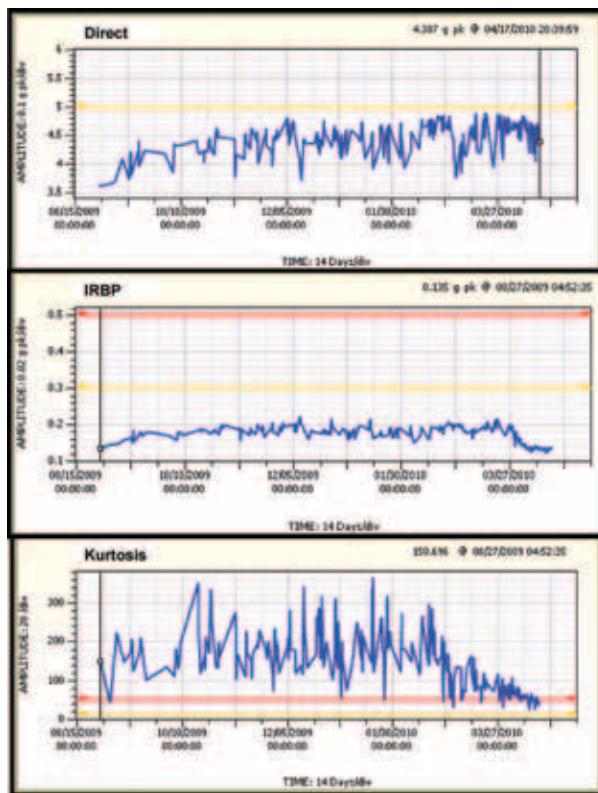
Figure 7: Trend plots from August 2009 to April 2010. Direct vibration (top) increases, but IRBP frequency amplitude (middle) and kurtosis (bottom) decrease near the end of the period.

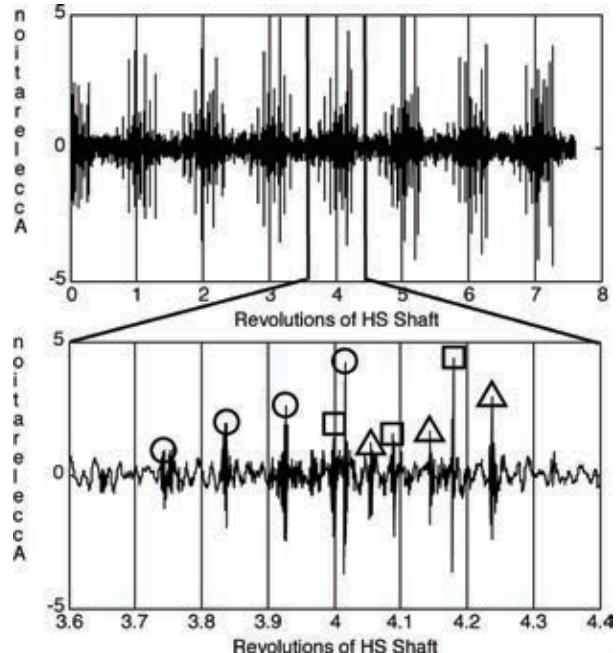
Figure 8: HSS accelerometer waveform from the second turbine gearbox. The circular, square, and triangular marks highlight three distinct patterns of fault induced impulses. This pattern suggests at least three separate inner race faults.

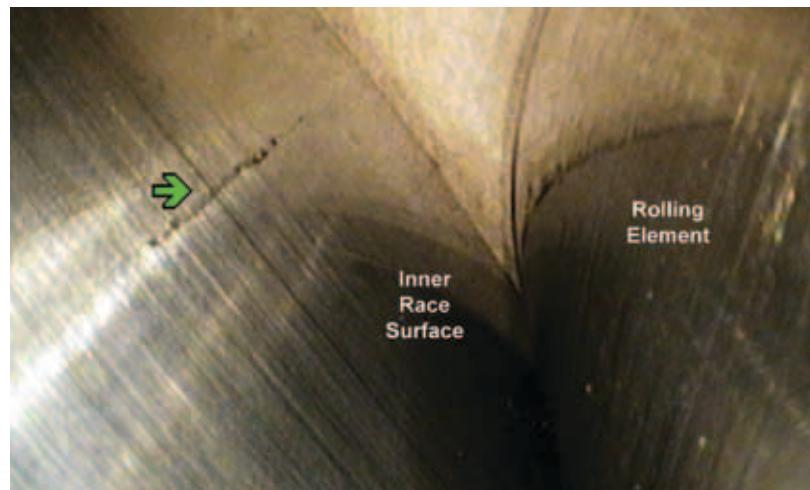
Figure 9: Crack in inner race of the high-speed downwind radial gearbox bearing (arrow). This was the largest of four race cracks found.

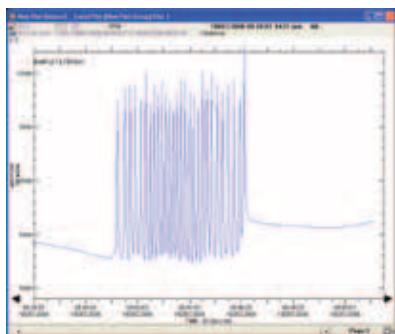
The turbine speed spiked to 10335 rpm in December 2006, above the rated trip speed.

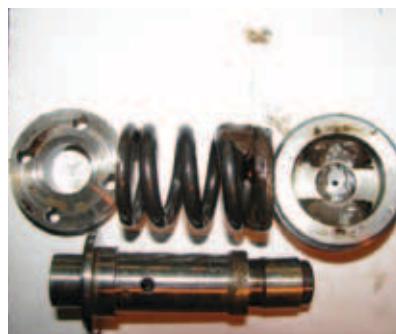
Sludge in trip bolt mechanism.

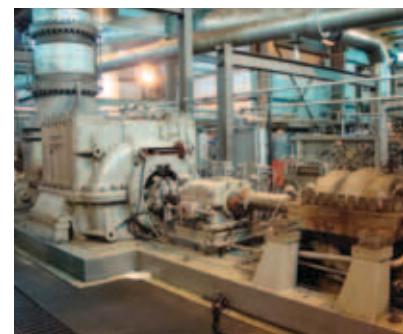
1

Process air compressor, compressor train.

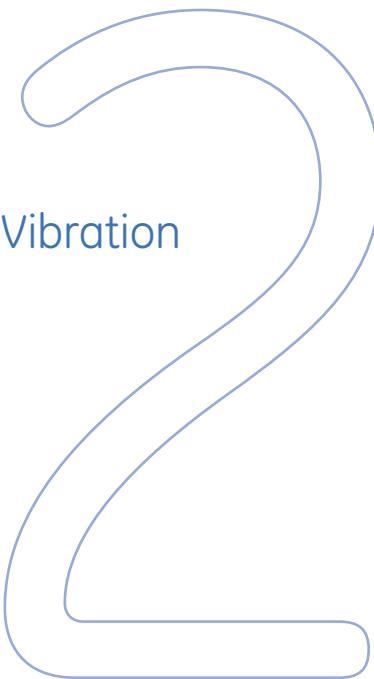
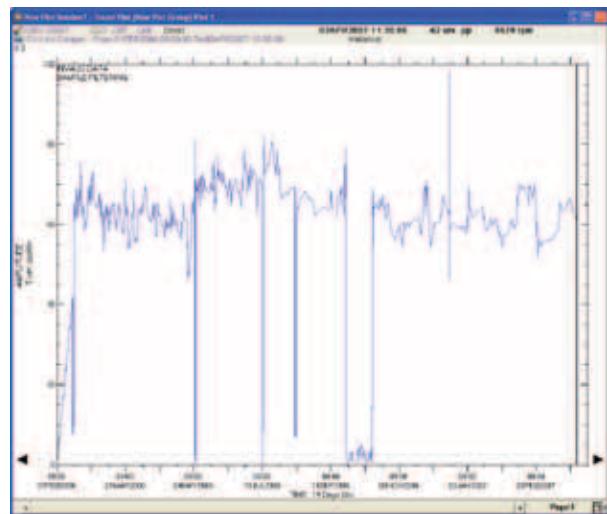
The maintenance engineer uncovered another malfunction of the steam turbine in case history #1 in February 2006. After an outage, the radial vibration on the exhaust bearing step-changed from about 40 micron to 60 micron, and then went as high as 80 micron occasionally. During the outage of June 2007, the turbine was run solo as part of the overspeed test. The shaft centerline plot from the solo test rundown was compared to that of the coupled rundown before the outage, and distinctive differences between the shaft centerline movements and vibration levels were observed. It was concluded a significant component of the vibration was caused by internal and external misalignment. Turbine alignment keys and supports were lubricated with Molykote® 321 in June 2007, and vibration decreased from 60 microns to 50 microns. In the outage of July 2008, the plant replaced the coupling and re-aligned the turbine and compressor. After the outage, vibration dropped and settled out at 40 microns. As explained by the maintenance engineer, "System 1 allowed us to see dynamic response of the turbine in real time. Although the 40-micron level is higher than desired, it is acceptable, but the 80-micron level is just a step away from a shutdown and overhaul. The potential consequence of such a failure would be an unplanned outage at \$5 million lost production. Even if the probability of this failure were 1 in 10, from this single incident we saved \$500,000."

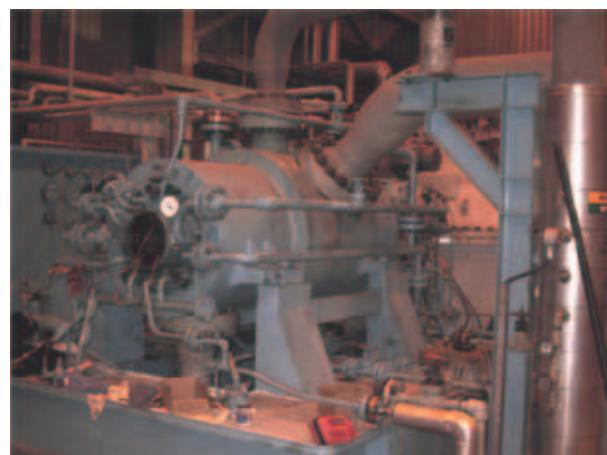
4

Synthesis Gas Compressor, High Pressure Case.

CASE HISTORY 4: Radial Bearing and Thrust Bearing Damage by Electrostatic Discharge

The synthesis gas and ammonia refrigeration compressors at the Redwater operation have experienced grounding problems from time to time, as static charges build up from impinging droplets of water in the wet stages of the steam turbines. In February 2008, the rotating equipment specialist at the plant observed erratic orbit patterns on both compressors and a slight increase in temperature of the syngas turbine thrust bearing. The random abnormal shaft vibration could not possibly represent any actual shaft movement. The enlarged orbit on the refrigeration compressor also indicated inboard bearing clearance had opened up. Electrostatic discharge was considered to cause the spikes. After reviewing System 1 data, the plant had a planned outage for other reasons in April and used the opportunity to inspect the syngas turbine thrust bearing and refrigeration compressor radial bearing. The grounding brushes were found badly worn on both machines. Severe surface erosion was found on the pads of the syngas turbine thrust bearing and some wear on the refrigeration compressor radial bearing leading to replacement of both. When the compressors returned to service, no more abnormal orbits were observed. The abnormality in the orbits was attributed to the radio frequency interference from the static discharges occurring in close proximity to the radial vibration probes. Accordingly, the plant revised the preventive maintenance program to inspect and replace the grounding brushes on a monthly interval or as necessary based on System 1 data. The static grounding brush maintenance has kept the bearing conditions stabilized. The plant engineer concluded, "System 1 allowed us to stay on top the situation until we could shut down and replace the thrust bearing. In some of our past experience, we have found that static discharge can destroy a bearing in only a few months. Even though System 1 was not designed to monitor static discharge within a piece of equipment,

Similar to Case history #3, the syngas turbine thrust bearing experienced substantial damage, while the thrust transducers didn't show any significant axial movement. Again, the thrust bearing temperature also increased indicating the damage.

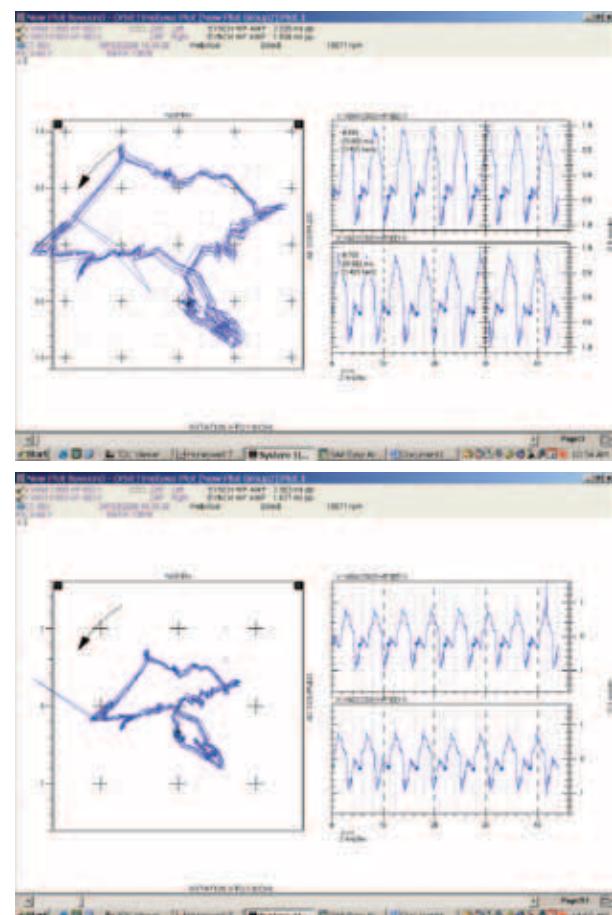
These random anomalies of the turbine vibration could not possibly represent any actual shaft movements. These were at the turbine HP casing radial bearing closest to the thrust bearing. Some anomalies still appeared at the bearings on the opposite end of the machine, quite a distance from the discharges themselves.

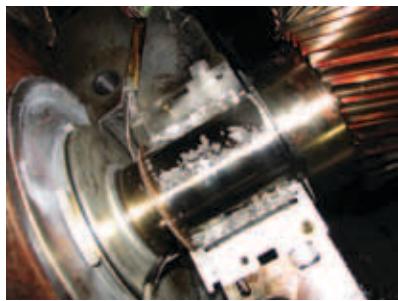
System 1 proved its value at 5AM Sunday, January 25, 2009. The main lube oil pump failed, and a few minutes later, the integral-gear air compressor tripped on high thrust vibration. The plant reliability engineer was alerted to the incident and quickly reviewed System 1 data. High axial movement was revealed at the thrust bearing on the high-speed shaft, starting about 20 seconds before tripping from losing pressurized lube oil. The high axial movement caused serious damage to the thrust bearing. First stage shaft radial bearings also experienced high vibration before and during the trip. The dominant radial vibration component was at running speed, 1x. Radial bearing damage was also found. To support the diagnostics, plant engineers reviewed DCS data, including data trends of thrust bearing temperature, lube oil pressure and running speed. Without this wealth of data, the likely scenario would have been restarting the compressor. But, based on data, a decision was made to remove the compressor cover for inspection and repair. Severe bearing damage and impeller damage was observed and a complete overhaul of the compressor was undertaken. The replacement parts cost more than \$200,000 in

Air Compressor High speed shaft thrust and radial bearing damage required a complete overhaul.

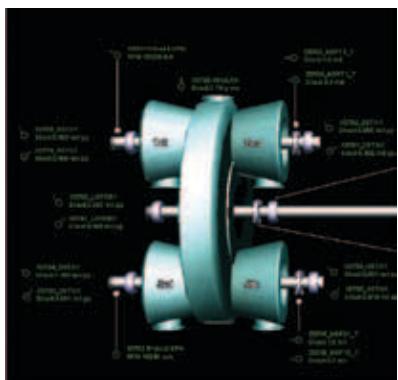
Motor driven 4 stage Air Compressor

material and labor, and it took more than a month to put the compressor back in service due to unavailability of some required parts; while the plant ran at reduced ammonia production. After this incident, several corrective actions were taken. The lubrication oil pump operation procedure was revised and an accelerometer installed on the main oil pump to catch pump faults early. The plant reliability engineer was convinced of the System 1 value in the unexpected trip situation. The trip data collected by System 1 proved to be extremely helpful in diagnosing the trip. Also, machine related parameters were in System 1, enabling diagnostics to be carried out in a timely fashion. The reliability engineer commented "as the compressor overhaul was a pretty big and costly job, it was crucial to make the right decision whether go forward and overhaul the compressor, or run it up based on uncertain thrust movement threshold setting. If the compressor had been restarted, it is inevitable that even higher production losses and repair costs would have occurred. Having data available in System 1 helped save money in terms of maintenance time, as we knew what was wrong and what parts to order."

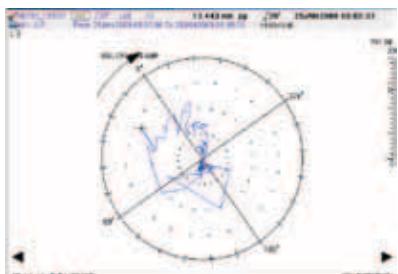
Air Compressor 1X Vibration Polar plot just after failure from 5:00.
