## Roof Repairs & Maintenance Proposal

**Aug 12th, 2026**

1350 Kingsway Avenue - WO 11395

1350 Kingsway Ave, Port Coquitlam, BC

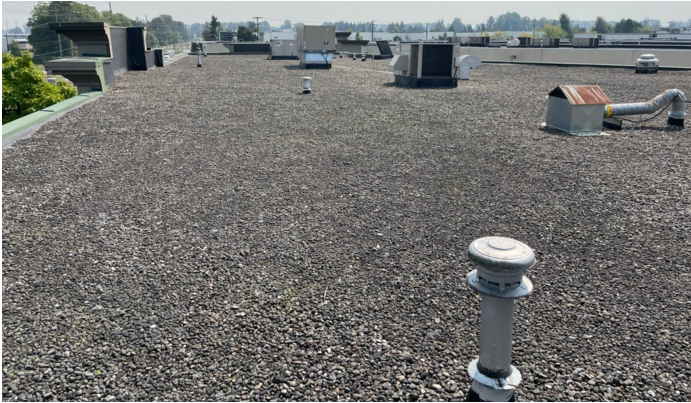
Typical roof overview.

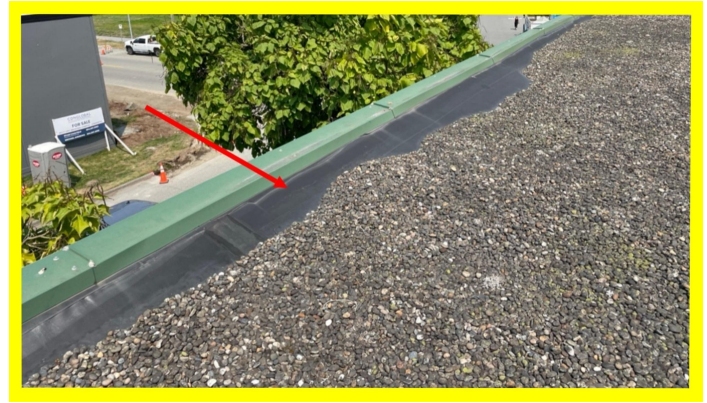
Severe tenting of the perimeter membrane interfaces were observed.

Excessive tenting of the membrane was noted on approximately 230' of the perimeter edge and at all of the curbs. Several open splices and open stripping plies were spotted, leaving these areas wide open to water to ingress into the building. It is pertinent to perform immediate repairs and implement a biannual preventative maintenance program to help extend the roof's serviceable life. With immediate repairs and a biannual maintenance program this roof has the potential to last at least another 5+ years. It may be possible to extend the roof further than the 5-year mark if a full repair scope is implemented. It would include replacing all of the stripping, penetrations, and lap sealant. Current recommendations are as follows:

- Implement a site safety plan.
- Repair the tenting at the perimeter of the roof and at the curb penetrations. Remove and store the ballast as well as the cap flashings, perform a relief cut in the membrane, patch accordingly, then reinstall cap flashings and ballast.
- Repair the open perimeter flashings.
- Repair the open splices.
- Remove the damaged pipe boot flashings and install EPEM pipe wraps and new hose clamps.
- Replace any degraded lap sealant that is exposed and replace any incorrectly installed sealant (used as lap sealant).
- Extend the b-vent flashings to terminate under the storm collars.
- Install new sealants, and replace any degraded ones, where applicable.
- Install a rust inhibiting paint on all corroded surfaces.
- Remove all roofing related debris.

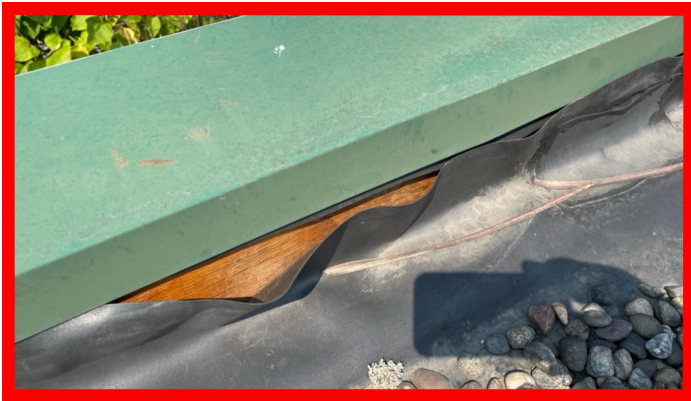
Some perimeter stripping is peeling away from the parapet.

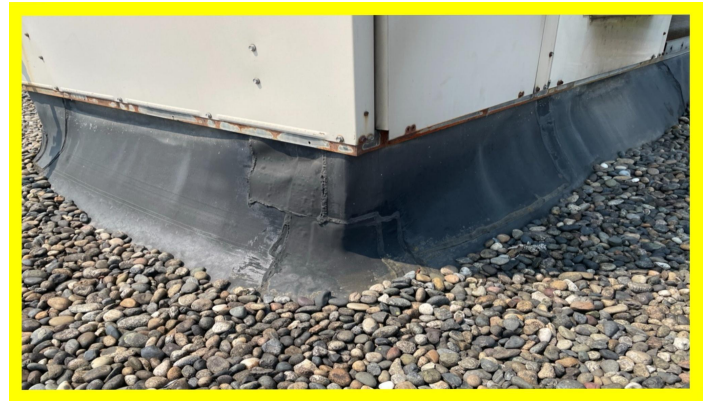
Extreme tenting is also happening at the RTU curbs.

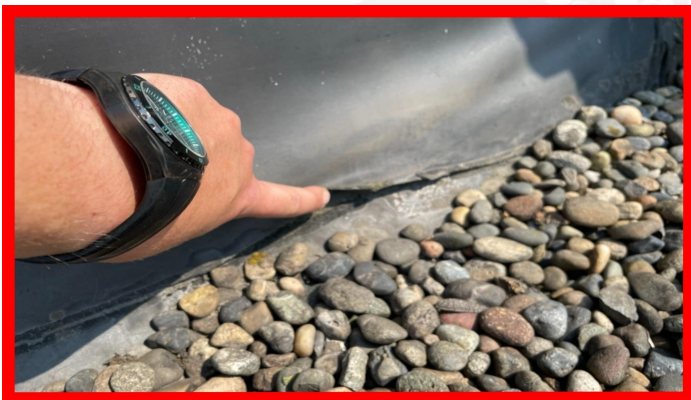
The membrane splices have become detached at the northern wall.

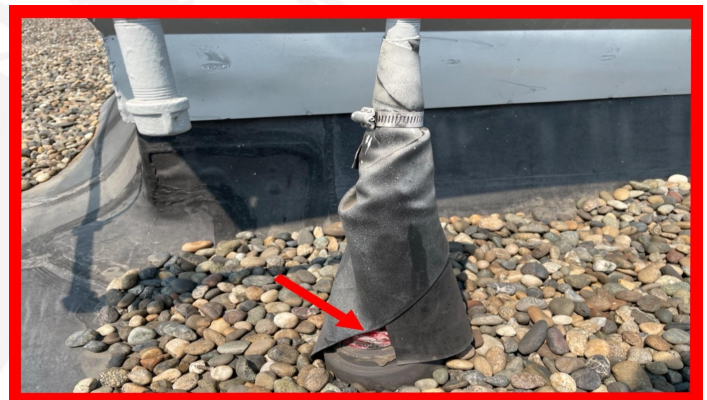
The pipe boot flashings are terminated too low and the backup seal is tuck tape.

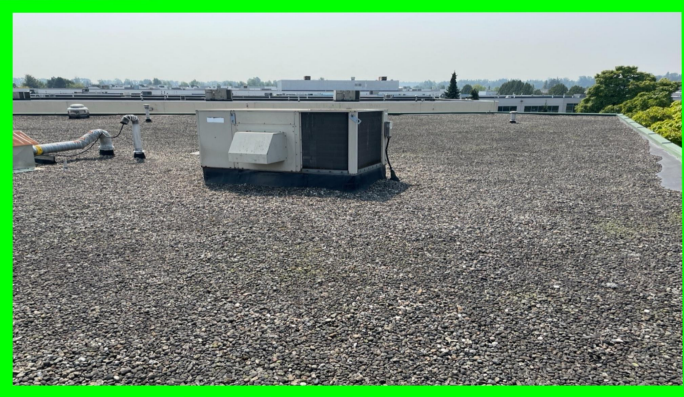
The ballast is evenly distributed.

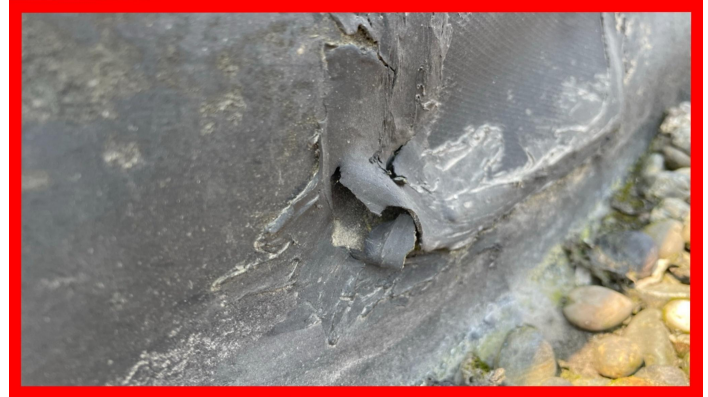
Degraded lap sealant was observed throughout.

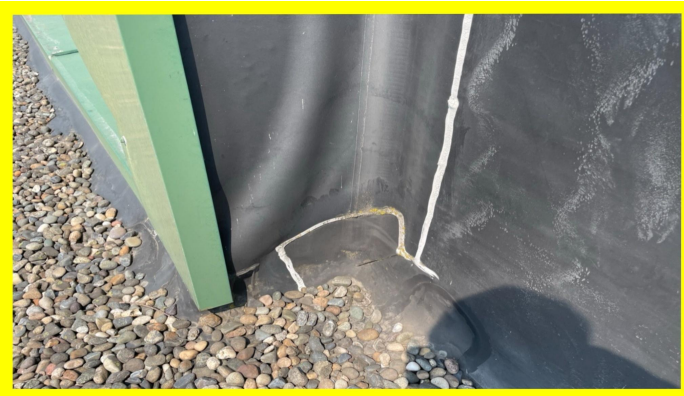
Some splices have been sealed with the incorrect lap sealant.

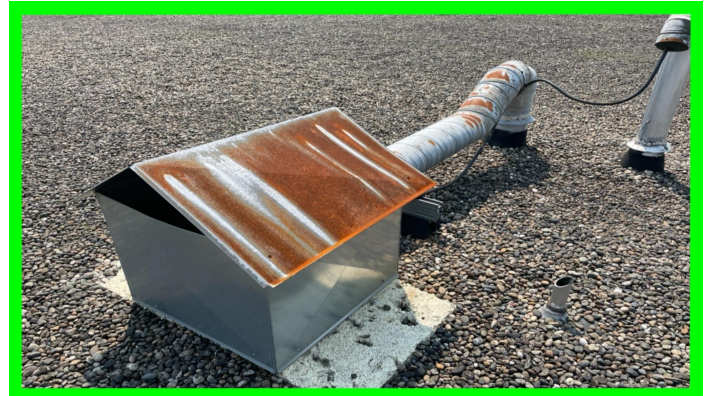
Some equipment sitting on the ballast is corroded. Although not affecting the roofing we can coat in a rust inhibiting paint.

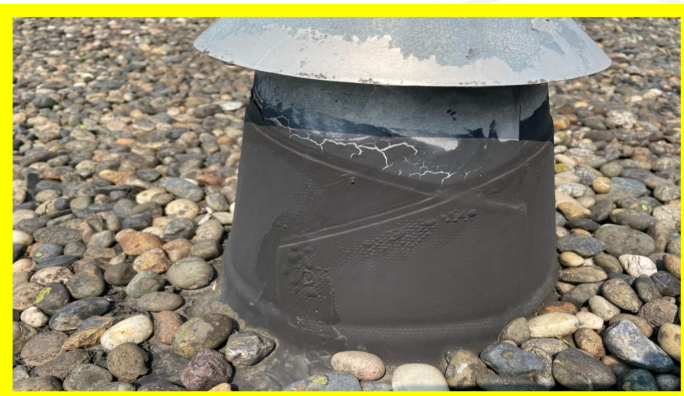
All of the lap sealant on the b-vents has degraded.

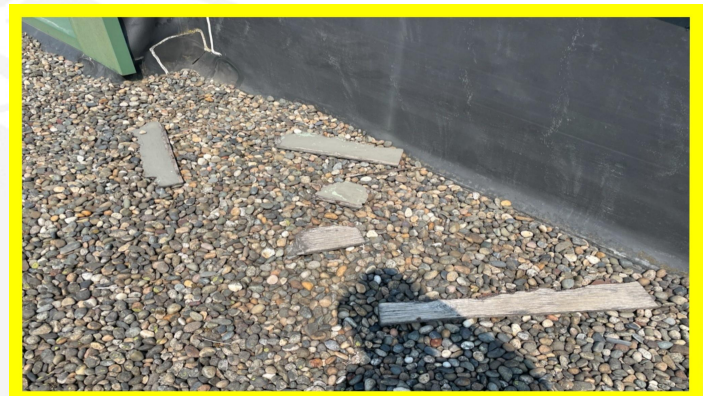
Debris was observed on the ballast.
