1010 HMC5883L Suplemental Bug Report

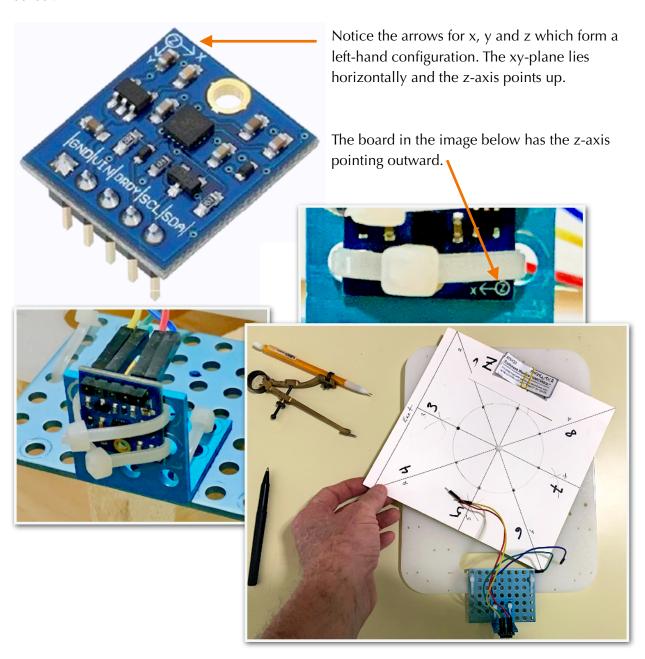
In the experiment, the board was positioned where one of the axis was pointing outward from the center of the circle. In the image above in this test, the z-axis is pointing outwards. This was also setup by positioning the x-axis and the y-axis so that they would point outwards. There were no iron metal placed near the compass while collecting the data at each of the 8 points numbered 1 through 8. The compass was placed away from the center of the circle to reduce the errors...

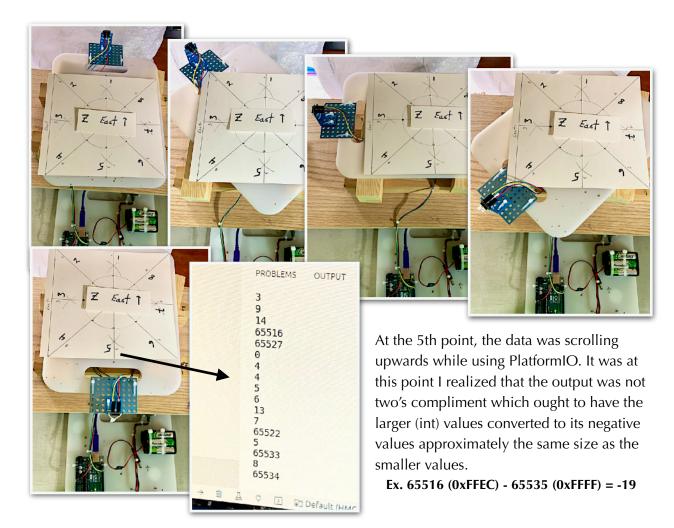
The method used to orient the compass around the circle while collecting data is demonstrated with the images below...

The Parallax HMC5883L compass was functioning as it should. The problem was the Arduino software in the Wire library. See the Bug Report for further information and other data obtained.
