## 1010 HMC5883L Suplemental Bug Report

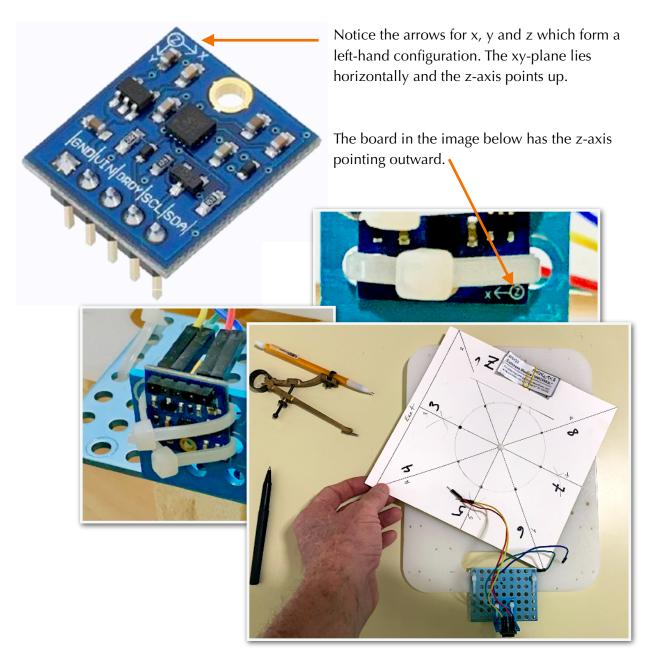
In the experiment, the board was positioned where one of the axis was pointing outward from the center of the circle. In the image above in this test, the z-axis is pointing outwards. This was also down for the x-axis and the y-axis. Also there were no iron placed near the compass while collecting the data at each of the 8 points numbered 1 through 8.

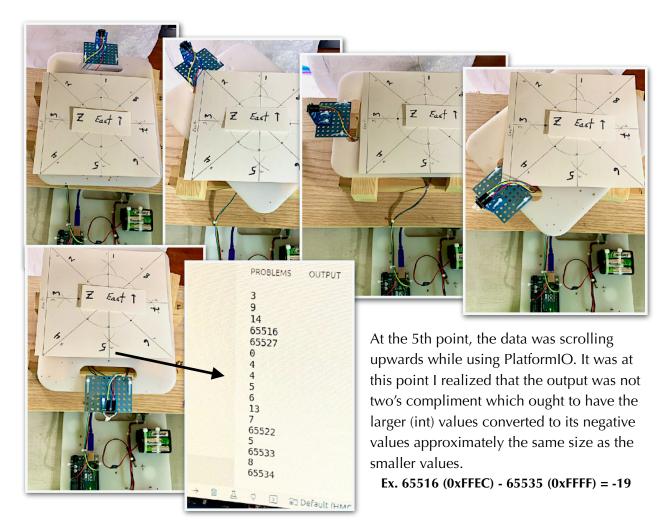
The method used to orient the compass around the circle while collecting data is demonstrated with the images below...

The Parallax HMC5883L compass was functioning as it should. The problem was the Arduino software in the Wire library. See the Bug Report for further information and other data obtained.
