1010 HMC5883L Suplemental Bug Report

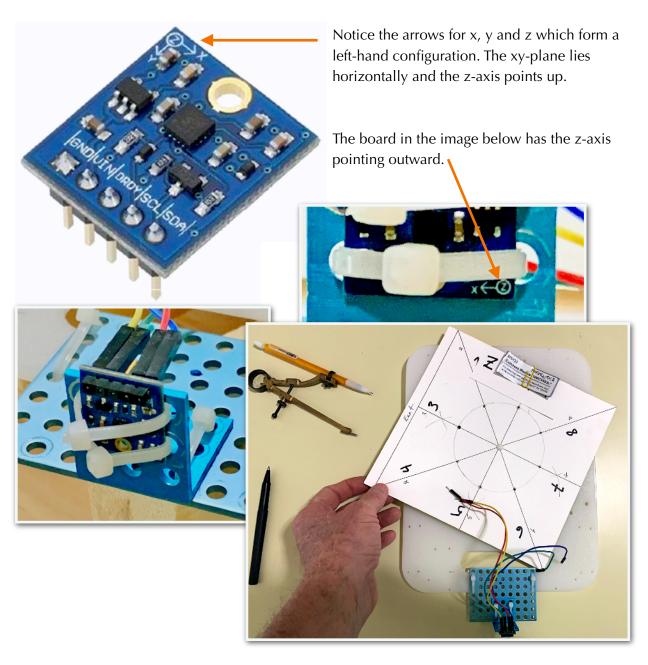
In the experiment, the board was positioned where one of the axis was pointing outward from the center of the circle. In the image above in this test, the z-axis is pointing outwards. This was also setup by positioning the x-axis and the y-axis so that they would point outwards. There were no iron metal placed near the compass while collecting the data at each of the 8 points numbered 1 through 8. The compass was placed away from the center of the circle to reduce the errors...
