No. ZT075-S1059

NIHON DEMPA KOGYO CO.,LTD.

Report on business requirements

Your Spec No. 11575443 NDK Model No. T01771 NDK Spec No. ZT07S-012

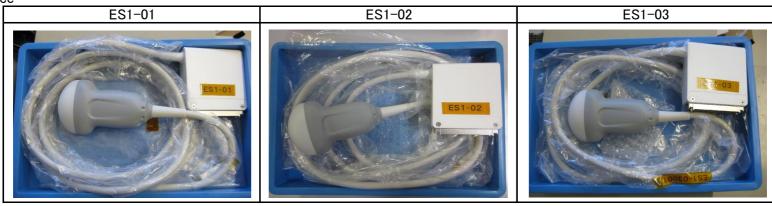
Separate sheet 11

The same	Results and judgment		
Items	ES1-01	ES1-02	ES1-03
Electrical			
characteristics	Pass	Pass	Pass
Hipot	Pass	Pass	Pass
Leakage Current	15.00 <i>μ</i> A	15.10 <i>μ</i> A	15.70 <i>μ</i> A
Leakage Gurrent	Pass	Pass	Pass
Appearance	Pass	Pass	Pass
