# Energy Audit Report

Homeowner(s): David Gibson

Address: 105 Eden Street, Bar Harbor, ME 04609

Report Date: June 9, 2025

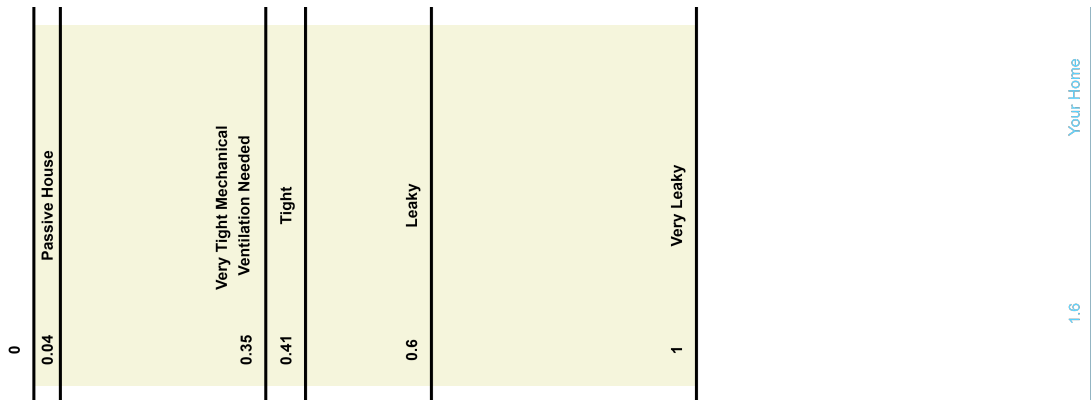
Air leaks are a big source of heat gain in warm weather and heat loss in cold weather. They also allow moisture to get into the home. Below are some numbers, pictures, and descriptions explaining what we found.

| Info | Values | Description |
|---|---|---|
| CFM50: | 910 | CFM50 describes how many cubic feet per minute of air are leaving the house at 50 pascals of pressure difference (while the blower door is running). For every cubic foot of air that leaves the house, a cubic foot of air enters the house as well. The higher the number, the leakier the house. |
| ACH50: | 29.2 | ACH50 tells us how many air changes per hour are taking place in the house at 50 pascals of pressure difference. This value is normalized for the volume of the house and thus allows for comparison between different houses. The higher the number, the leakier the house. |
