**The Construction Phases of the Bent Pyramid at Dahshur
A Reassessment**

Franck Monnier, Alexander Puchkov

Fr. Monnier, A. Puchkov, « The Construction Phases of the Bent Pyramid at Dahshur. A Reassessment », *ENiM* 9, 2016, p. 15-36.

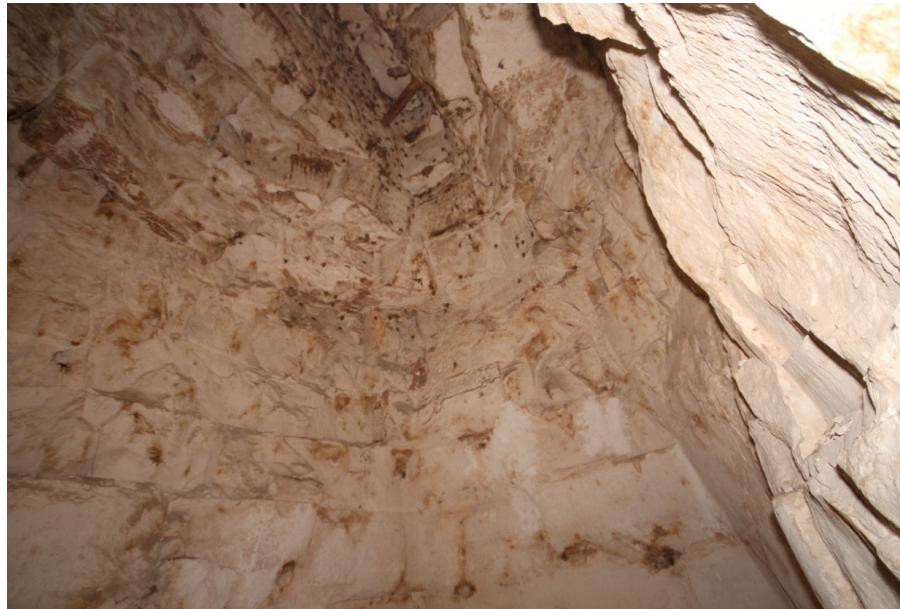
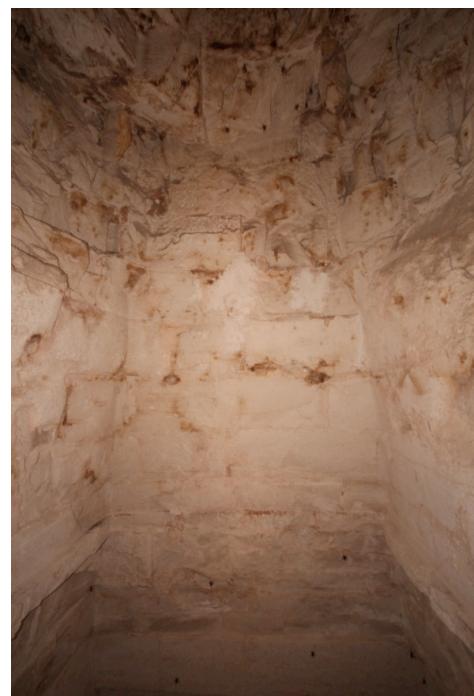
Fig. 6. The vault of the upper chamber (photo: Valeriy Senmuth Androsov).

Fig. 8. The corbel vault with its flat faces in the upper chamber (photo: Valeriy Senmuth Androsov).

The highest of the overhangs are extensively damaged today, and great fragments seem to have fallen down from the walls [fig. 6, 8]. Compared to the re-cut and unbroken lower courses, such a condition might seem surprising.

It would appear that the stones of the uppermost courses suffered from serious splitting, although the degradation may not have been sudden. Nevertheless, despite the impression of serious structural failure this degradation is not unusual for the type of stone used (cf. *infra*).

From a mechanical point of view, the compressive stresses of a corbelled vault are concentrated on the inside angles of the overhangs, all the more so if the latter are deep, which increases the risk of cracks at these angles. Overall, nothing in these chambers suggests the existence of serious structural defects but rather an accumulation of damage attributable to the re-cutting of the corbels and the nature of the material used. Moreover, it is certain that the modifications were never completed as demonstrated by the wooden log still lying in its housing at the level of the penultimate overhang.⁴⁴

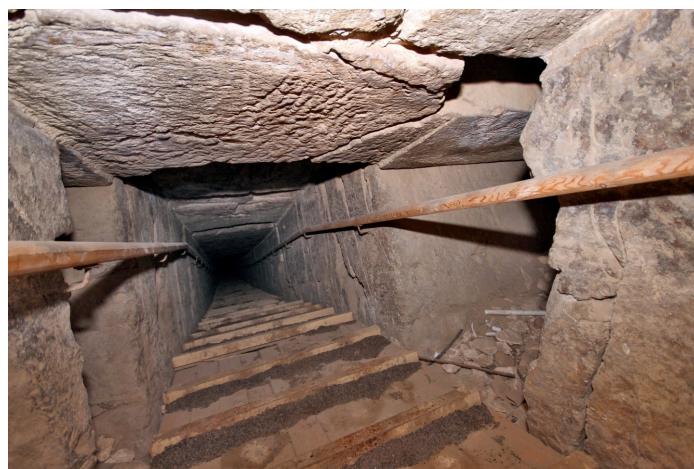
The north descending corridor consists of a 12.60-meter-long first section with a slope of $28^{\circ}38'$,¹⁴ separated from the rest of the passage by a peripheral joint where important fractures appear in the side walls, as well as a sinking of 23 centimeters of the ceiling and the floor with respect to the lower part of the corridor¹⁵ [fig. 10].

Fig. 10. The cracks and settlement in the outer part of the northern descending corridor (photo: Valeriy Senmuth Androsov).

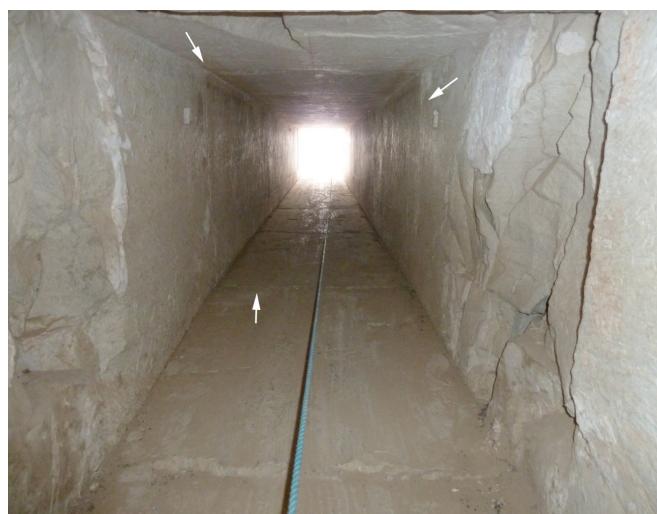
The west descending passage consists of two main sections: the outer one inclined at an average angle of $30^{\circ}9'$ over 21.81 meters, and an inner part inclined at $24^{\circ}17'$ over 45.85 meters.²² Like in the north descending passage, there is a continuous peripheral joint, situated this time a little bit closer to the entrance, at 10.63 meters [fig. 11].

Shortly afterward, one meter below this joint, a fracture breaks the flat surface of the ceiling which, like the walls, sank by about 5 centimeters.²³ It should, however, be noted that the floor is flat, suggesting that either a re-cutting or the introduction of floor slabs was carried out after the settlement had occurred [fig. 11]. Unlike what we can see in the north descending passage, it is not the outmost section which has slightly sunk, but the core of the pyramid. The inner section of the corridor is seriously damaged. In all other respects, the outer part of the peripheral joint shows no damage or settlement of the masonry.²⁴

Fig. 11. The peripheral joint in the outer part of the western descending corridor. Settlement and small cracks are visible in the foreground (photo: Valeriy Senmuth Androsov).

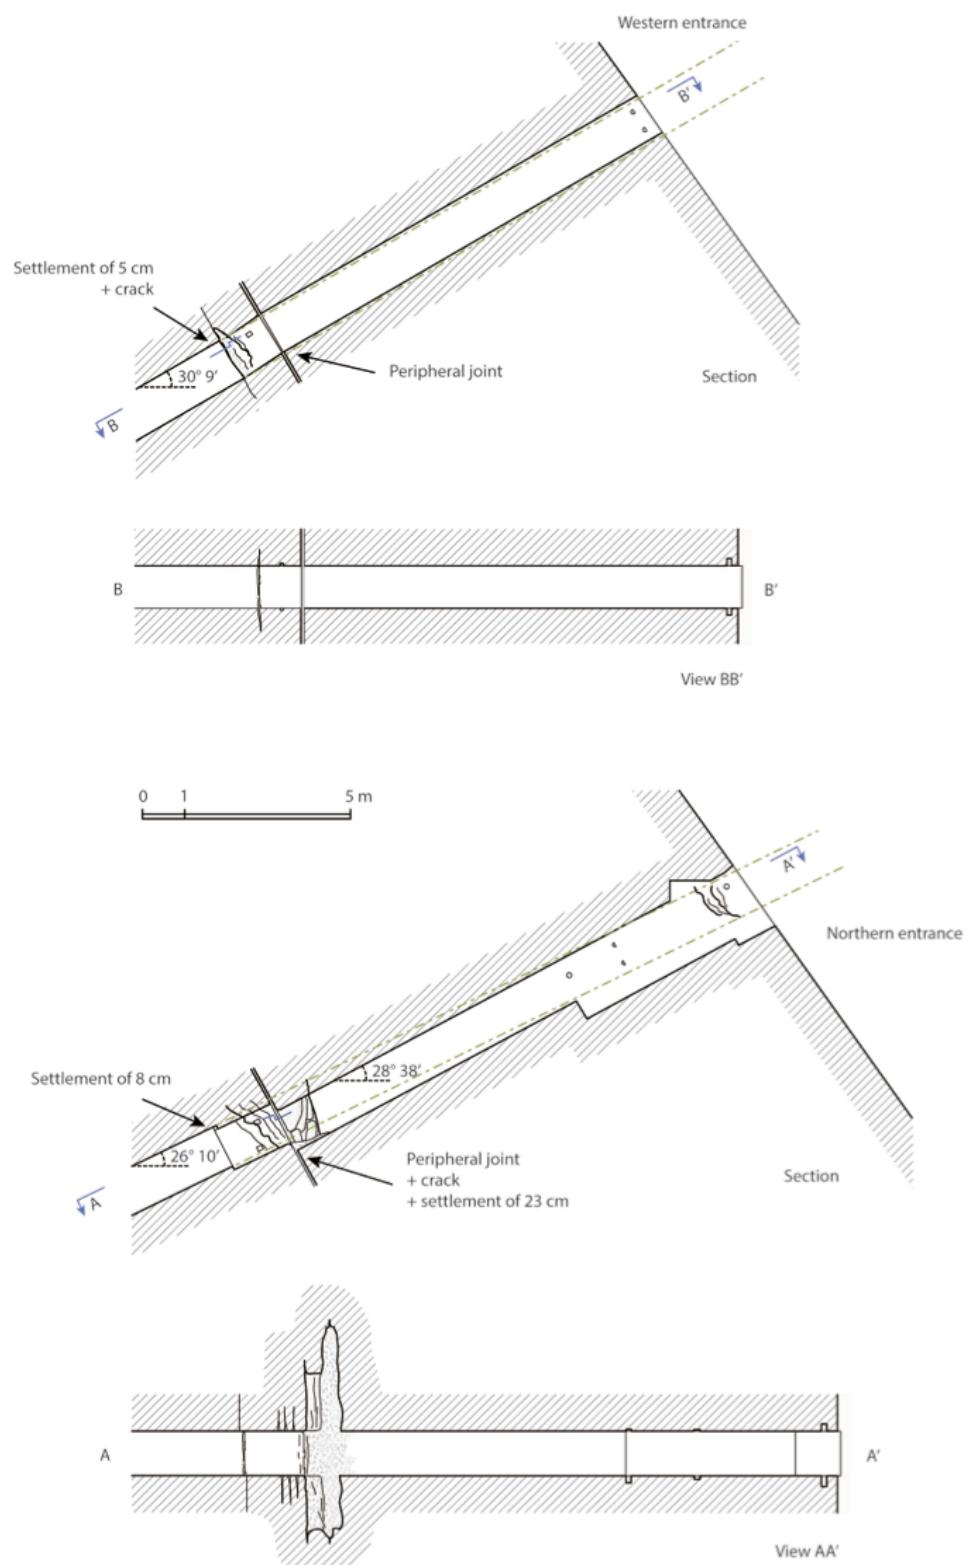
Fig. 12. Description of the cracks and settlement in the outer parts of the descending corridors.

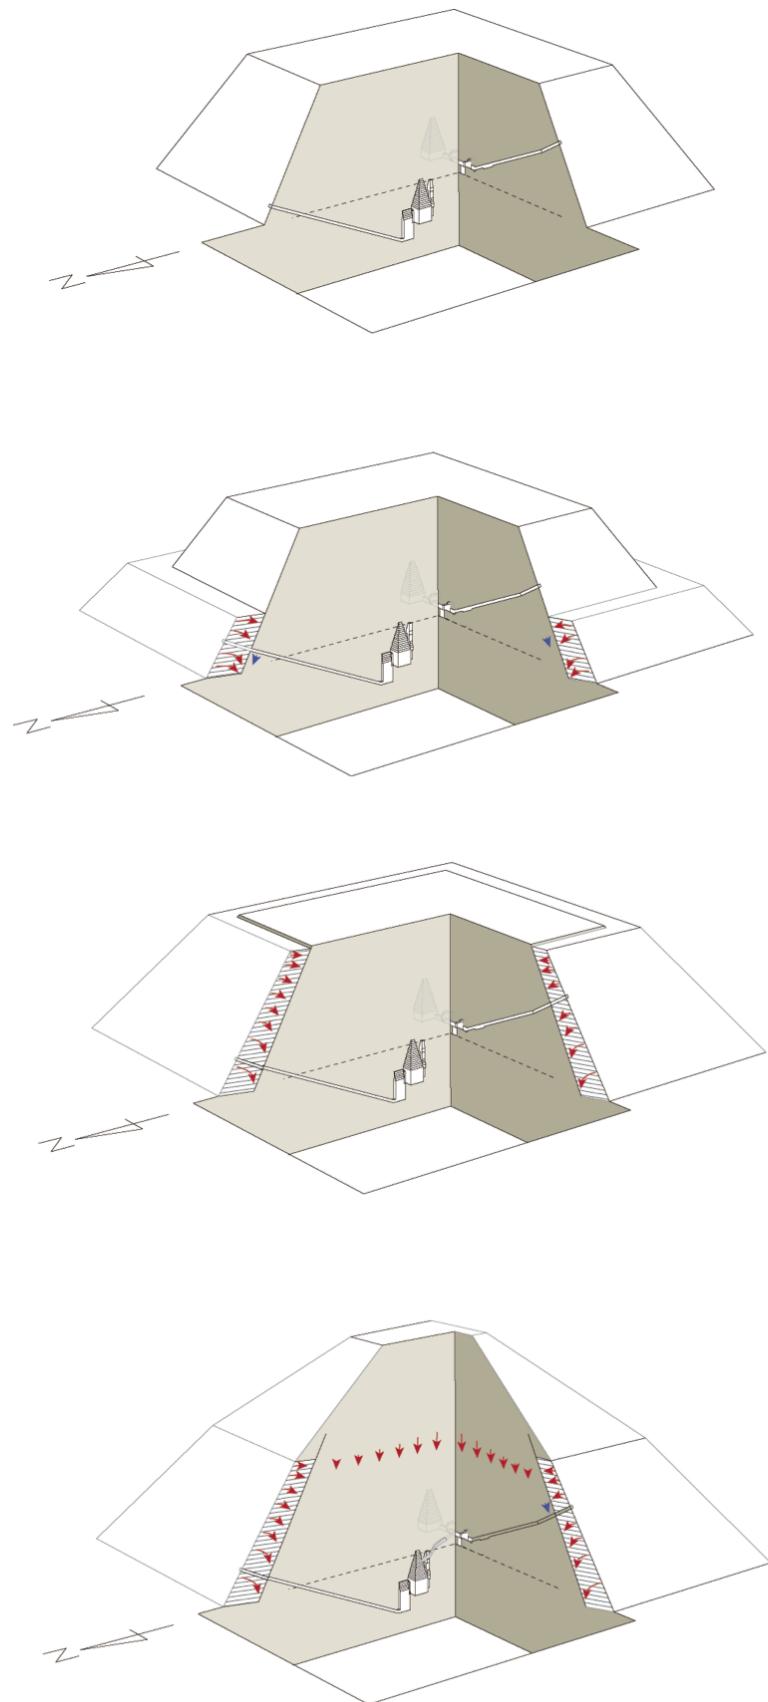
During the construction of this envelope, the foundations seem to have become unstable and yielded under the increasing loads of the masonry. We have seen that the dimensions of these foundations are heterogeneous, being much deeper at the corners whereas the sides effectively rest on sand only. This heterogeneity is doubtless one cause of the unexpected differential settlement. Cracks and the 23-centimeter collapse at the junction between the two sections of the northern descending passage testify to this outer settlement.

Fig. 14. Behavior of the superstructure during the different building stages of the Bent pyramid.

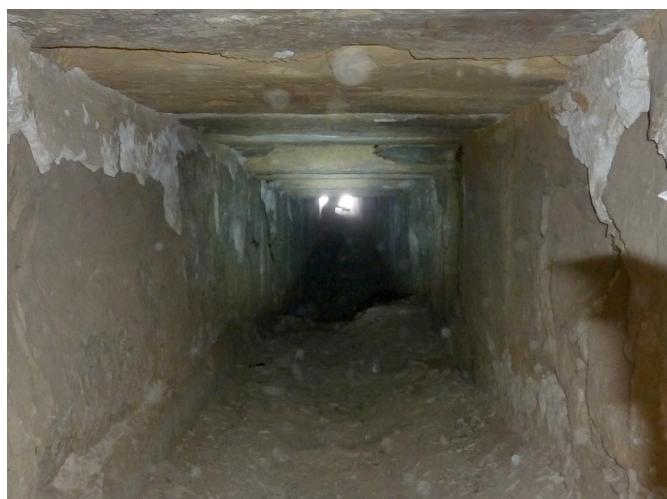
Fig. 15. Sinking of the ceiling stones in the western descending passage (photo: Olga Kozlova).
