Mangirish Kulkarni-

Products worked on-

FAILURE ANALYSIS REPORT

Subject	: Field complaint
Reference	: Servicing
Complaint	: Engine not starting
Engine Type	: CH 196
Engine sr. no.	: Disclosed for
Privacy.	
Engine Application	: Power Generator
Hrs. run	: 340 hrs.
Material Received	: All parts.
Dealers	: Gangpur Sales and services

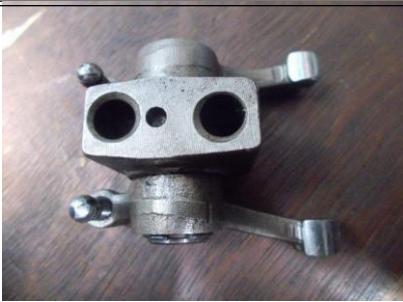
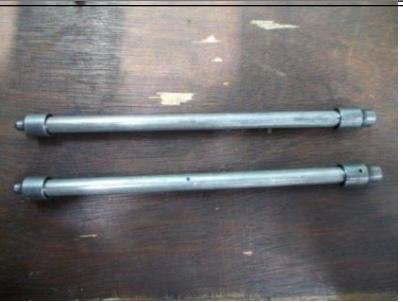
Intake valve observed in bend condition		
Valve springs, Collets and its cup checked- No abnormality observed

No abnormality in push rod and rocker lever

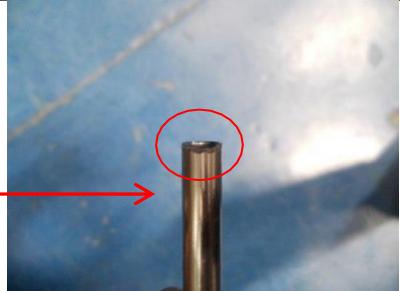
Inlet valve tappet- Push rod mounting cavity observed in damaged condition (Secondary failure)

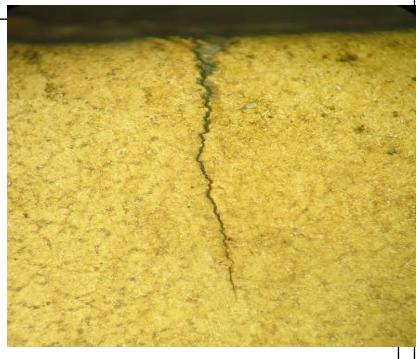
Quench crack of 0.7 mm observed in Sample B. Location top surface	Material flow is observed at surface	
Comments			
<ul style="list-style-type: none"> - 1. Camshaft is manufactured from CK45 grade & induction hardened. 2. At needle bearing mounting area, sample A shows drop in case hardness. This is due to heat generated due to metal-to-metal contact during running. This may be due to insufficient lubrication 3. Sample B shows proper induction hardening pattern (case depth, case hardness & microstructure) barring the quench crack.

- **Suspected cause (Non-conclusive): Valve timing and tappet setting (Tappet clearance cannot be confirmed because of engine received in dismantle condition)**

1. Check list preparation by QA to be circulated to CS for confirmation and checking to be done at site during dismantling.
2. Information to be given to Assembly Plant (M/s Champ)
3. Audit to be performed for assembly at M/s Champ

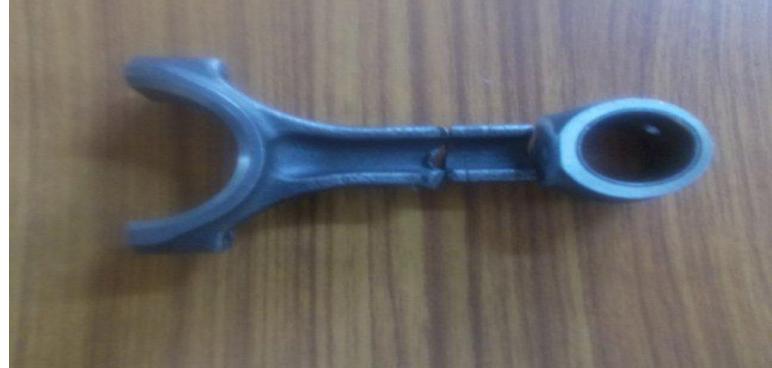
Connecting rod broken from i-section

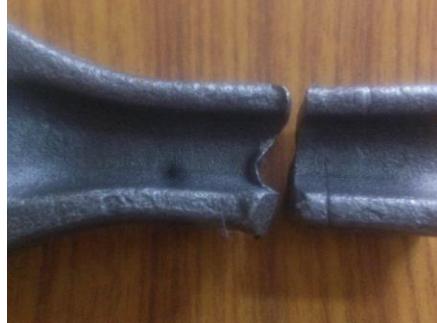
Failed connecting rod- Initial crack observed on connecting rod i-section

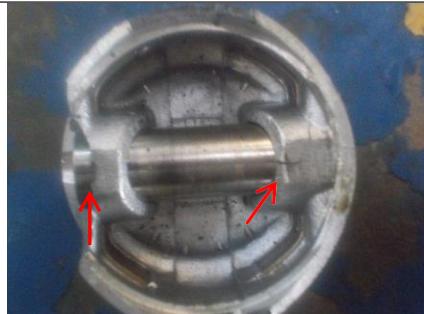
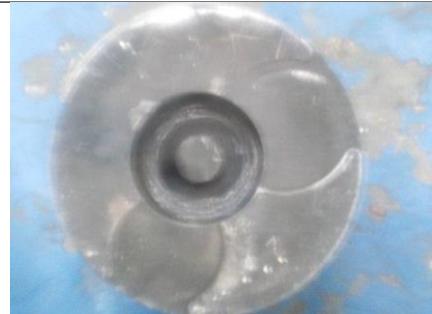
Piston observed in at gudgeon pin mounting area

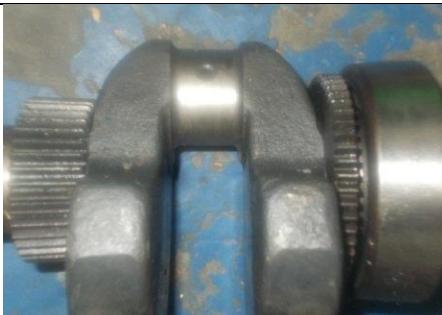
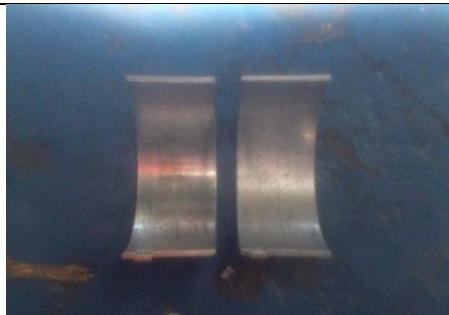
No abnormality observed in crankshaft and connecting rod bearing
