**SPE-229883-MS**

## **Extended Coiled Tubing Straddle for Integrity Restoration: Three Deployment Cases from the Norwegian Continental Shelf**

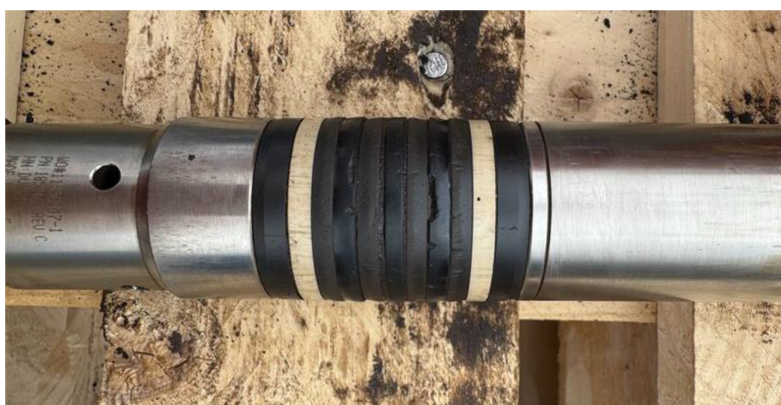
Figure 1—A system integration test was conducted to see if subsequent interventions could be performed through the CT straddle. During those tests it was found out that the internal seam weld of the CT pipe would damage rubber seal area of plugs or other intervention tools. The picture displays the damage seen on one of the plugs run though the CT pipe. As an outcome the CT straddle used had the internal seam weld removed.

**Design Adaptability:** The CT string was custom-engineered to support future interventions, with internal seam welds removed to prevent tool damage—an improvement confirmed through system integration testing.
