**SPE-227275-MS**

## **How a Tailored Intervention Workflow for Large Size Completion Averted a Remedial Workover Rig Operation**

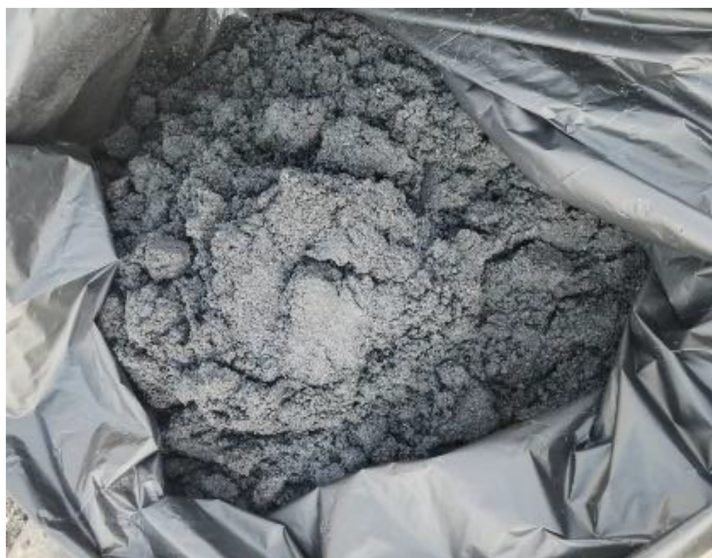
Debris characterization was conducted through a basic solubility test sequence. The soft debris (Fig. 9) neither float nor dissolve in water, but dissolved readily in hydrochloric acid while releasing a rotten egg odor, indicative of  $H_2S$ . This suggested the debris was primarily iron sulfide ( $FeS$ ) scale, a common byproduct of corrosion in water injector wells with sulfide-rich environments. The 134 kg of  $FeS$  was likely formed over extended shut-in periods or during the well killing phase.

Figure 9—Sample of the soft debris recovered during the cleanout operation.

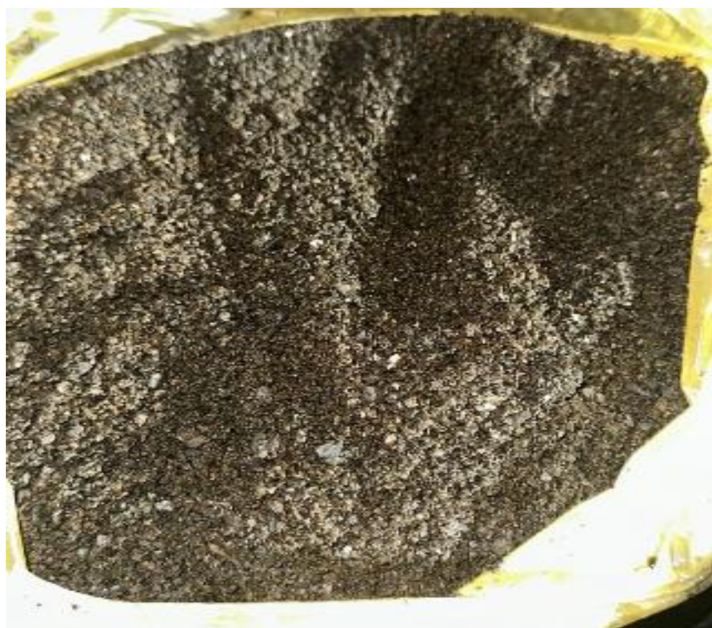
The harder metallic debris (Fig. 10), totaling 20 kg, did not exhibit similar reactivity. While its exact origin remains uncertain, it is suspected to be from either previous intervention attempts, erosion or wear of wellbore components, or residual fragments from earlier downhole tool deployments.

Figure 10—Sample of the hard debris recovered during cleanout run.
