**SPE-229686-MS**

## **Application of 3.5-Inch Small-Diameter Well Coiled Tubing Workover Technology in South Sulige**

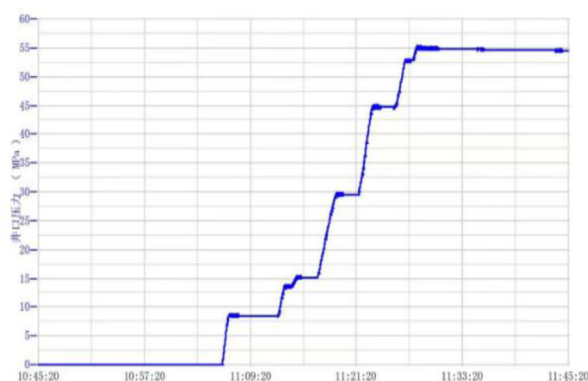
Figure 16—Pressure Test Results After Casing Patching

Stepwise pressure test to 55 MPa, 10 min pressure drop 0.3 MPa – successful. After parameter adjustments, the patch was qualified, subsequent fracturing was completed, and the well was put on production with a 60 000 m<sup>3</sup>/d gas rate.
