**SPE-229720-MS**

## **Underwater Structure Inspection and Analysis by 3D Subsea Photogrammetry Technology**

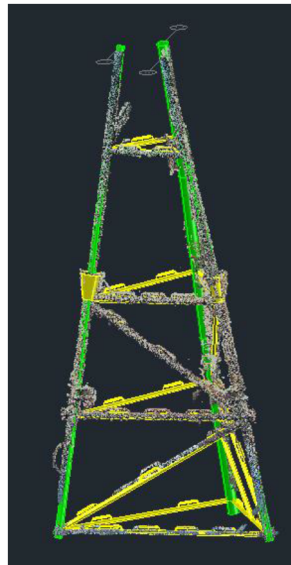
Figure 9—3D Model overlayed with point cloud data

The 3D model reconstruction was modelled and overlayed with the coloured point cloud data to allow thorough analysis of the substructure. The 3D photogrammetry survey successfully delivered centimeter level accuracy in measuring the relative lateral deflection and vertical misalignment of the Platform A substructure. Model accuracy and point cloud data were checked with components on the substructure such as anode and bracing.

Overlaying the 3D model with coloured point cloud data enhances visual clarity and enables intuitive understanding of complex geometries. This fusion of geometric and visual data allows analysts and engineers to identify anomalies, deformation patterns, or areas of concern more efficiently than with traditional methods.

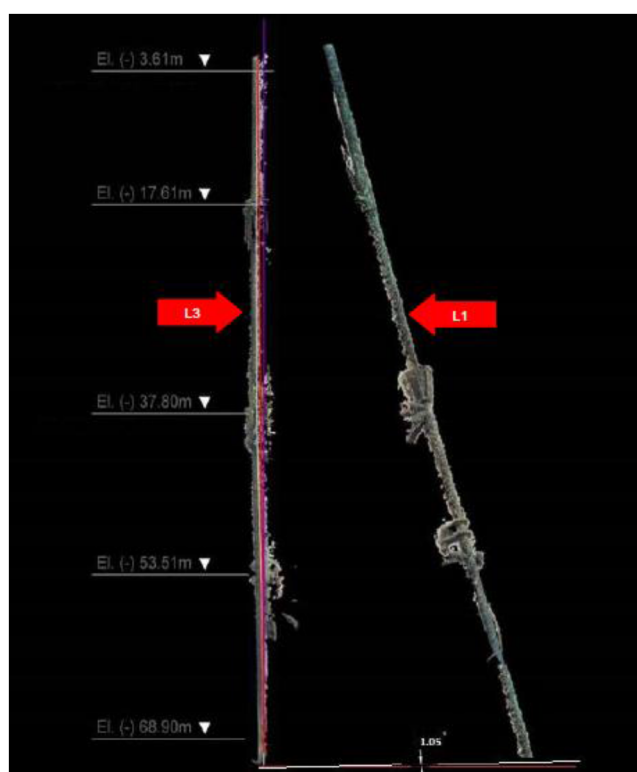
- Slope angle value between L2 – L3 =  $0.74^\circ$
- Slope angle value between L1 – L3 =  $1.05^\circ$

Figure 12—Mudmat Inclination Angle L1 - L3 Side
