**SPE-229784-MS**

## **First in the World Complex Through Tubing Sand Control System (Screen Expansion) Installation Via Combination of E-Line Conveyance with Tractor and Stroker**

M. S. Hashim, K. Selamat, M. N. Ghazali, R. Intiran, and G. S. Z Mandy, PLW/W, PTTEP Sarawak Oil Limited, Kuala Lumpur, Malaysia

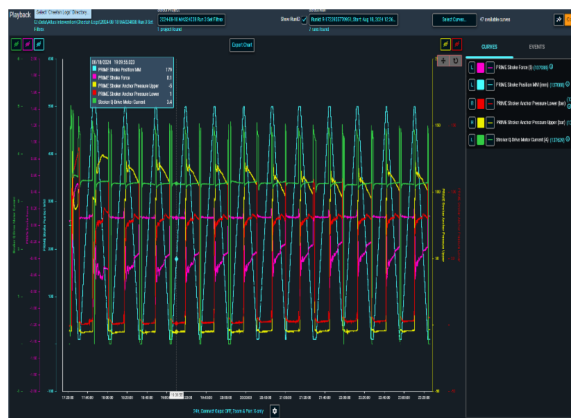
Overall stroker activation to release compression sleeve was executed as per plan it is shown clearly in the chart (as shown in Fig. 13). Total 12 stroker cycle was executed to let the running tools free which indicate the compression sleeve is out of the high expansion screen section assemblies. When pull out of hole, the tools is stuck across TRSCSSV, push the decision to activate the stroker and pull to maximum of 7,000 lbs (downhole) to get the whole assemblies out of wellbore.

Figure 13— Stroker activation cycle to set High Expansion Screen

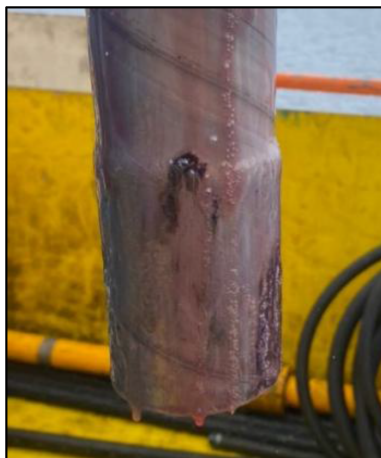
As and when the tools arrived surface, visual inspection conducted, and it was observed the bottom part of compression sleeve are expanded to 2.82" OD with expanded length of 3" from bottom of the compression sleeve (as shown in Fig. 14).

Figure 14— Expanded bottom part of compression sleeve.

| Issue | Lab Simulation Finding | Conclusion |
|---|---|---|
| #1 | Compression sleeve movement to overlap the high expansion sleeve end ring when the 6500 lbs of set down weight applied (as show in Fig. 16) | There are chances of even the limit was set @ 1000 lbs (on wireline), spike in inertia and momentum (due to tools string weight) when tools are touching the seal contribute to excessive weight. |

| Issue | Improvement Plan |
|---|---|
| #1 | a. Maintaining Eline wire pull to 1000 lbs while activating tractor in order to eliminate the momentum while latching the tools.<br>b. Latching assy. to be in contact with sealbore via tractor force ONLY during latching process (approx. 500 lbs of tractor force). |

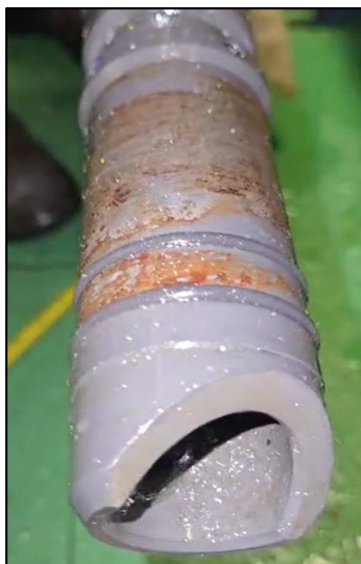
After the recovery of the stuck compression sleeve, 2<sup>nd</sup> run was made to convey 2<sup>nd</sup> High Expansion Screen section to the depth. When arriving to the top of screen section, multiple attempts were made in order to latch the sealbore assemblies of screen section. In view of the issue, it was decision to pull out of well and recheck the tools condition. Then, rerun was conducted to continue with latching attempt. Total 3 runs were conducted for the same purpose without any success.

Fig. 15 show the condition of the latch assemblies when it reach surface post multiple latching attempts. There was no marking on the latch mechanism to conclude potential issue with tool centralization issue.

Figure 15—Latch mechanism for screen.

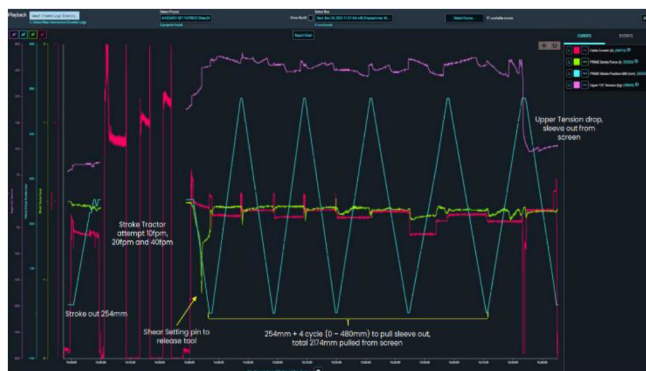
Figure 18—Improvement sequence of screen setting.
