**SPE-227352-MS**

## **Well Pad Piping Displacement Beyond Limits Predicted During Design**

N. Al Abri and S. Latil, Shell Development Oman LLC, Madinat Sultan Qaboos, Muscat, Sultanate of Oman

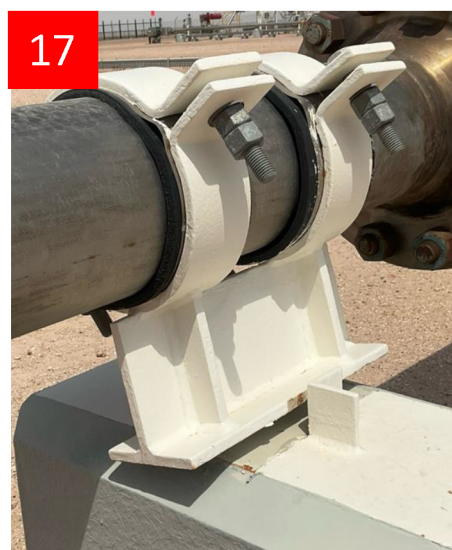
On the pads, line movements have been detected only from support #17 onwards. This is a pattern which has been seen on a number of pads. Because the piping cannot move sideways at support #17, the piping got twisted as shown below in Fig. 5 and Fig. 6.

Figure 5—Piping twisted on support #17 from one of the well pads (A)

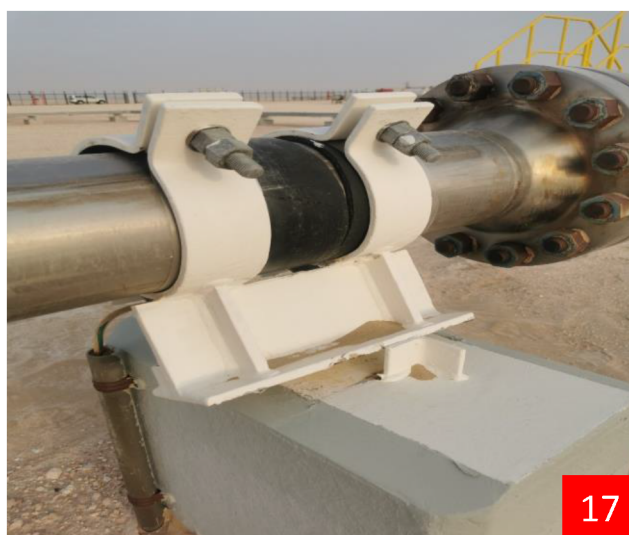
Figure 6—Piping twisted on support #17 from one of the well pads (B)

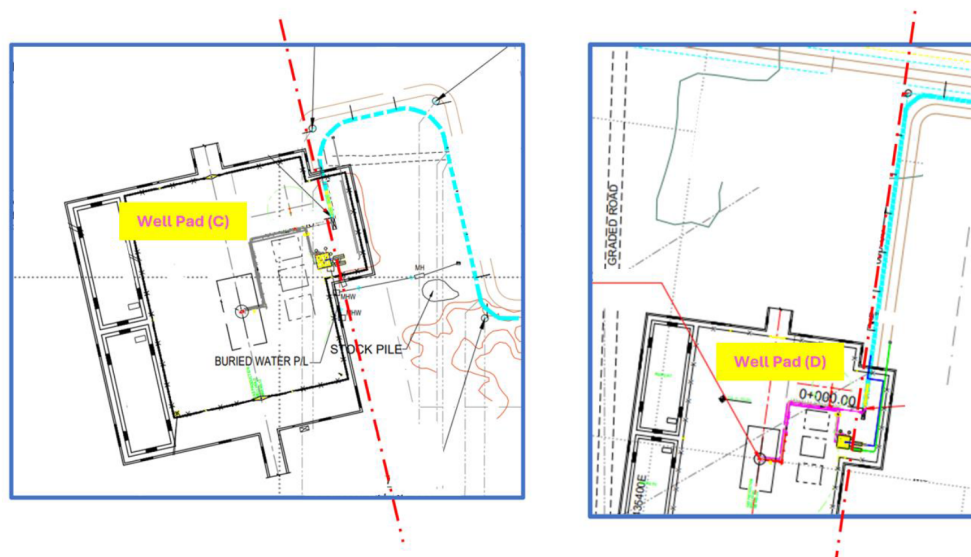
Another element which is of interest in the context of thermal expansion is the lay out of the pipeline once it has entered the ground. Two examples of flowline routings outside of the well pad (C & D) are presented in Fig. 13 below to highlight the potential difference in impact:

In the case of Well Pad (C), it is apparent that only a small stretch of flowline leaving the pad is aligned with the flowline on the pad, whereas a much longer stretch of pipeline is aligned in the case of Well Pad (D). The expansion of the flowline is more likely to have a significant impact on Well Pad (D) than it would for Well Pad (C). Based on the current measurements of line movement, Fig. 14 is derived.
