**SPE-228914-MS**

## **From Surveillance to Solution: A Unified Approach to Well and Reservoir Integrity in a Mature EOR Asset**

Pranay Shrivastava, Manuel Guzman, Junghun Leem, Avinash Bohra, and Ritik Raj, Cairn Oil & Gas, Vedanta Ltd, Barmer, Rajasthan, India.

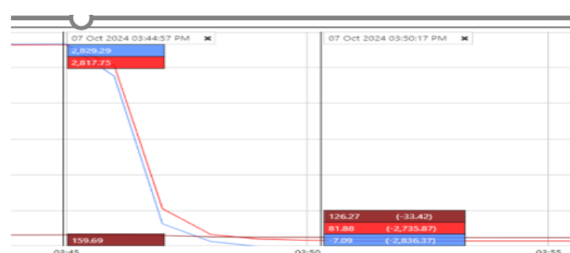
Figure 3—'A' & 'B' Annulus Pressure reduced after well shut down
