**SPE-230244-MS**

## **Deepwater FPSO Mooring Chain Integrity Management: Lessons from Severe Pitting Detected Through UWILD and 3D Assessment**

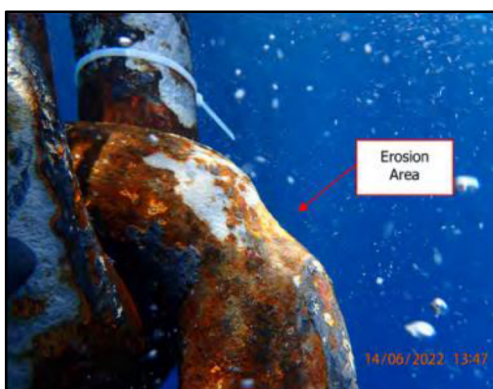
Figure 3—Side view of erosion area

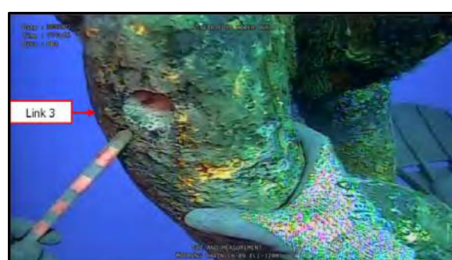
Figure 5—Close up surface pitting corrosion area

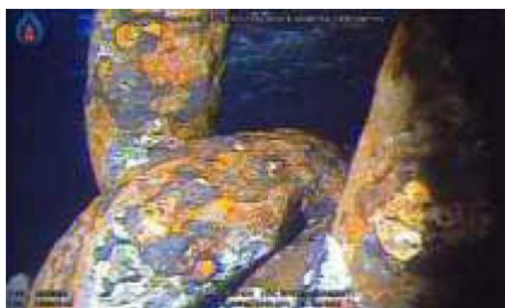
UWILD Inspection Findings illustrated in [figure 8](#) until [figure 11](#) below. Indication of surface corrosion and pitting corrosion at certain link which identified to be inspected. air diver use manual gauging tool to measure dimension and geometry of the chain link which translated to finite element analysis model.

Figure 9—Pitting corrosion Common Link

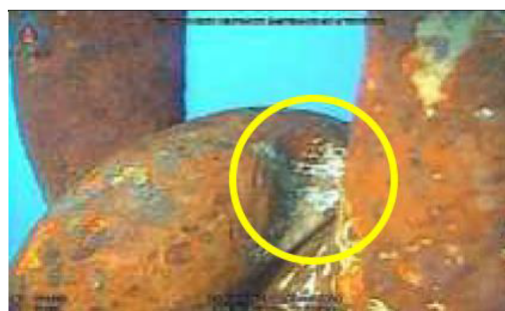
Figure 10—Pitting corrosion Common Link

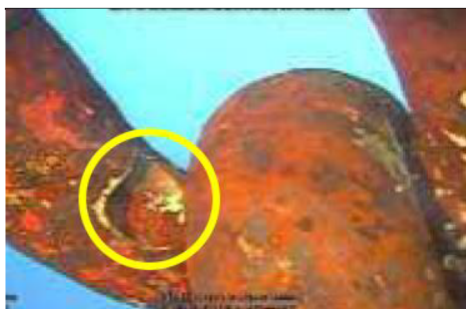
Figure 11—Pitting corrosion Common Link
