**SPE-230167-MS**

## **Syngas Compressor High Vibration Diagnosis and Resolution**

Kiran Vangari and Mustafa Shalabi, Cordant™, Baker Hughes, Dubai, United Arab Emirates

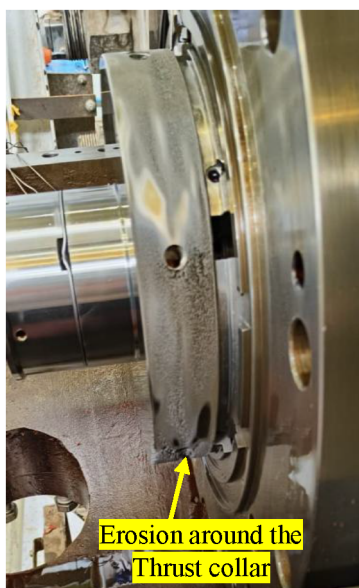
Figure 11—LP Compressor Thrust collar erosion found during the inspection leading to mass loss from the thrust collar

1. **Severe damage to the balance drum seal:** This caused elevated leakage of high-pressure gas across the seal, reducing axial balancing effectiveness. The resulting cross-coupled fluid forces likely triggered sub-synchronous whirl, seen as 0.3X vibration during multiple vibration excursion events.
2. **Erosion of the thrust collar near the NDE bearing:** This introduced rotor mass imbalance consistent with the observed gradual 1X vibration increase at the NDE bearing.

Customer replaced the LP Compressor rotor following the inspection findings. The compressor was back in normal operation after rotor replacement and the vibration levels stayed well below alarm limit (max vibration < 15 μm pk-pk) and there were no intermittent vibration excursions seen indicating that the issue was successfully resolved, please see Fig. 13.
