## **Drones**

(March 2023)

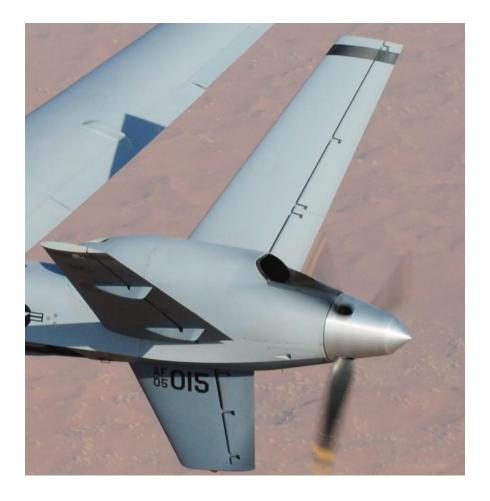
The picture below shows the relative geometries of the tail fins and of the propeller of a MQ-9 Reaper aircraft.

It can be noted that the liquid was released from behind and right in the direction of the gas turbine exhaust, just between the fins and in front of the propeller.

Exhaust temperature from a gas turbine of the kind used on a MQ-9 drone being about 500 C, it is apparent that the fuel that was released must have ignited instantaneously, creating a detonation.

The propeller blades being made of composite material were quite probably damaged by the heat and the blast that probably resulted.

Given the geometry of the propeller and of the tail fins it seems quite unlikely that the fighter jet may have hit the drone's propeller without serious damage to itself and to the drone.

Furthermore, part of the film shows clearly that the propeller is rotating counterclockwise as seen from the camera (the direction may have been stroboscopically altered but both drones exhibit the same direction of rotation), and that the bending of one blade is curved ahead of the blade's motion, which would be quite unlikely if there had been a collision, while another blade seems to have just withered away under the heat.
