## Marine Investigation Preliminary Report

# Contact of Containership *Dali* with the Francis Scott Key Bridge and Subsequent Bridge Collapse

<b>Location:</b>	Baltimore, Maryland	<b>Accident Number:</b>	DCA24MM031
<b>Date and Time:</b>	March 26, 2024 0129 local time (eastern daylight time)	<b>IMO Number:</b>	9697428
<b>Ship:</b>	<i>Dali</i> (Neo-Panamax containership)	<b>Injuries:</b>	8 (6 fatal)

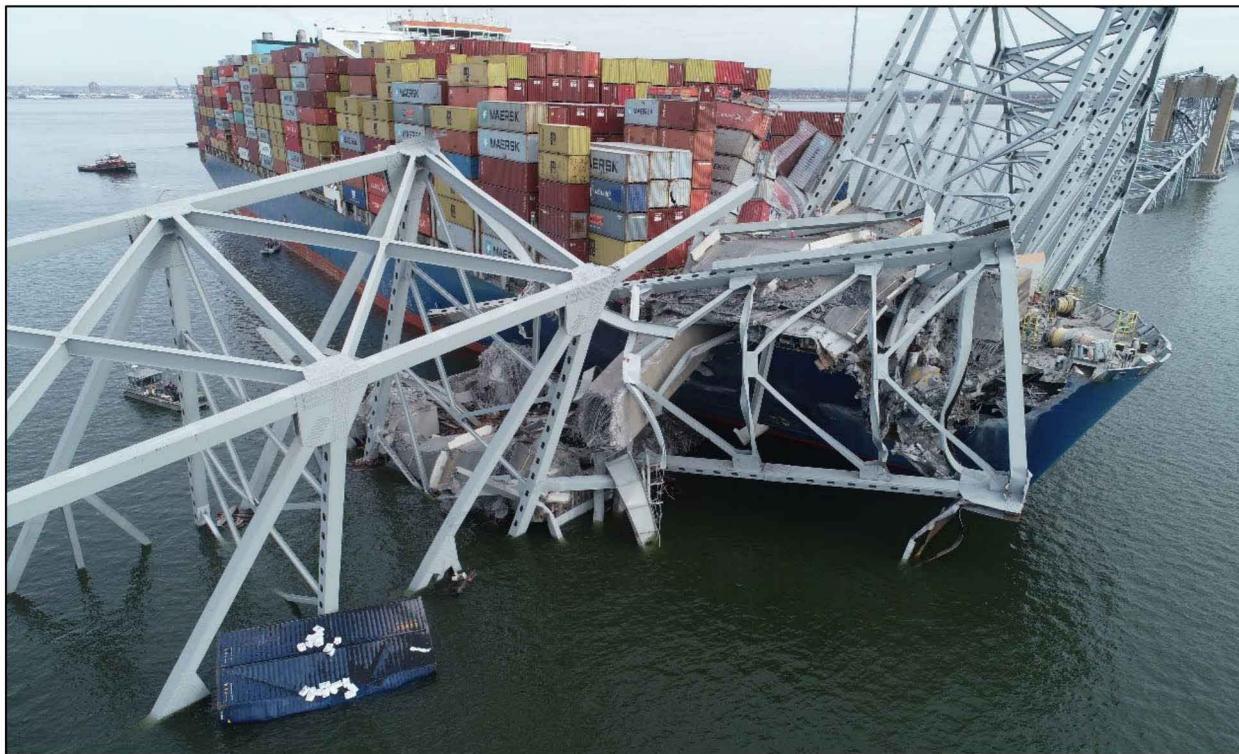
**Figure 1.** The *Dali*, with portions of the collapsed Key Bridge across its forward deck and in the Patapsco River, on March 28.

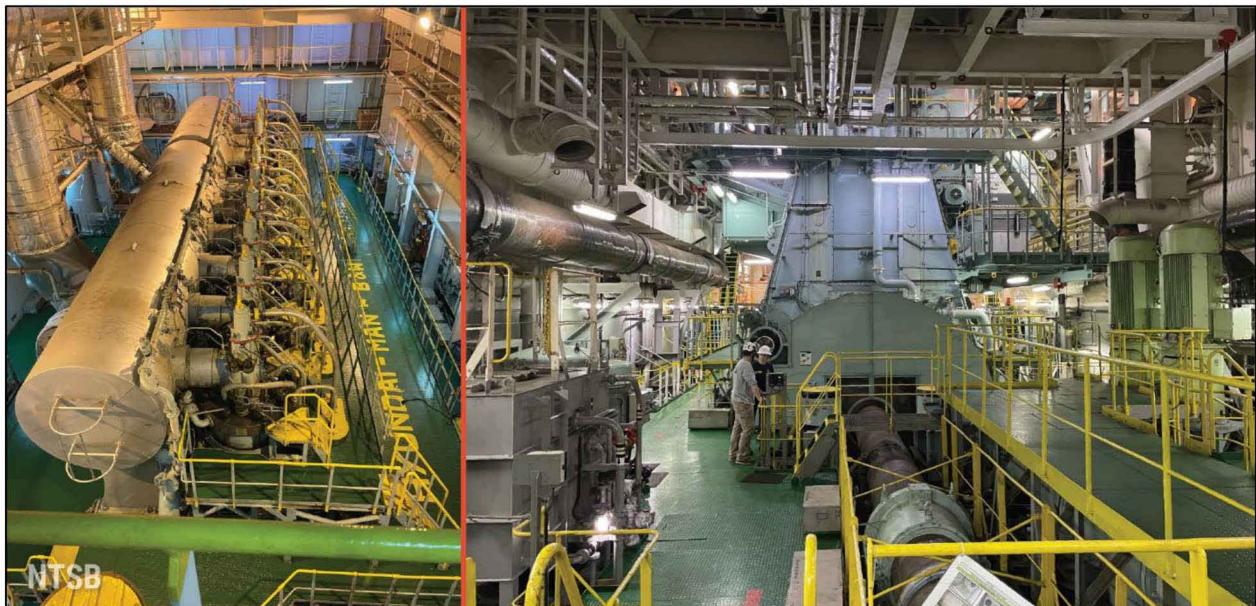
**Figure 2.** Left: The *Dali*'s main engine room (looking aft), showing the vessel's engine. Right: NTSB investigators examining the lower level of the vessel's engine room (looking forward).

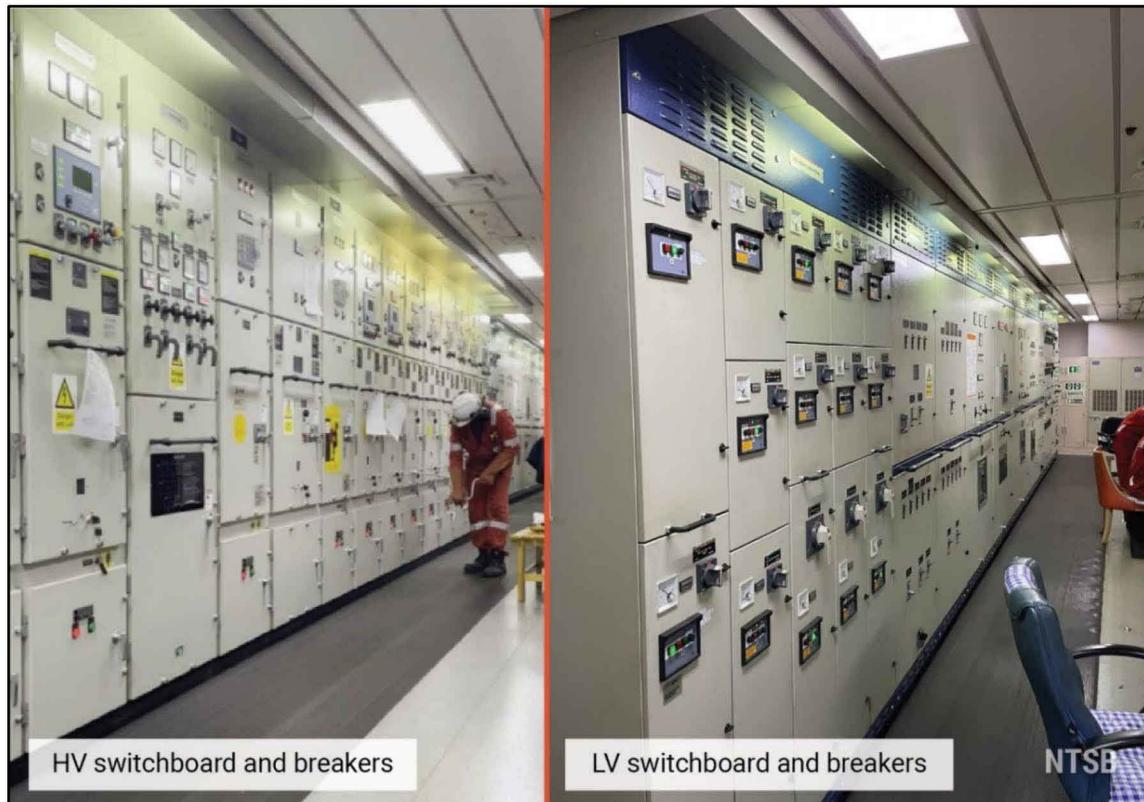
**Figure 3.** The *Dali*'s power management system in the ship's engine control room. The HV switchboard (which houses the HV bus) and breakers (*left*) and the LV switchboard (which houses the LV bus) and breakers (*right*).

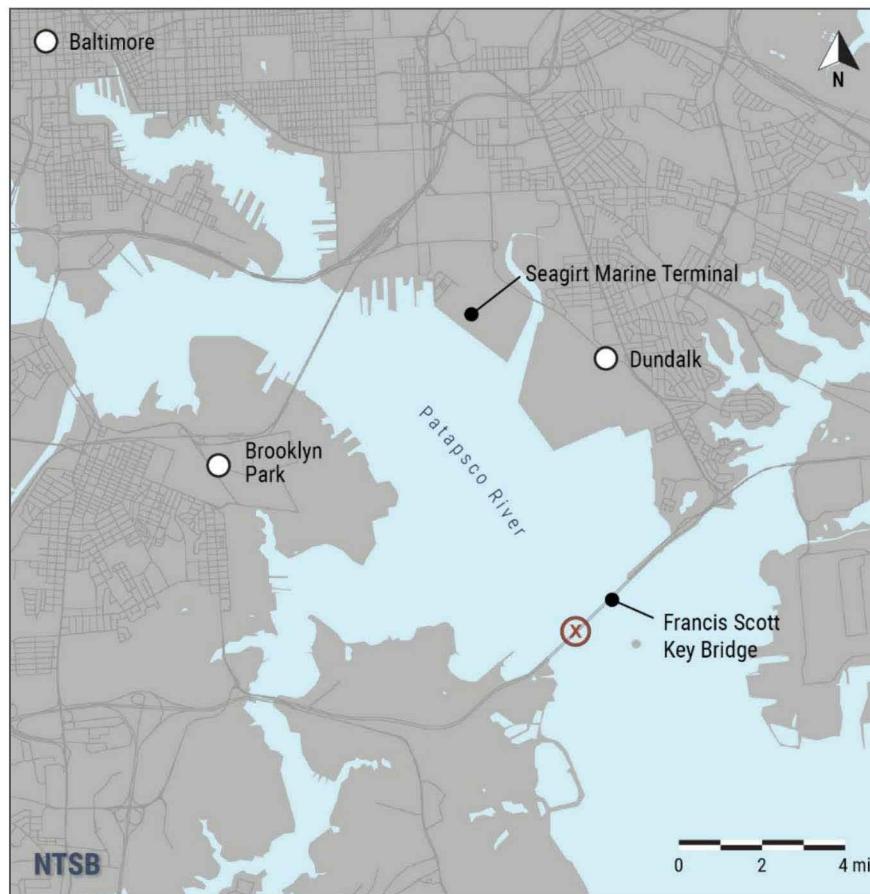
**Figure 4.** Area where the *Dali* struck the Key Bridge, as indicated by the red X. (Background source: Google Maps)

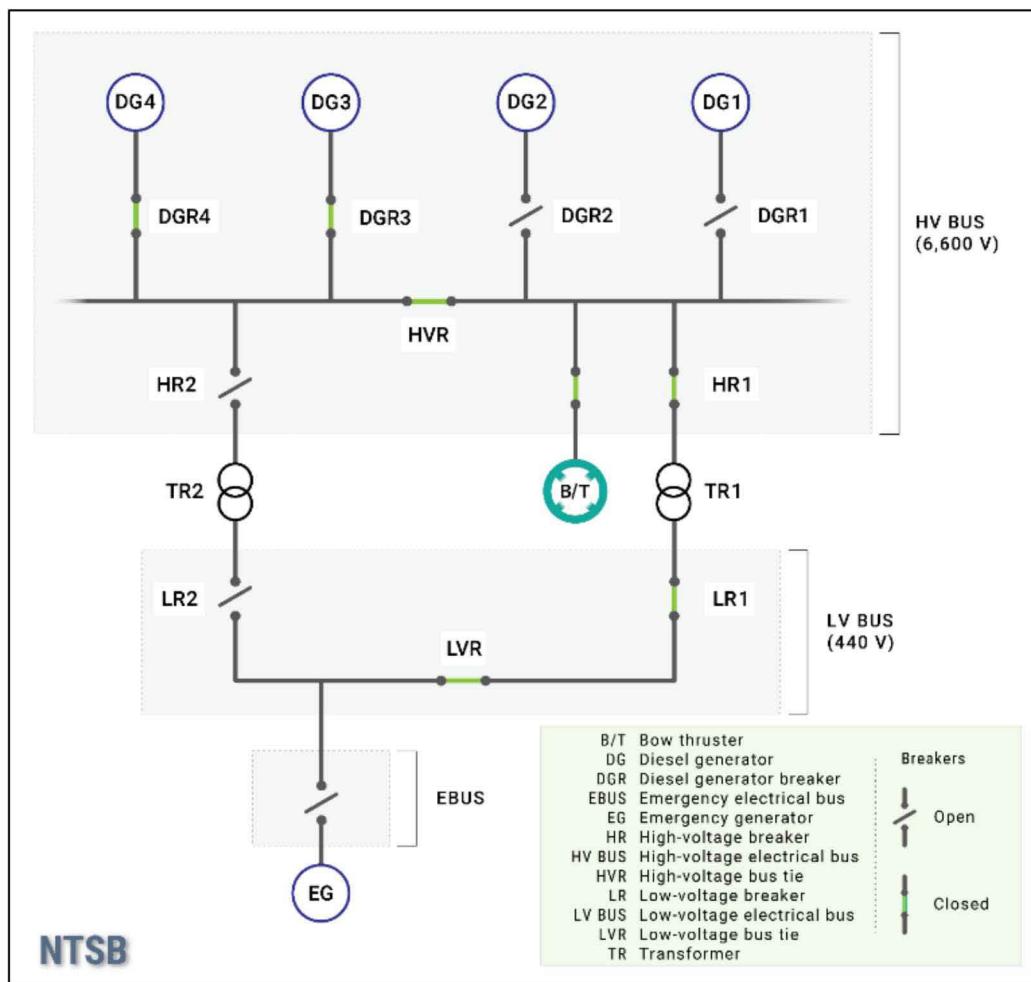
**Figure 5.** Simplified one-line electrical diagram of the *Dali* electrical power distribution system. Breakers shown reflect their positions at departure on March 26.

About 0125, the *Dali* was 0.6 miles—or three ship lengths—from the Key Bridge when electrical breakers (HR1 and LR1) that fed most of the vessel's equipment and lighting unexpectedly opened (tripped) (see figure 7). This caused the first blackout (loss of electrical power) to all shipboard lighting and most equipment, including the main engine cooling water pumps (which controlled engine cooling water pressure) and steering gear pumps.

- The *Dali* crew was able to restore electrical power to the vessel, but, when the ship was 0.2 miles from the bridge, a second electrical blackout occurred because DGR3 and DGR4, the breakers that connected generator nos. 3 and 4 to the HV bus, opened, causing a total loss of vessel electrical power (HV bus and LV bus). Having connected to the emergency bus by this time, the emergency generator provided electrical power to the emergency equipment continuously through the second electrical blackout.
- Generator no. 2, which had previously started automatically because it was in standby mode, connected and restored power to the HV bus via DGR2.

The first vessel blackout after departure on March 26 occurred when the HR1 and LR1 breakers opened unexpectedly.

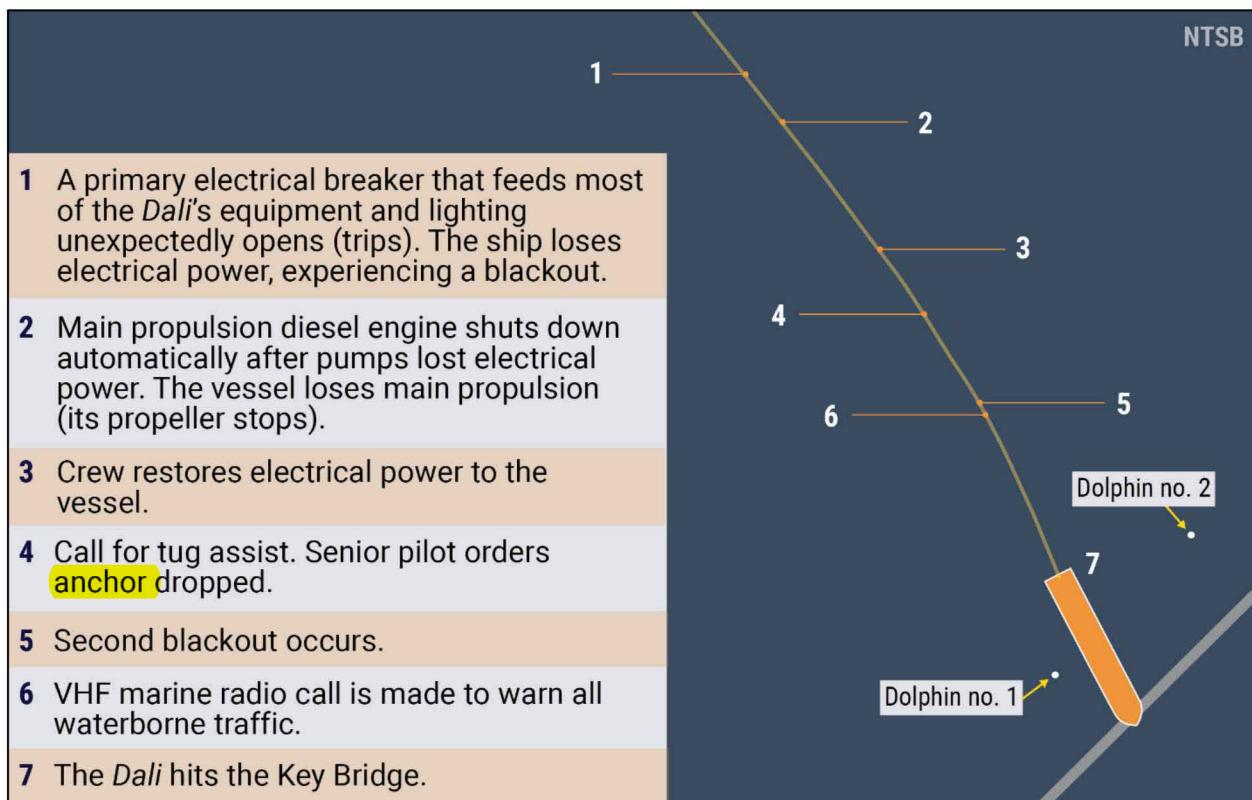
**Figure 7.** The *Dali*'s route on March 26, between the first blackout, and the *Dali* striking pier no. 17 of the Key Bridge. The location and approximate size of two of the bridge's "dolphins," sheet pile and concrete structures protecting the bridge's piers, are labeled in the lower right.

The loss of electrical power stopped all three steering pumps, and, therefore, the rudder was unable to be moved. At the time, the ship was on a heading of  $141.7^\circ$ , a course over ground of  $140.8^\circ$ , and speed over ground of 9.0 knots, with the rudder amidships ( $0^\circ$ ).

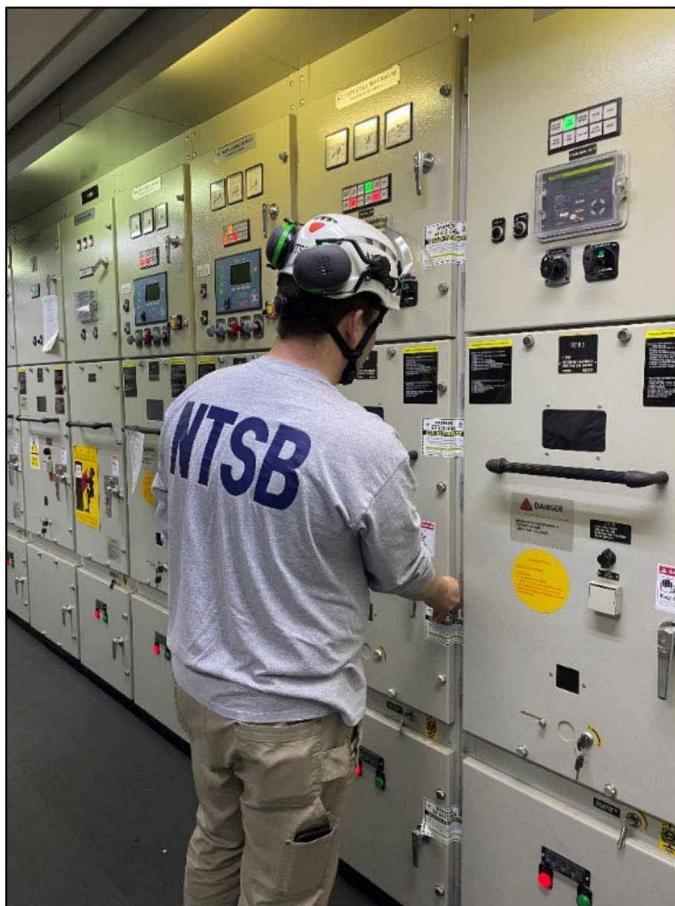
**Figure 8.** An NTSB investigator examining the *Dali*'s HV switchboard (which houses the HV bus) and applying tamper-evident preservation seals.

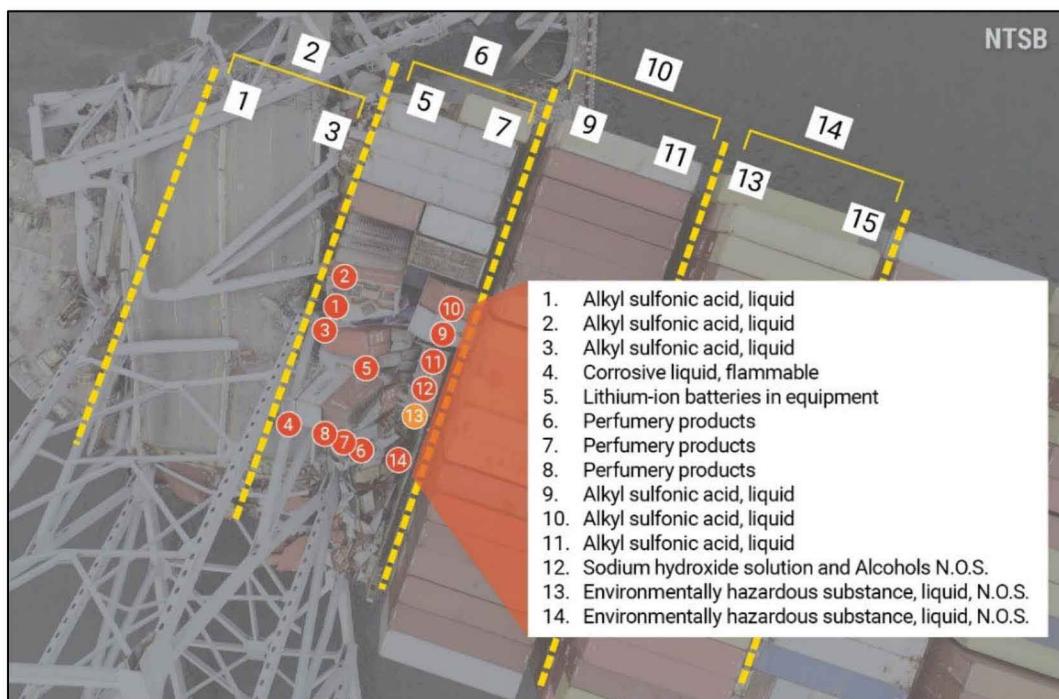
Of the 4,680 containers on board the vessel at the time of the accident, 56 were identified as containing dangerous goods (hazardous materials). The containers were located throughout the ship. The NTSB identified 14 containers, which were recorded as containing hazardous materials, that may have been damaged when the ship struck the Key Bridge or during the subsequent collapse of the bridge deck onto the ship (see figure 9 and table below). These 14 containers were all located forward of the superstructure, inboard in bays 5, 6, and 7.<sup>9</sup>

**Figure 9.** Approximate locations of cargo bays (yellow with numbers in white squares) and the 14 impacted hazardous materials shipping containers (orange circles with white numbers) transposed onto the *Dali* as seen after the accident. Hazardous material container no. 13 was in a portable tank, stored in the hold, below the deck.

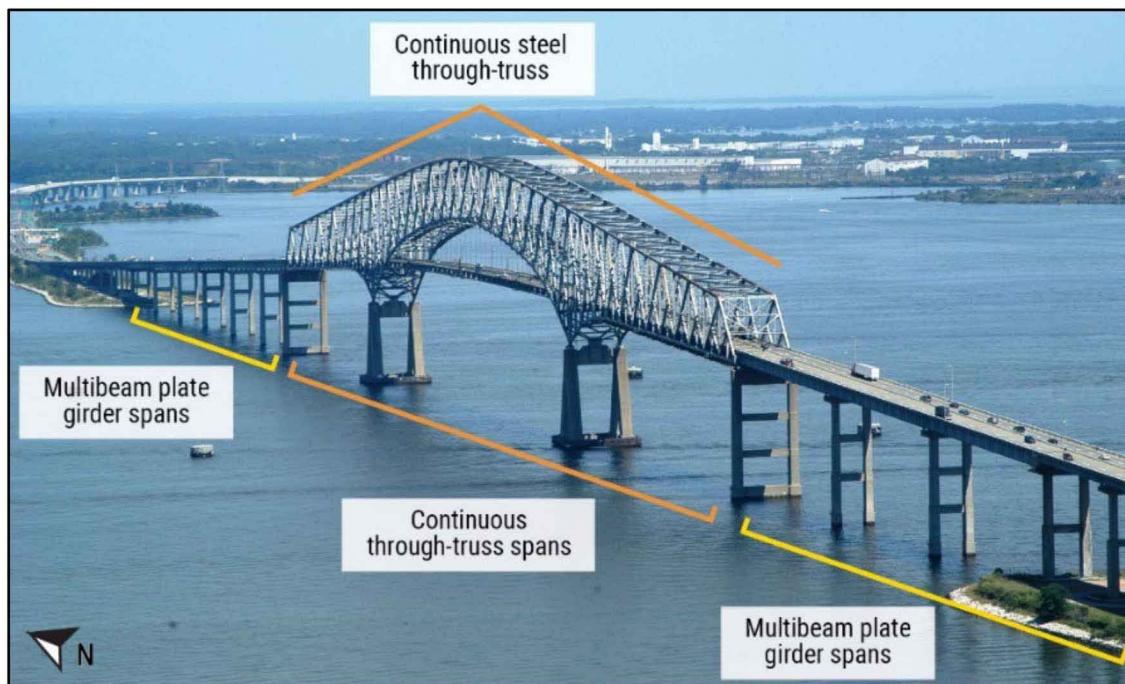
**Figure 10.** The Key Bridge with its truss and spans labeled. (Background source: MDTA)

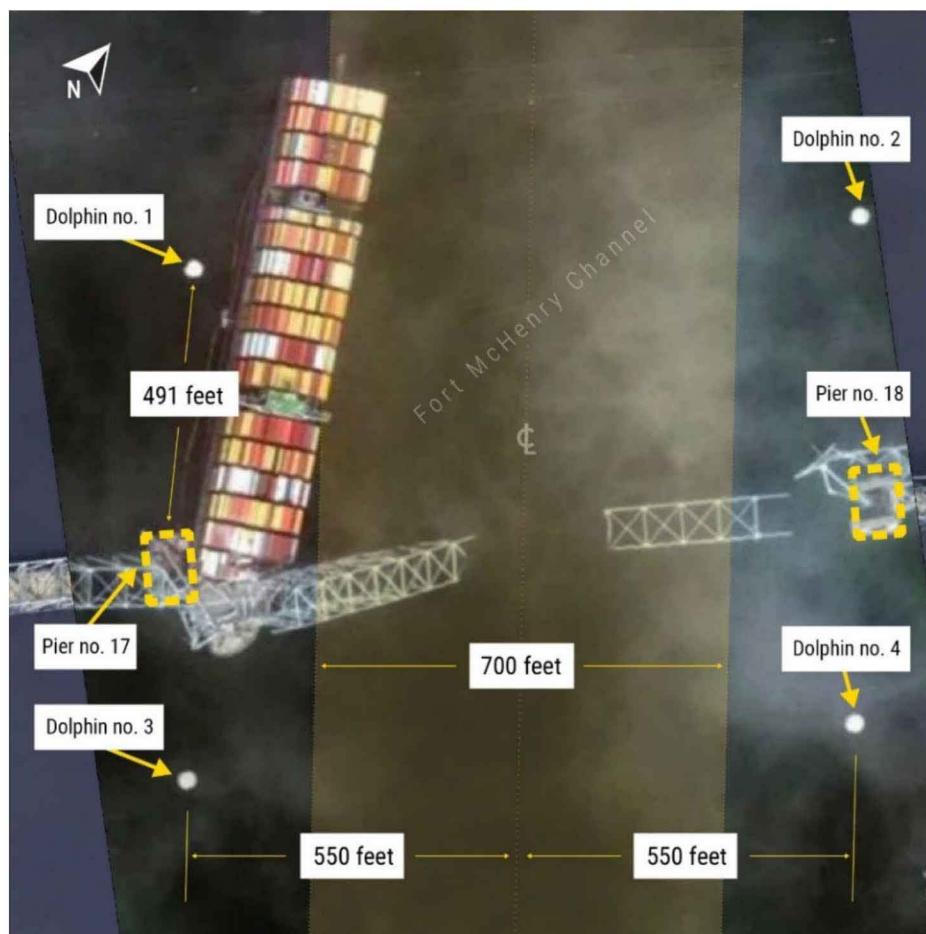
When the Key Bridge was constructed, four large dolphins—two located on the west side of the bridge and two located on the east side of the bridge—were also constructed at the same time to protect pier nos. 17 and 18 supporting the bridge's central through-truss spans. Dolphin no. 1 was about 491 feet west of the center of pier no. 17 and 550 feet clear of the centerline of the navigational channel (see figure 11). The dolphins were constructed with a 25-foot-diameter sheet pile filled with tremie concrete and capped with reinforced concrete (see figure 12). Attached at various locations on the dolphin were 17-foot-long rubber fenders.

**Figure 11.** Locations of dolphins relative to the *Dali*, the Key Bridge, and Fort McHenry Channel. (Background sources: MAXAR and Google Earth)

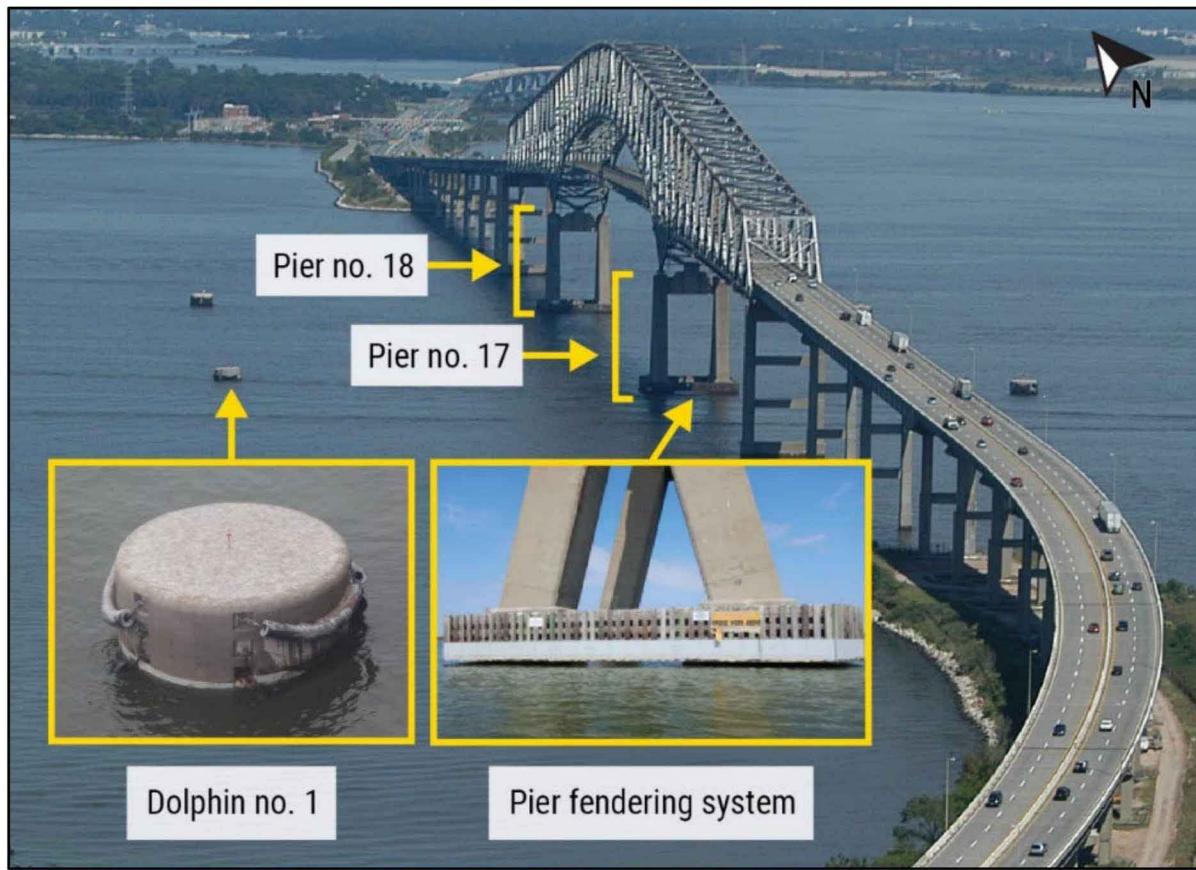
**Figure 12.** The Key Bridge and the locations of pier nos. 17 and 18. Insets show dolphin no. 1 as well as pier no. 17's fendering-system surrounding. (Background source: MDTA)

In addition to the dolphins, pier nos. 17 and 18 were each surrounded by a 100-foot-by-84.5-foot crushable concrete box and timber fender system, as seen in figure 12. These systems were comprised of hollow, thin-walled, concrete box structures attached to the piers. The timber portions of the fender were attached to the outer face of the concrete box and utilized a combination of vertical and horizontal members. Additionally, steel plates were secured at the base of the vertical timber members.

The *Dali* struck pier no. 17 and the fendering system surrounding the pier but did not contact dolphin no. 1 or its rubber fenders. Both fendering systems surrounding pier nos. 17 and 18 were further damaged during the collapse of the truss spans of the bridge when components of the truss spans impacted portions of the fenders as the components fell into the water.
