## Sjónarhóll AtNorth

### M12 Lagnir

#### Athugasemdir:

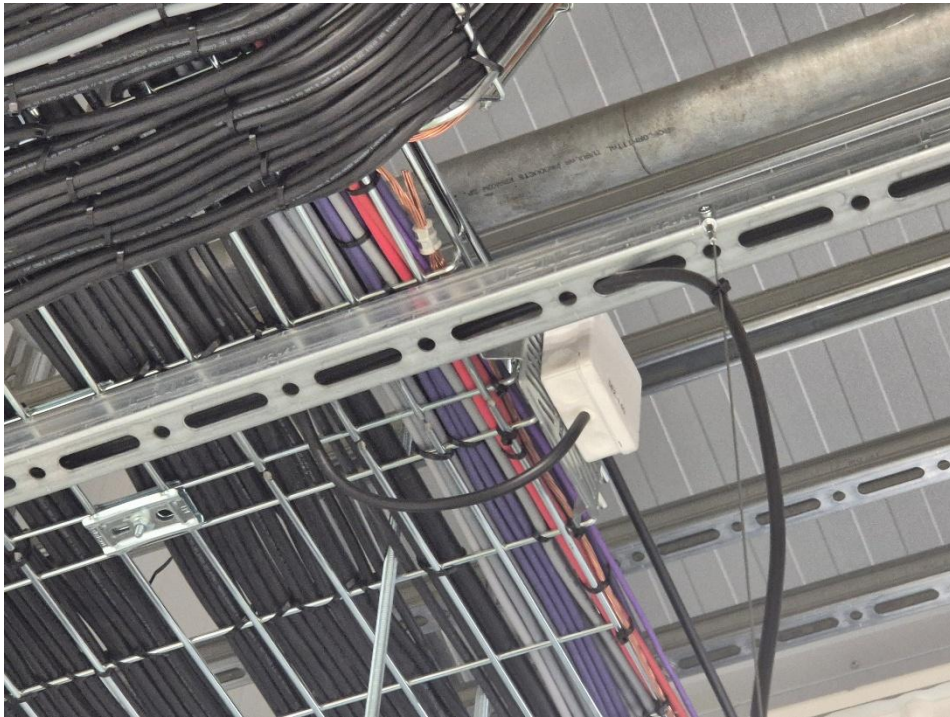
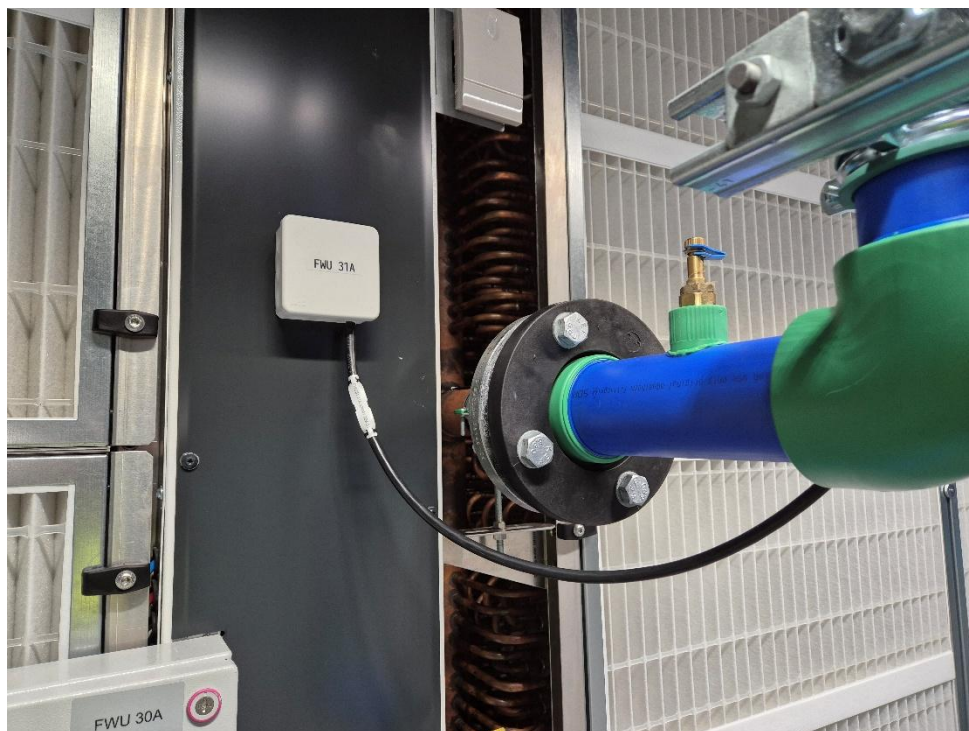
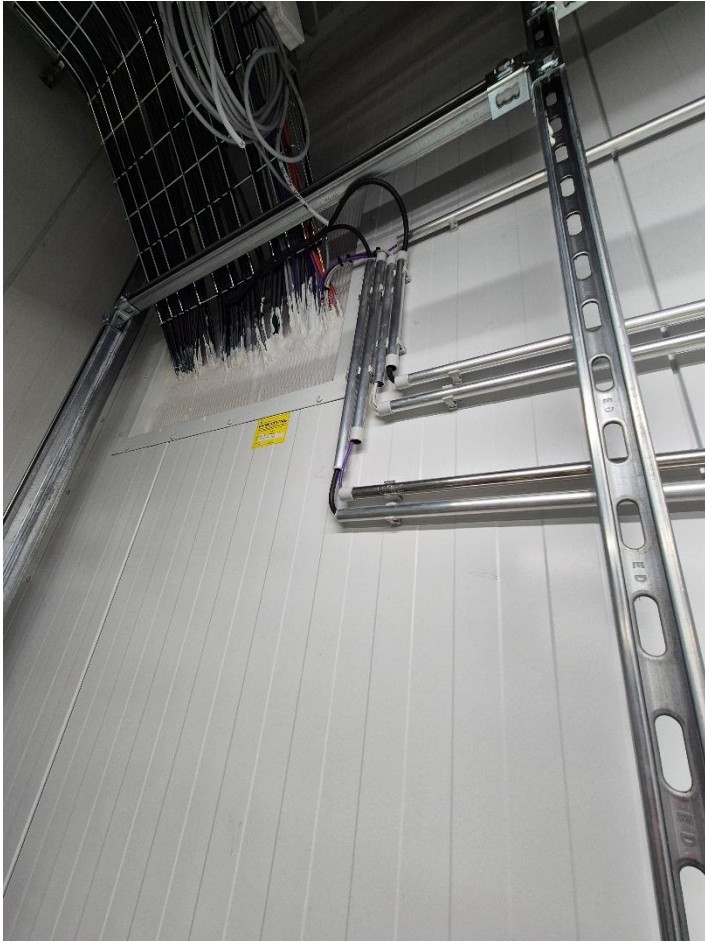
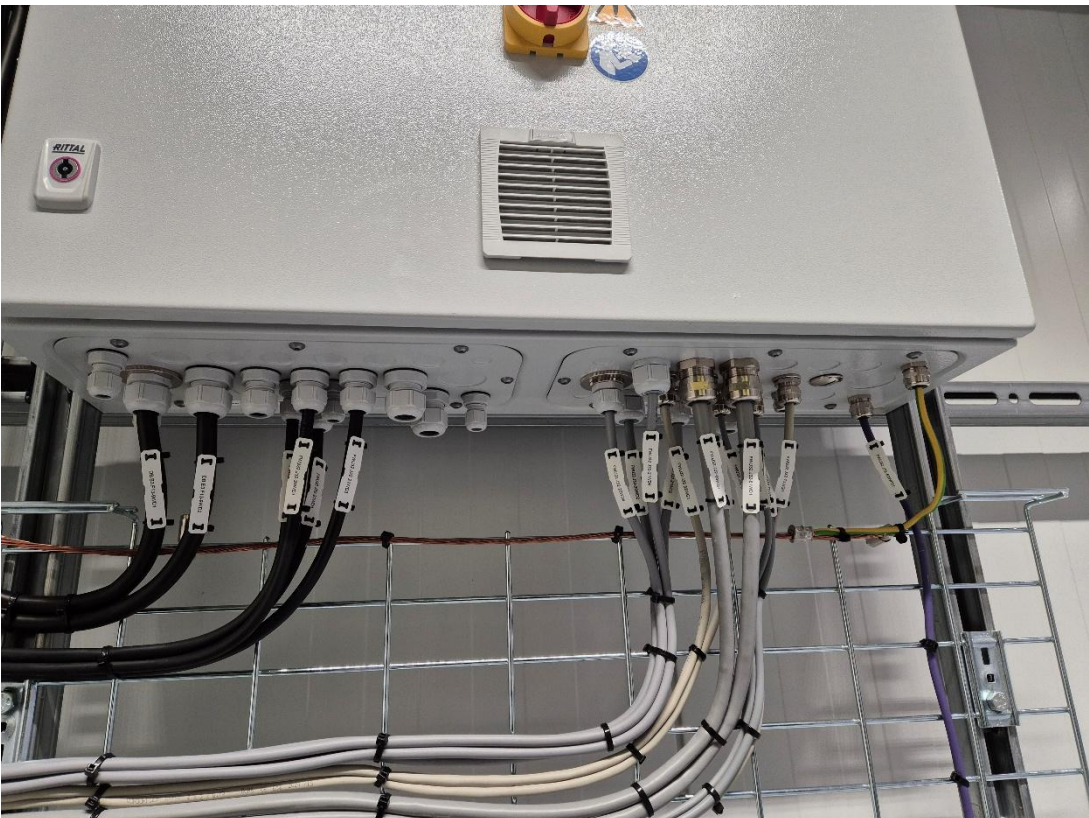
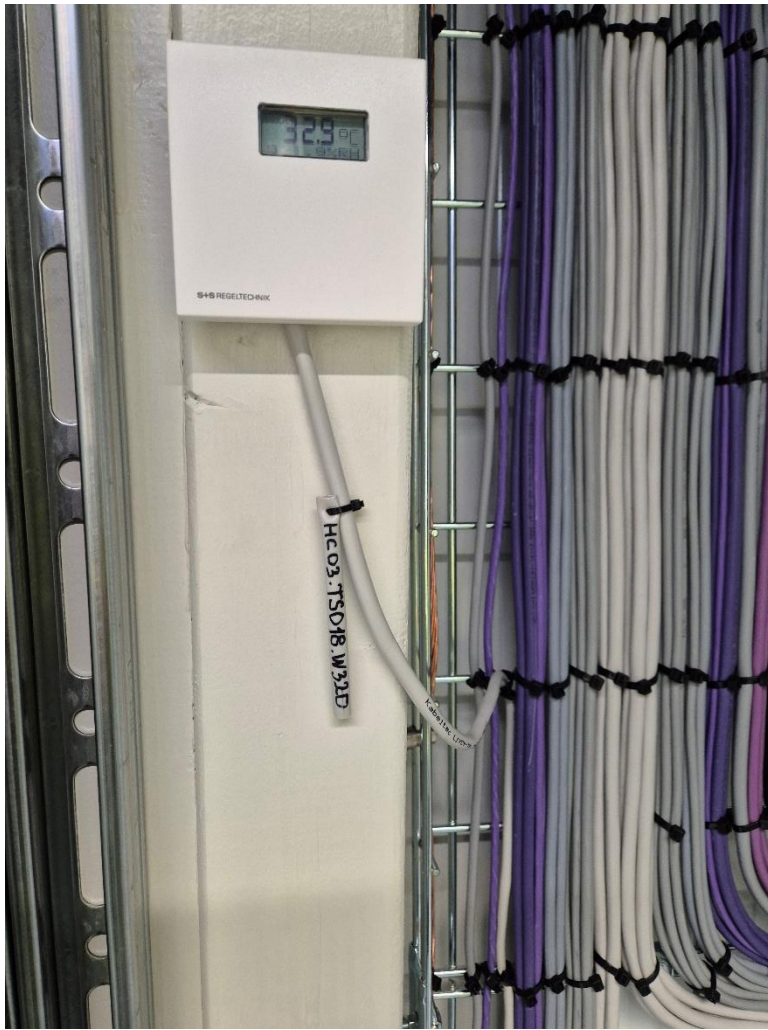
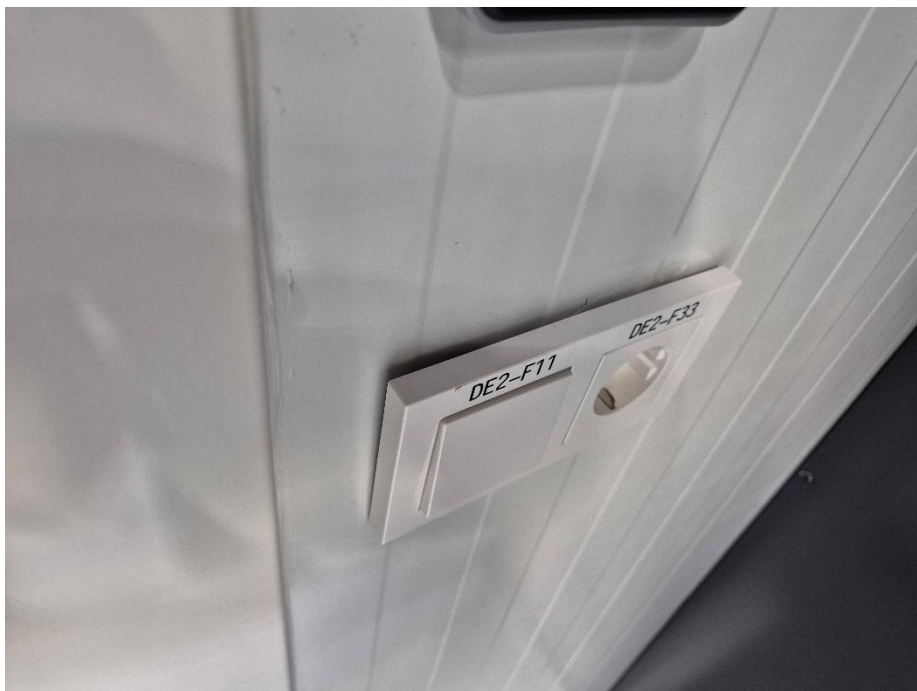
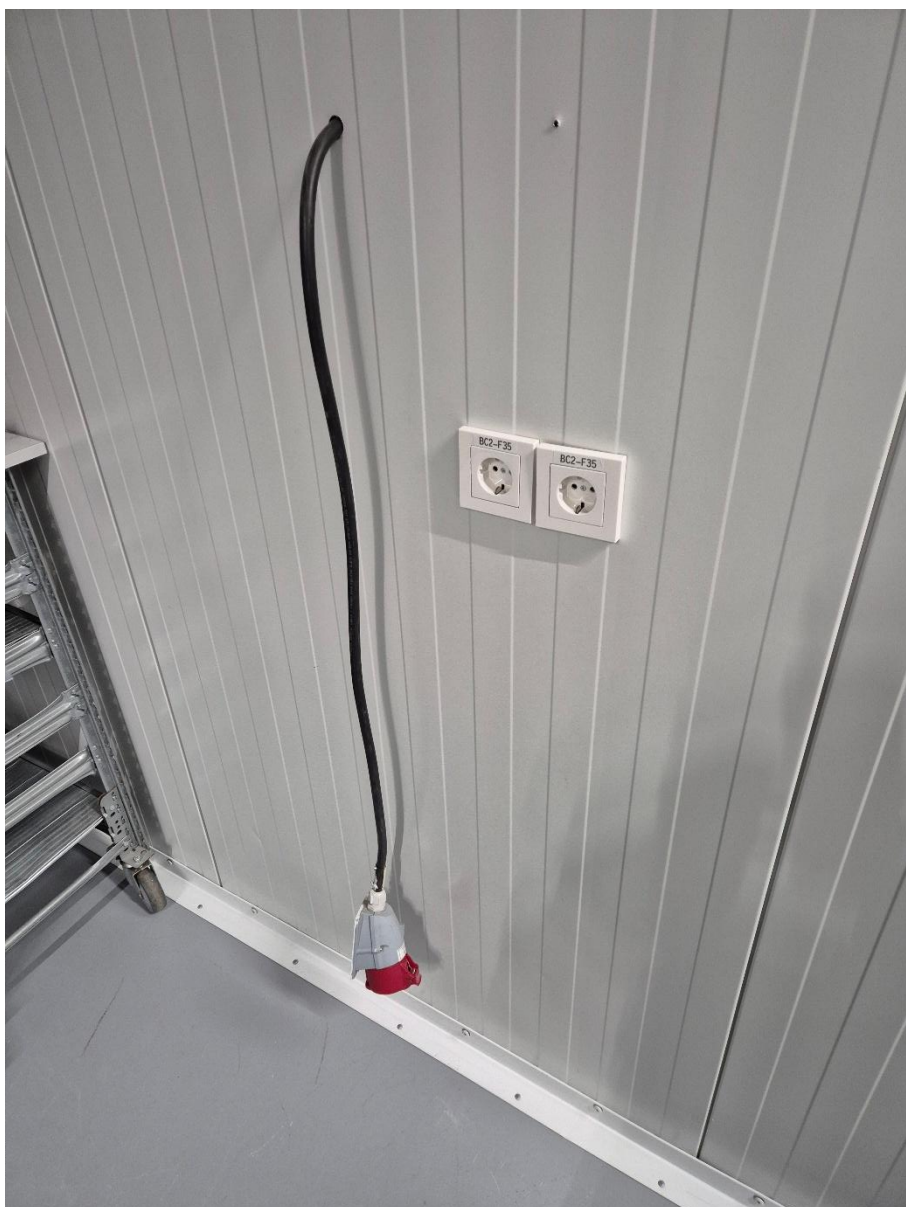
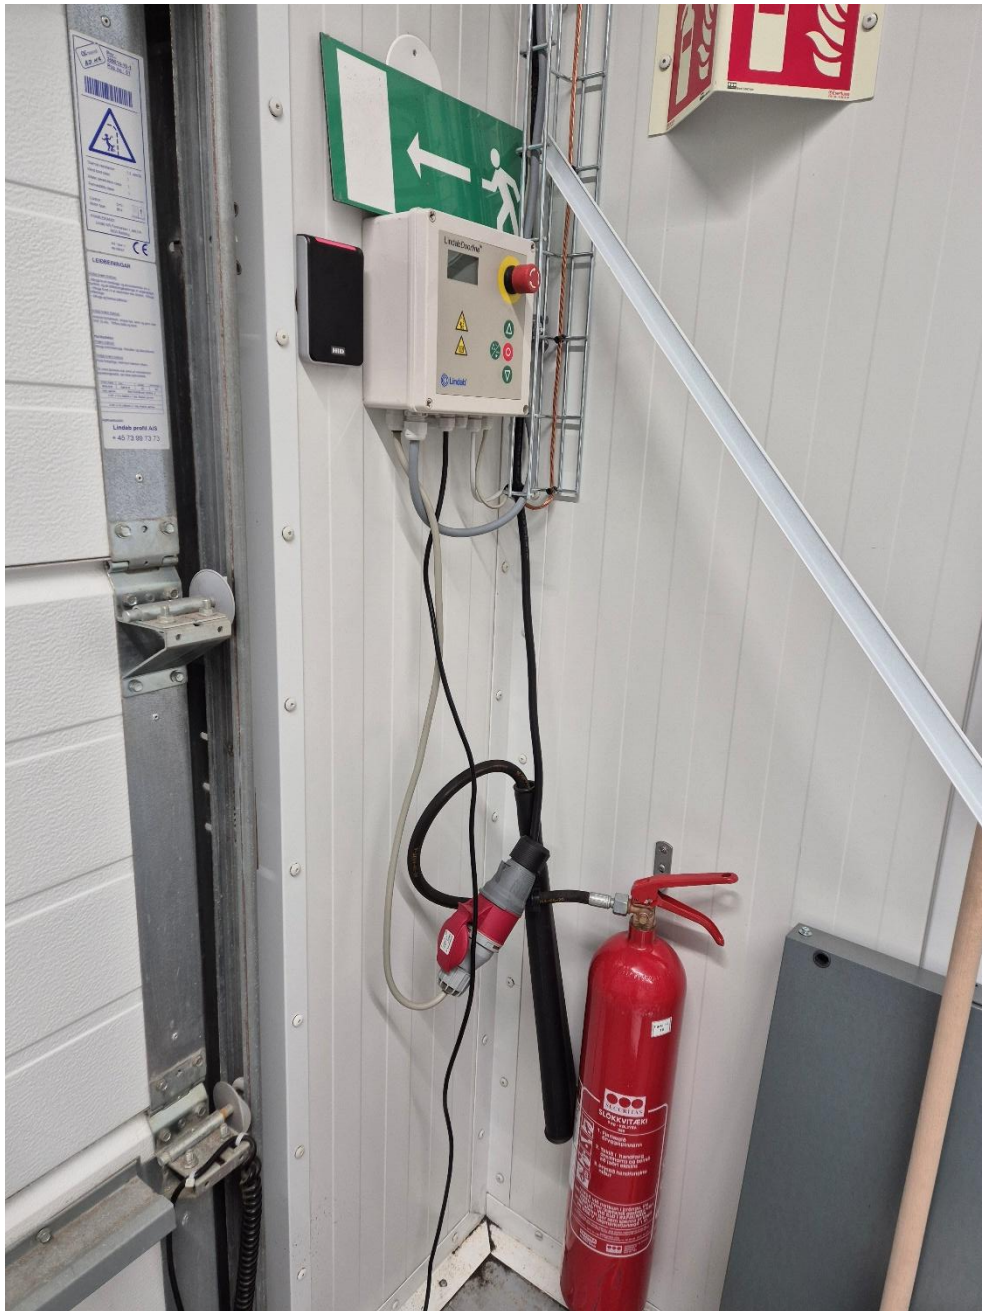
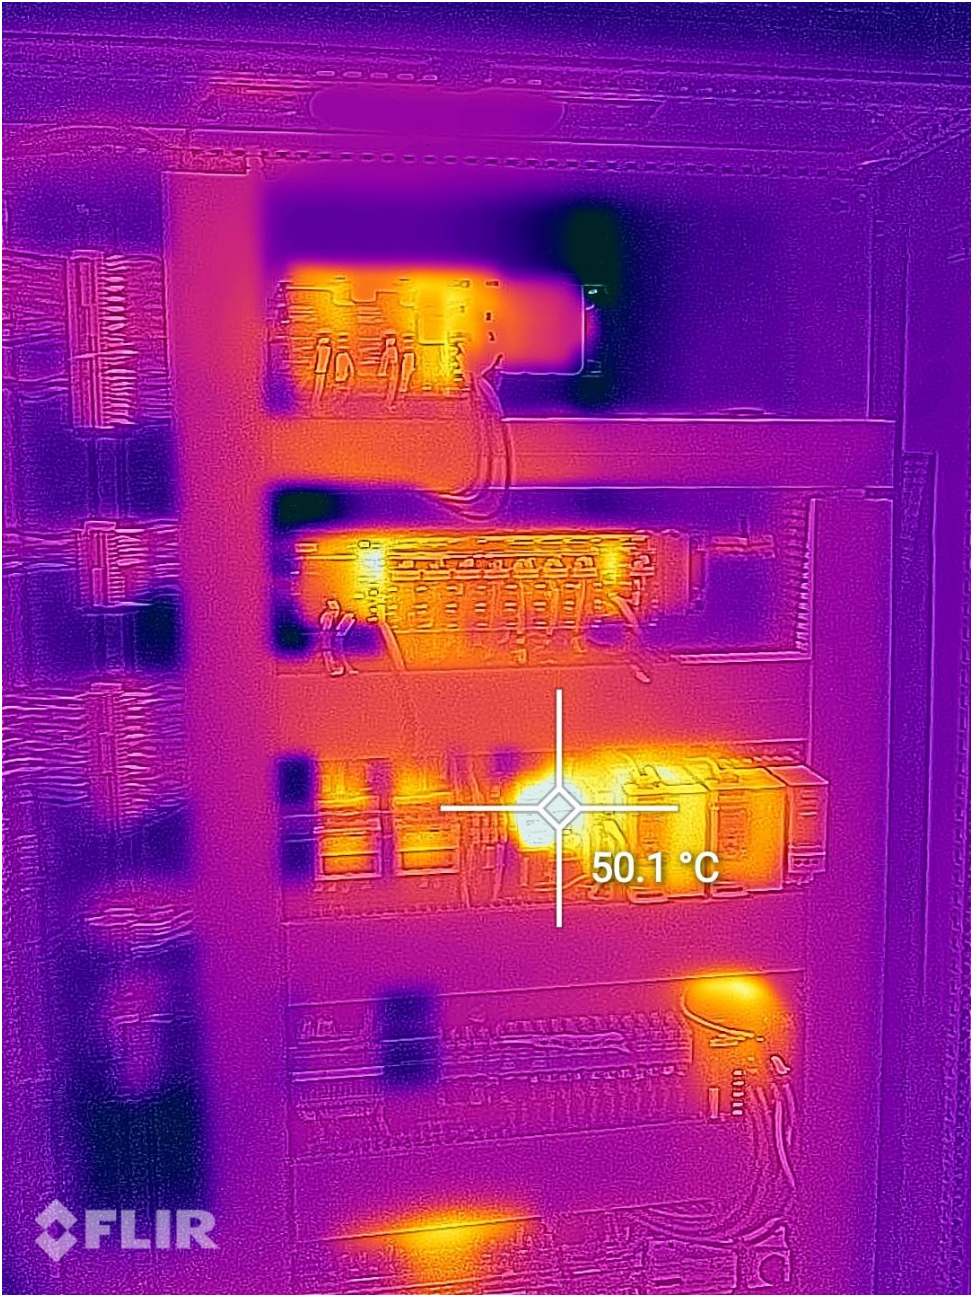
1. Vantar togfestur í tengidósir
2. Vantar enda í álrör
3. Opnir nipplar í FWU skápum
4. Vantar varanleg strengmerki
5. Rofar og tenglar falla ekki að veggeiningum
6. Laus 3f tengill (hangir í streng)
7. Tenging á vöruhurð ófrágengin
8. Merkingar á tengidósum á lokum (merking þarf að vera við hlið tengidósar)
9. Stjórnskápar heitir, mælist 52° inn í skáp

1. Needs to be fixed. We were putting cable ties inside to stop from pulling out.

2. There was no more rubber ends in Iceland at the time.

3. We were not told that unused nipples need to be closed. Cabinets passed inspection from Mannverk and AtNorth.

4. We had no details about some of the markings for cables.

5. The metal is too thin and in some places where panels connect it is not possible to put it so it fits nicely. All other houses had external switches and sockets because it is much easier to do it.

6. Probably used as temporary power for testing purposes. Not 100% sure that we did this.

7. Where to connect it? What breaker? No details in drawings.

8. Why? Where does it say it needs to be marked on the side?

9. Rafmidlun was last to work on these BMS cabinets. Girl from Rafmidlun told me that she was told to do some additional wiring and fixing inside cabinets. When we finished with them, everything was OK
