SOFFIT REPAIR SCHEDULE FOR UNDERSIDE OF LEVEL 03		
IMAGE REF.	IMAGE	REPAIRS REQUIRED
A. SOFFIT REPAIR		MINOR REPAIR TO DAMAGED HOLLOW POT REQUIRED. REMOVE LOOSE POT MATERIAL AND BOARD OVER SOFFIT WITH SUITABLE FIRE BOARD TO REINSTATE FULL FIRE PERIOD. IF WHOLE POT IS DAMAGED, REMOVE ALL AS PART OF THIS PROCESS.

LTW-BHE-XX-02-DR-S-20-1300

Architect: BOWMAN RILEY  
Project: LEEDS TRINITY WEST  
Dwg Title: LEVEL 03  
Job No: 035795 Scale/A: As indicated  
Drawing No: LTW-BHE-XX-02-DR-S-20-1300 Revision P01

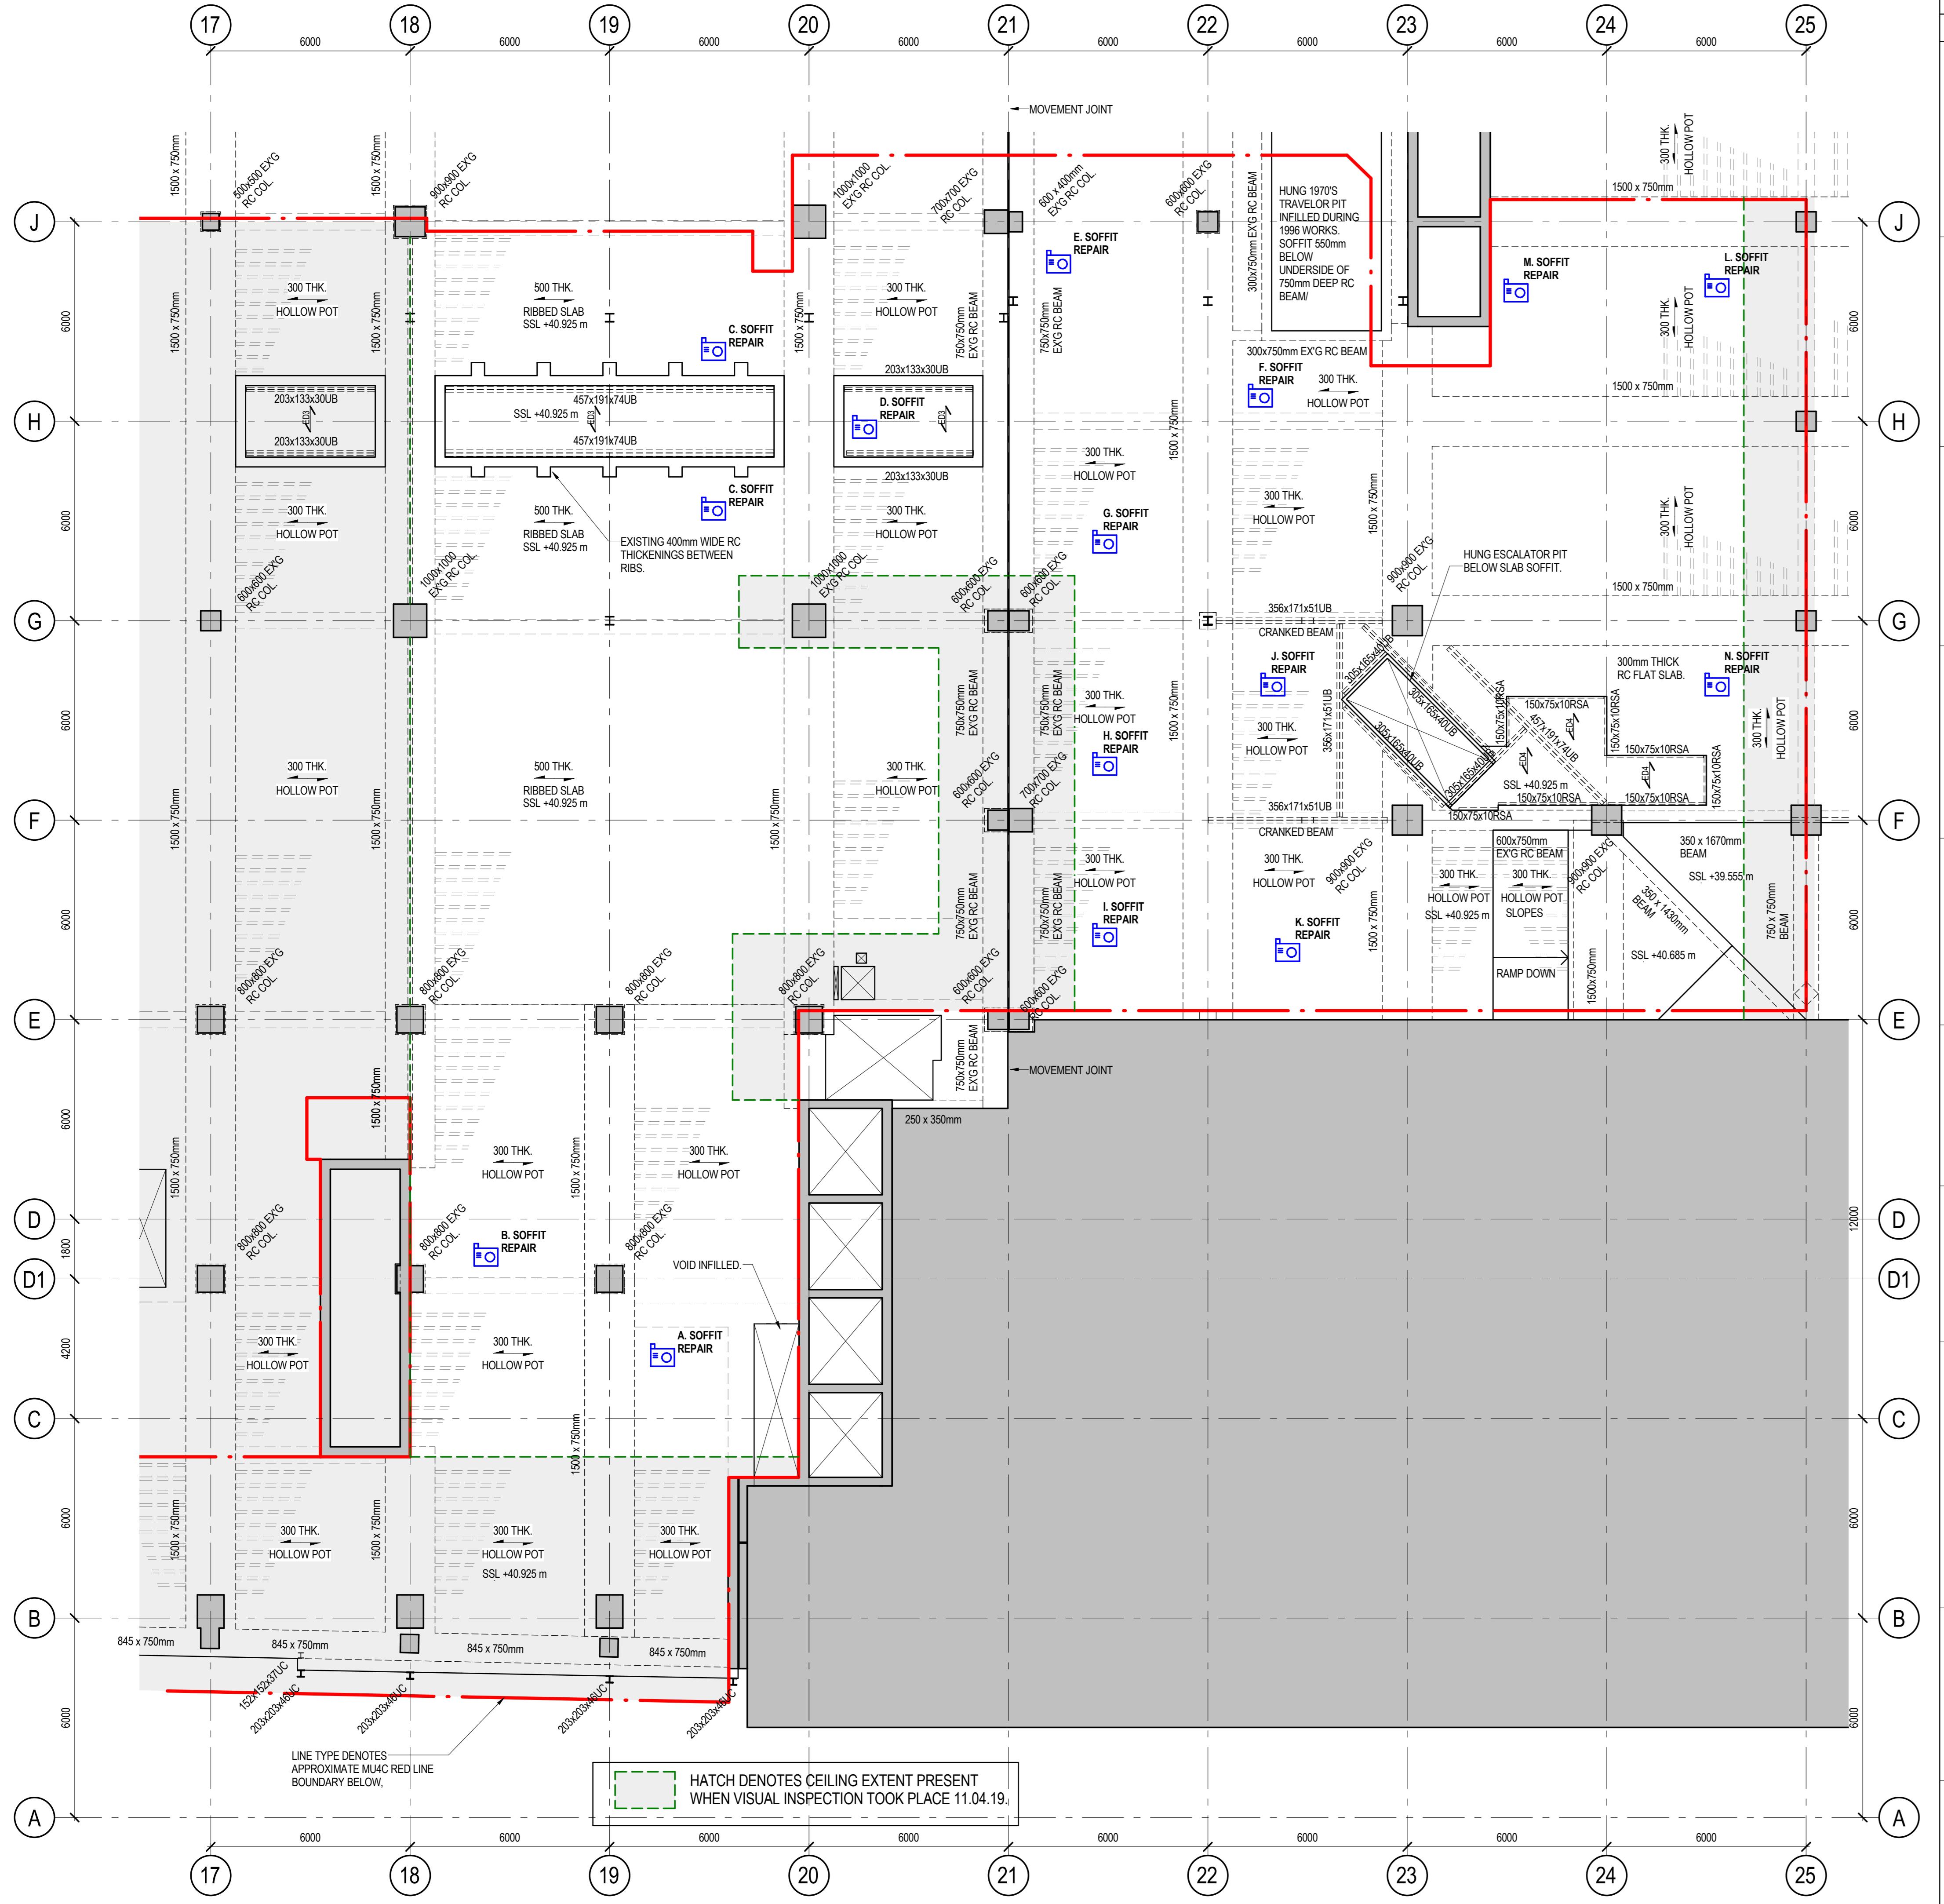
B. SOFFIT REPAIR		MINOR CONCRETE SOFFIT REPAIR REQUIRED. REINSTATE CONCRETE WITH FOSROC RENDEROC OR EQUAL APPROVED.
C. SOFFIT REPAIR		FIRE BOARDING IS INSUFFICIENTLY SEALED WHERE A PREVIOUS REFURBISHMENT HAS BEEN CARRIED OUT. REINSTATE FIRE BOARD TO ENSURE STEEL IS FULLY ENCAUSED TO ARCHITECT'S DETAILS. NOTE - IN ORDER TO DO THIS IT MAY BE NECESSARY TO FIRST REPAIR THE CONCRETE EDGE TO CREATE A PERPENDICULAR FACE TO BOARD AGAINST. IF SO, REINSTATE CONCRETE WITH FOSROC RENDEROC OR EQUAL APPROVED.

D. SOFFIT REPAIR		LOOSE CONCRETE ON PREVIOUS REFURBISHMENT. REMOVE LOOSE MATERIAL. REINSTATE CONCRETE WITH FOSROC RENDEROC OR EQUAL APPROVED.
E. SOFFIT REPAIR		DAMAGED SOFFIT CAUSED BY PREVIOUS REFURBISHMENT WORKS. REINSTATE CONCRETE WITH FOSROC RENDEROC OR EQUAL APPROVED.

F. SOFFIT REPAIR		MINOR REPAIR TO DAMAGED HOLLOW POT REQUIRED. REMOVE LOOSE POT MATERIAL AND BOARD OVER SOFFIT WITH SUITABLE FIRE BOARD TO REINSTATE FULL FIRE PERIOD. IF WHOLE POT IS DAMAGED, REMOVE ALL AS PART OF THIS PROCESS.

G. SOFFIT REPAIR		MINOR REPAIR TO DAMAGED HOLLOW POT REQUIRED - 2 NO. REMOVE LOOSE POT MATERIAL AND BOARD OVER SOFFIT WITH SUITABLE FIRE BOARD TO REINSTATE FULL FIRE PERIOD. IF WHOLE POT IS DAMAGED, REMOVE ALL AS PART OF THIS PROCESS.

H. SOFFIT REPAIR		DAMAGED RIB SOFFIT WITH EXPOSED REINFORCEMENT. REMOVE LOOSE MATERIAL AND CLEAN SURROUNDING AREA, INCLUDING PAINT REMOVAL TO ENSURE APPROPRIATE BONDING IS ACHIEVED. EXPOSED REINFORCEMENT TO BE PROTECTED WITH FOSROC NITROPRIME ZINC RICH PRIMER OR EQUAL APPROVED. REINSTATE CONCRETE WITH FOSROC RENDEROC OR EQUAL APPROVED, ENSURING A MINIMUM COVER OF 30MM. NOTE - THIS DEFECT MAY BE CAUSED BY INSUFFICIENT BOTTOM COVER IN THE ORIGINAL CONSTRUCTION. IF SO, THE RIB WILL NEED TO BE BUILT OUT DURING THE REPAIR TO ENSURE A ROBUST DETAIL IS DEVELOPED.

I. SOFFIT REPAIR		DAMAGED RIB SOFFIT WITH EXPOSED REINFORCEMENT. REMOVE LOOSE MATERIAL AND CLEAN SURROUNDING AREA, INCLUDING PAINT REMOVAL TO ENSURE APPROPRIATE BONDING IS ACHIEVED. EXPOSED REINFORCEMENT TO BE PROTECTED WITH FOSROC NITROPRIME ZINC RICH PRIMER OR EQUAL APPROVED. REINSTATE CONCRETE WITH FOSROC RENDEROC OR EQUAL APPROVED, ENSURING A MINIMUM COVER OF 30MM. NOTE - THIS DEFECT MAY BE CAUSED BY INSUFFICIENT BOTTOM COVER IN THE ORIGINAL CONSTRUCTION. IF SO, THE RIB WILL NEED TO BE BUILT OUT DURING THE REPAIR TO ENSURE A ROBUST DETAIL IS DEVELOPED.

J. SOFFIT REPAIR		DAMAGED RIB SOFFIT WITH EXPOSED REINFORCEMENT. REMOVE LOOSE MATERIAL AND CLEAN SURROUNDING AREA, INCLUDING PAINT REMOVAL TO ENSURE APPROPRIATE BONDING IS ACHIEVED. EXPOSED REINFORCEMENT TO BE PROTECTED WITH FOSROC NITROPRIME ZINC RICH PRIMER OR EQUAL APPROVED. REINSTATE CONCRETE WITH FOSROC RENDEROC OR EQUAL APPROVED, ENSURING A MINIMUM COVER OF 30MM. NOTE - THIS DEFECT MAY BE CAUSED BY INSUFFICIENT BOTTOM COVER IN THE ORIGINAL CONSTRUCTION. IF SO, THE RIB WILL NEED TO BE BUILT OUT DURING THE REPAIR TO ENSURE A ROBUST DETAIL IS DEVELOPED.

K. SOFFIT REPAIR		POOR INFILL CARVED OUT DURING PREVIOUS WORKS. ASSESS IF THE INFILL IS LOOSE IF SO, REMOVE LOOSE MATERIAL AND DAMAGED POT FRAGMENTS. BOARD OVER SOFFIT WITH SUITABLE FIRE BOARD TO REINSTATE FULL FIRE PERIOD. IF WHOLE POT IS DAMAGED, REMOVE ALL AS PART OF THIS PROCESS.

L. SOFFIT REPAIR		DAMAGED RIB SOFFIT WITH EXPOSED REINFORCEMENT. REMOVE LOOSE MATERIAL AND CLEAN SURROUNDING AREA, INCLUDING PAINT REMOVAL TO ENSURE APPROPRIATE BONDING IS ACHIEVED. EXPOSED REINFORCEMENT TO BE PROTECTED WITH FOSROC NITROPRIME ZINC RICH PRIMER OR EQUAL APPROVED. REINSTATE CONCRETE WITH FOSROC RENDEROC OR EQUAL APPROVED, ENSURING A MINIMUM COVER OF 30MM. NOTE - THIS DEFECT MAY BE CAUSED BY INSUFFICIENT BOTTOM COVER IN THE ORIGINAL CONSTRUCTION. IF SO, THE RIB WILL NEED TO BE BUILT OUT DURING THE REPAIR TO ENSURE A ROBUST DETAIL IS DEVELOPED.

M. SOFFIT REPAIR		POOR INFILL AROUND REDUNDANT PIPEWORK. REMOVE LOOSE MATERIAL, INCLUDING PAINT IF POSSIBLE. REINSTATE CONCRETE TO PROVIDE A NEAT AND ROBUST REPAIR WITH FOSROC RENDEROC OR EQUAL APPROVED, ENSURING A MINIMUM COVER OF 30MM.
