Prime Accident Assessors Ltd.

ASSESSMENT REPORT

PAA/558/SANLAM/2021 30-Jul-2021, Fri

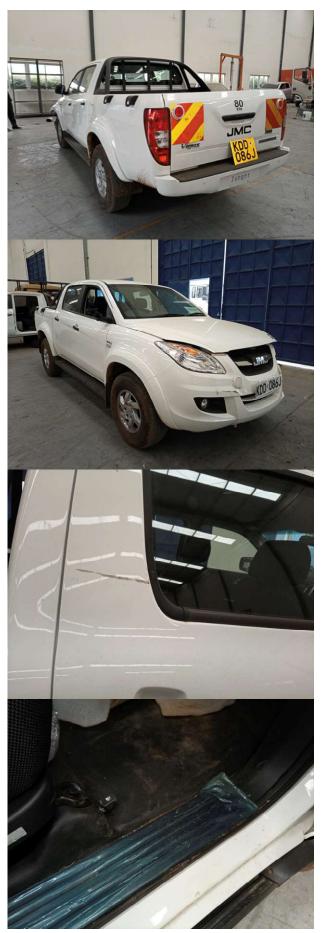
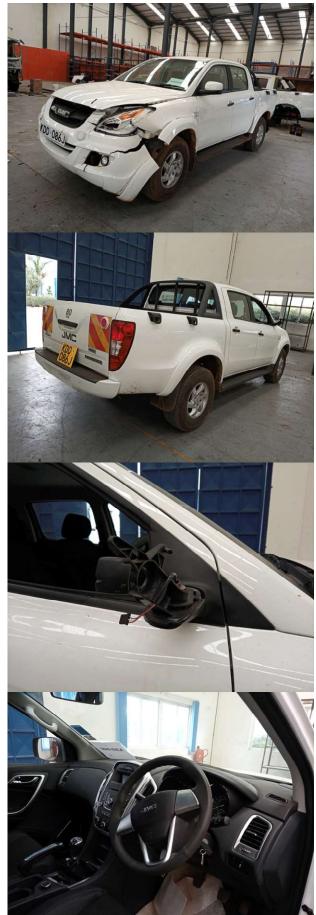
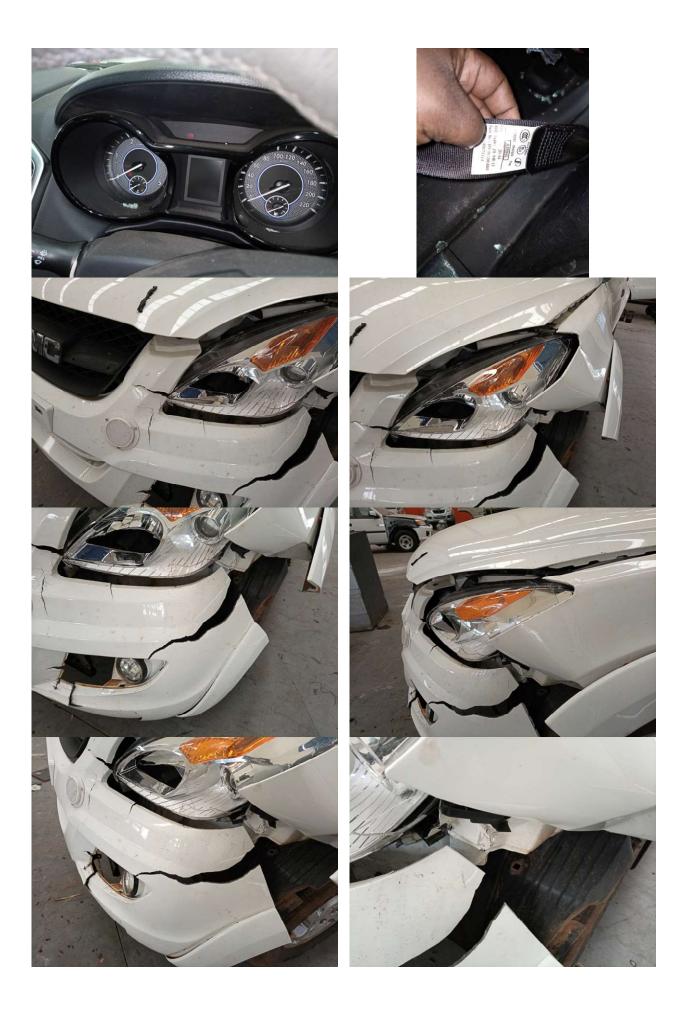
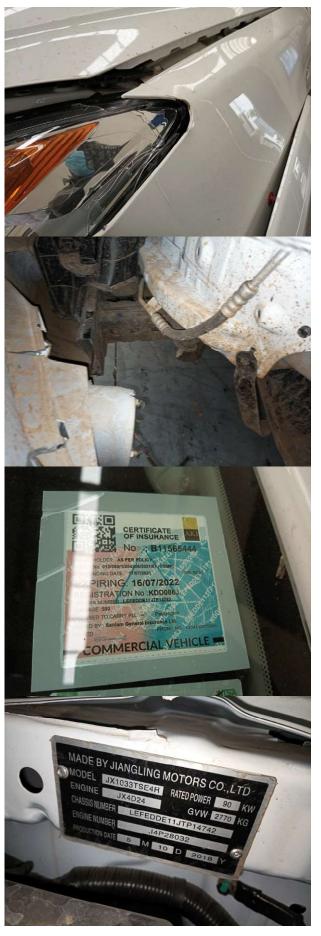
NATURE OF IMPACT COMBINED MODERATE LHF END IMPACT COUPLED WITH MODERATE RHS GLANCING IMPACT

Photo showing damage caused by the impact

GENERAL SUMMARY									
RECOM	IMENDED CLAIM SETTL	EMENT METHOD								
● A	Authorise Repairs Settle as cash in lieu Pay out pre-accident value									
PRE-A	PRE-ACCIDENT DAMAGES NOTED									
	NOT ESTABLISHED									
DAMAG	SED PARTS									
то ве	REPLACED	See repairs estimate bel	ow							
то ве	REPAIRED	LHF DOOR, RHR DOOR	R, BONN	IET LID						
то ве	REPAINTED	FRONT BUMPER, RHR	DOOR,	BONNE	T LID, LI	HF WING, L	HF DOOR			
		REI	PAIRS	ESTIM	ATE
