Elk River Watershed Group Fish Passage Restoration Planning 2021

Prepared for
Nupqua Resource Limited Partnership

Prepared by
Al Irvine, B.Sc., R.P.Bio.
New Graph Environment Ltd.

Version 1.0.2
2022-04-28

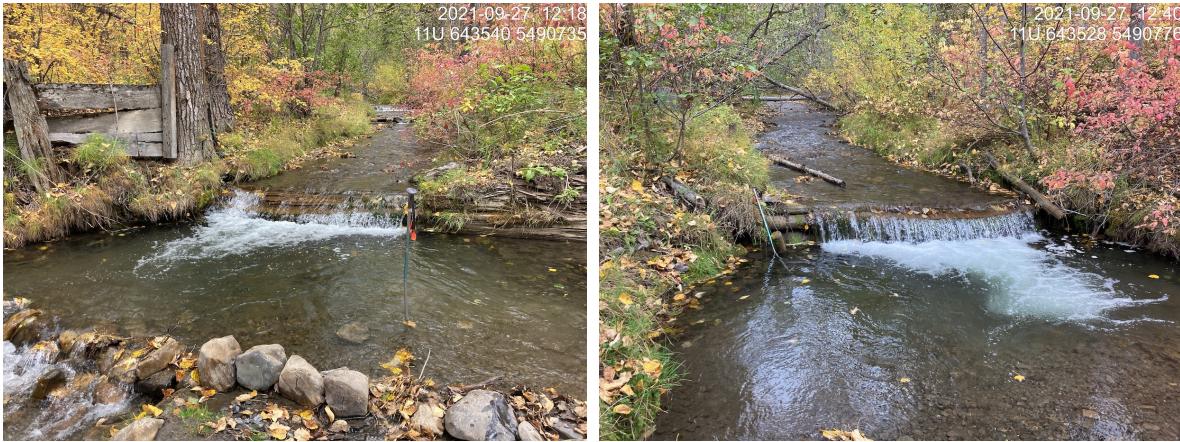
Site	Stream	Easting	Northing	Mapsheet	Barrier	Notes
197542	Hartley Creek	643537	5490723	082G.113	T	Two small dams (30cm and 40cm high) located just upstream (7m and 20m) of Dicken Road. Likely easily passable by adult WCT but barrier to fry and small juveniles. If culvert replaced these could potentially be fixed at the same time.
1100000129	Boivin Creek	647275	5541987	082J.103	F	Remnant dam not located in main channel.
1100002016	Harmer Creek	657051	5522119	082G.123	T	Large dam (15m high at 55% grade) located in main channel. No fish ladder.

Figure 4.1: Left: Small dam ~7m upstream of PSCIS crossing 197542 on Hartley Creek. Right: Small dam ~20m upstream of PSCIS crossing 197542 on Hartley Creek.

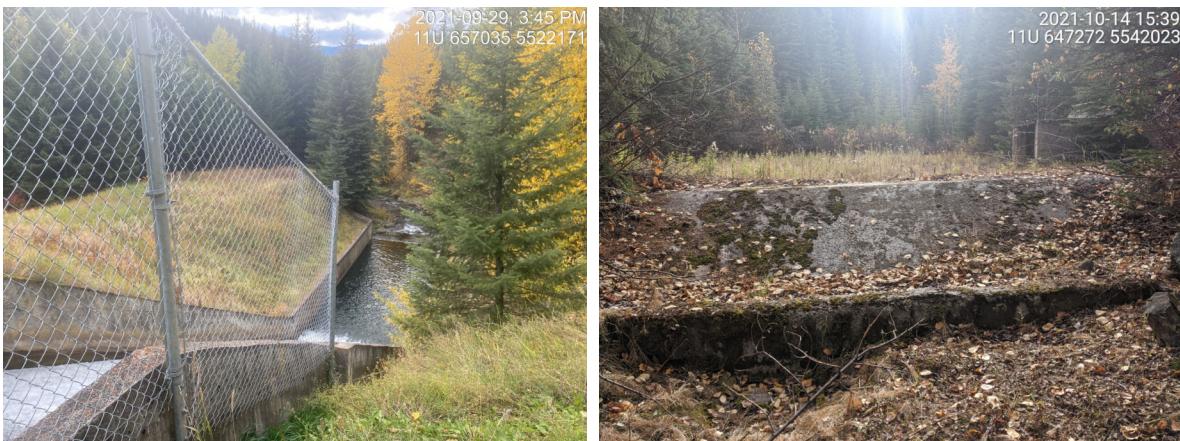
Figure 4.2: Left: Teck Coal Limited dam (15m high and 55% gradient) on Harmer Creek. Right: Historic dam structure adjacent to Boivin Creek.

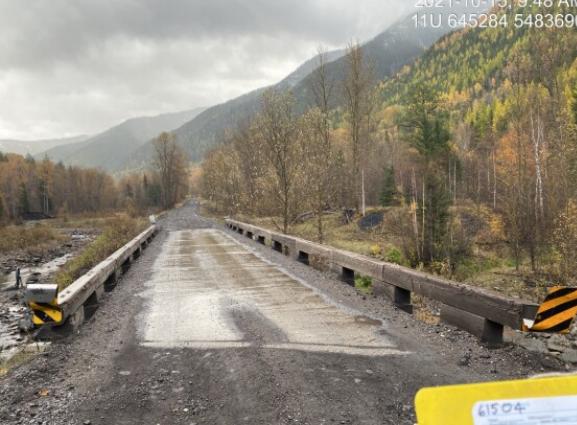
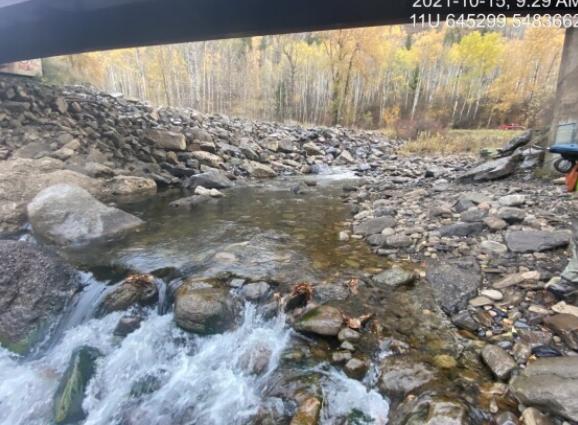
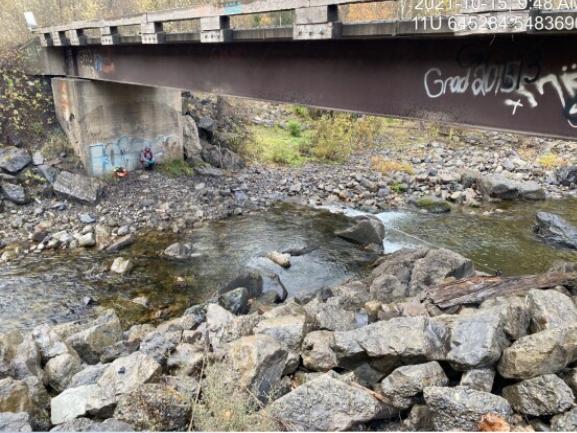
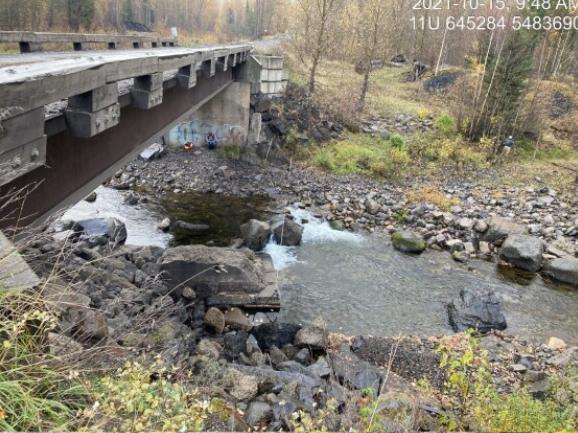
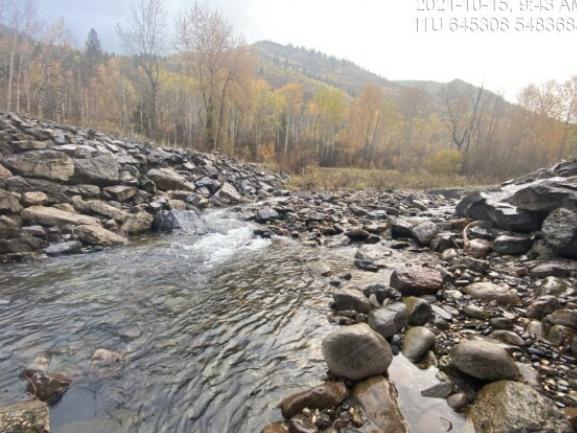
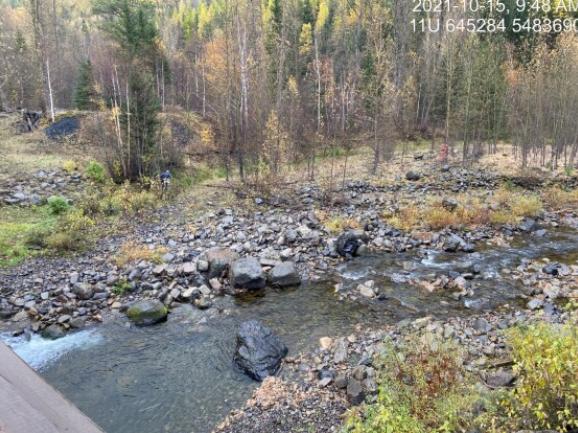
Location and Stream Data	• Crossing Characteristics
Comments: Habitat confirmation conducted due to debris in stream that causes small drop across stream (0.2 - 0.6m high) just downstream of the bridge. 9:20

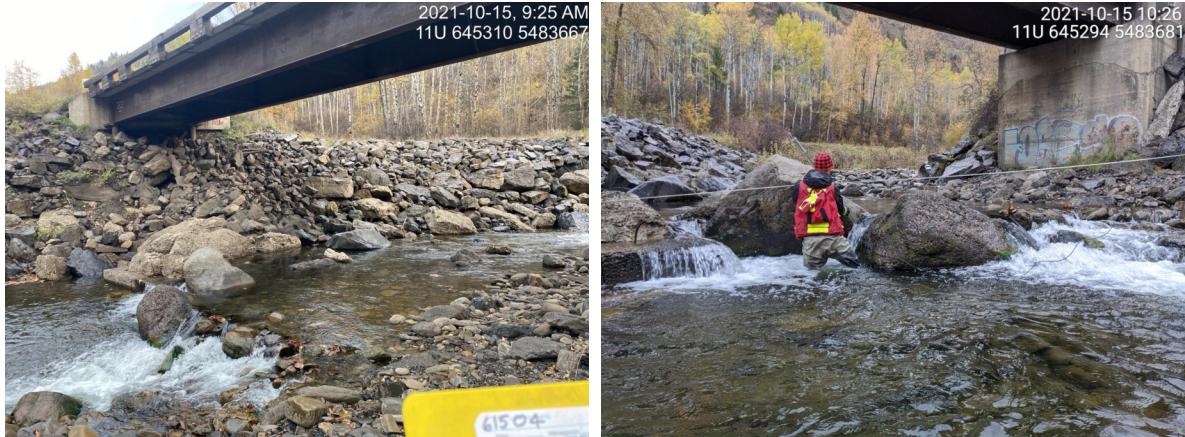
Figure 5.1: Left: Cascade adjacent to PSCIS crossing 61504. Right: Flow velocity measurement adjacent to PSCIS crossing 61504.

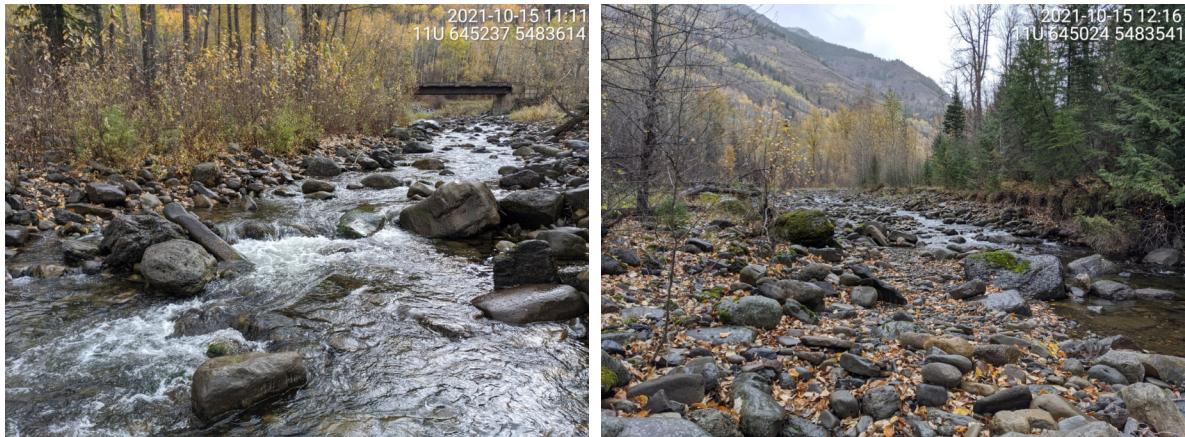
Figure 5.2: Left: Typical habitat downstream of PSCIS crossing 61504. Right: Typical habitat downstream of PSCIS crossing 61504.

The stream was surveyed downstream from 61504 for 365m (Figure 5.1). Overall, total cover amount was rated as abundant with boulders dominant undercut banks subdominant (Table 5.4). The average channel width was 27.8m, the average wetted width was 10.5m and the average gradient was 2.8%. The dominant substrate was NA with NA subdominant. Some pockets of gravel suitable for westslope cutthroat trout spawning were observed. Habitat value was rated as high within the large system with abundant habitat available for fry/juvenile salmonid rearing.

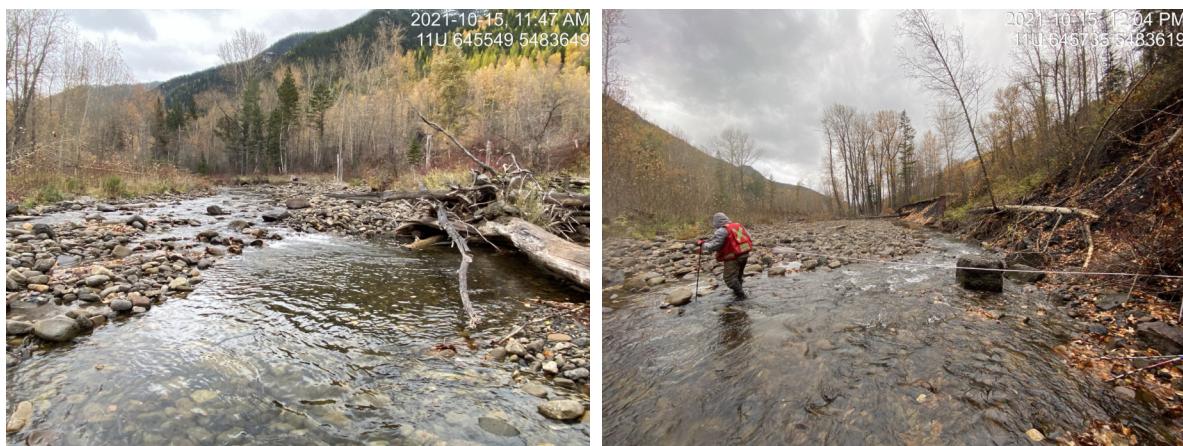
Figure 5.3: Left: Typical habitat upstream of PSCIS crossing 61504. Right: Typical habitat upstream of PSCIS crossing 61504.

The stream was surveyed upstream from 61504 for 520m (Figure 5.2). Within the area surveyed, total cover amount was rated as abundant with boulders dominant. Cover was also present as large woody debris and deep pools (Table 5.4). The average channel width was 12.1m, the average wetted width was 11.2m and the average gradient was 2.8%. Some deep pools up to ~1.8m deep were available for overwintering westslope cutthroat trout adults and occasional pockets of gravel suitable for spawning were present. The riparian area was comprised of mature black cottonwood with intermittent naturally formed large woody debris structures throughout providing structure and cover. Beaver dams were located within the area surveyed primarily on tributaries or side-channels with one dam noted as partially spanning the main channel. Habitat value was rated as high for salmonid rearing and spawning.

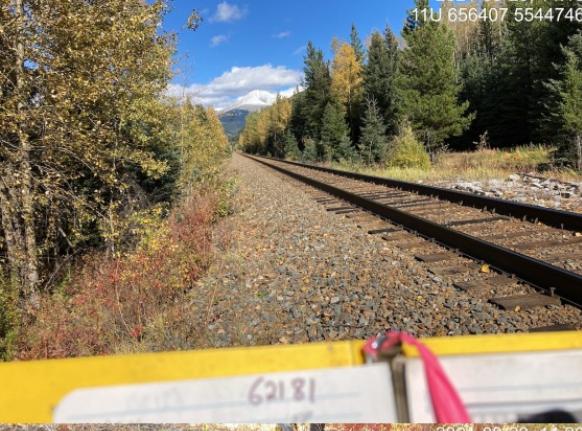
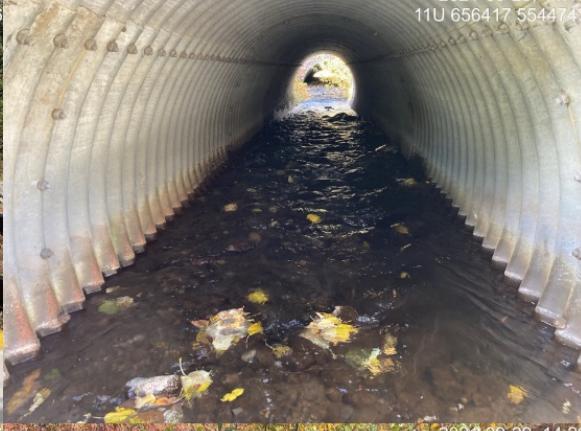
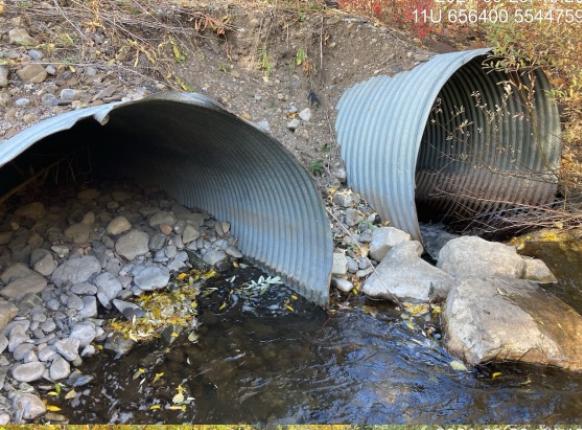
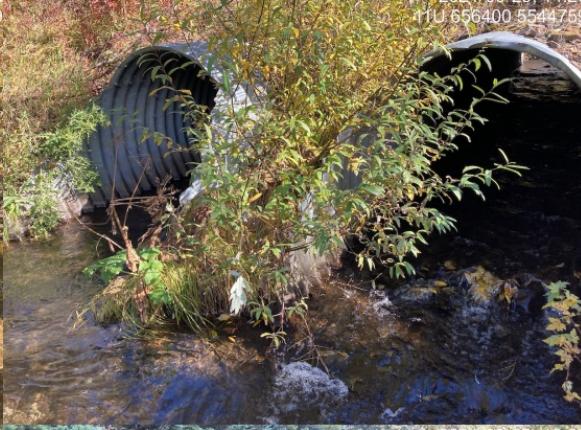
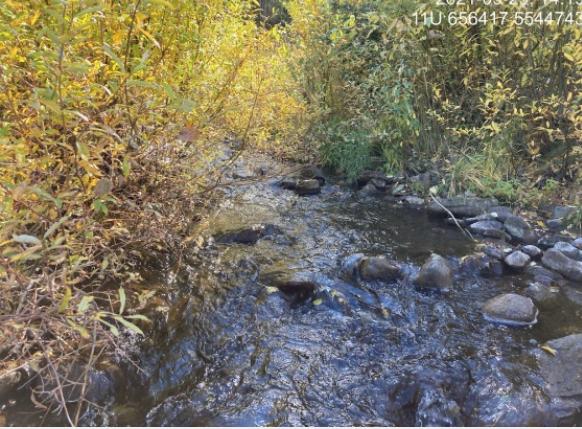
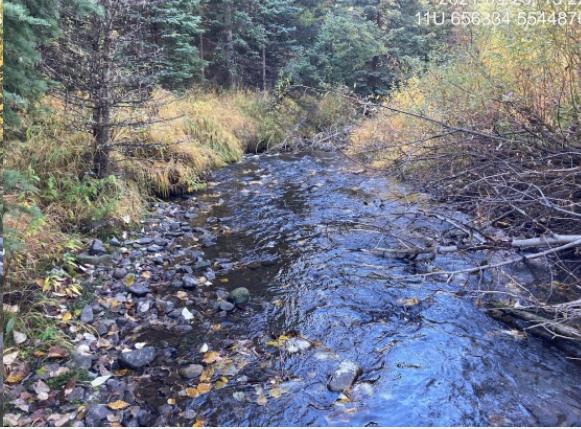
Location and Stream Data	Crossing Characteristics
<p>Comments: Two pipes (1.8m x 1.8m). Left pipe was measured. Right pipe gradient ~3%. Right pipe partially embedded.</p>	
<p>14:16</p>

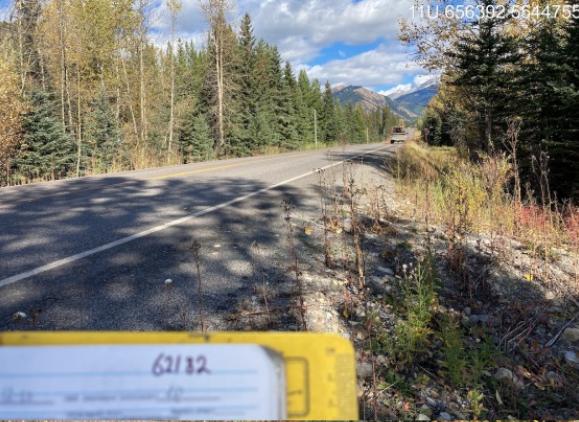
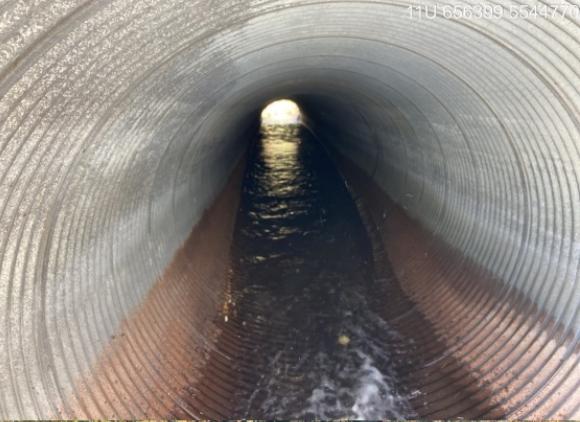
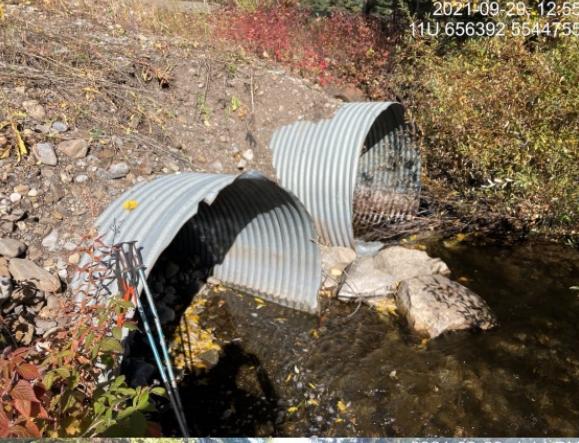
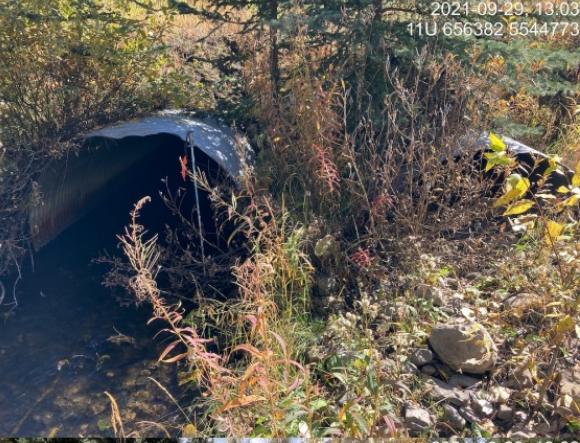
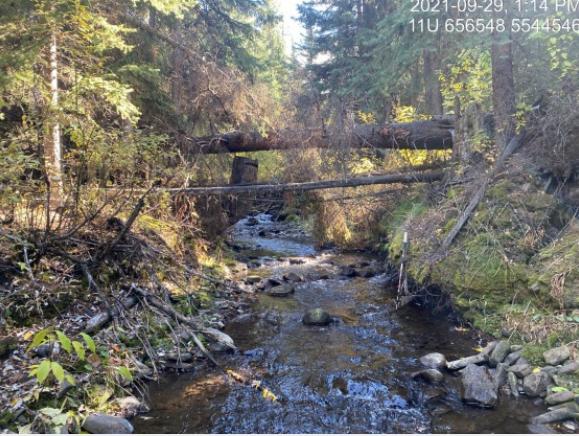
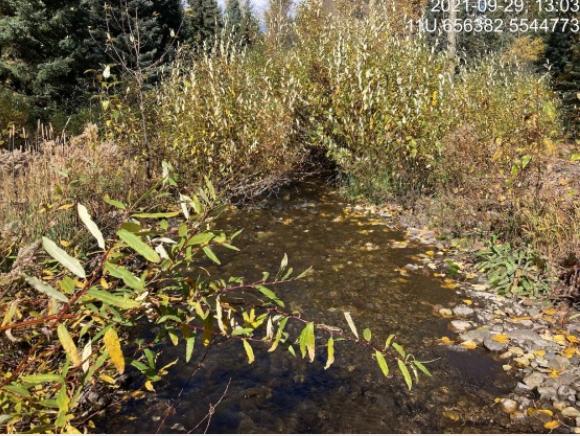
Location and Stream Data	• Crossing Characteristics
<p>Comments: Two pipes (1.8m x 1.8m). Stream left pipe embedd at outlet 0.6m but not at inlet and there is a significant inlet drop. PSCIS crossing 62182 is located ~30m upstream of the crossing under the railway. 12:50</p>

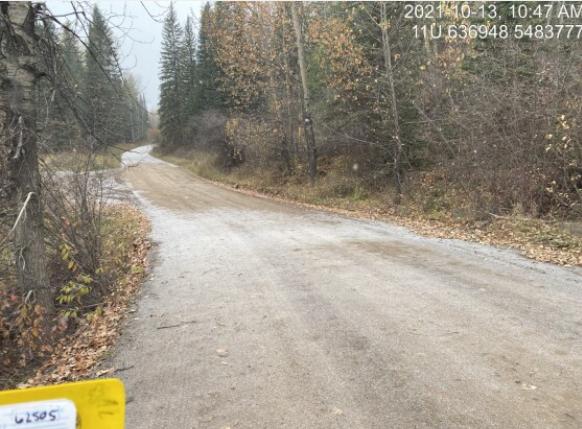
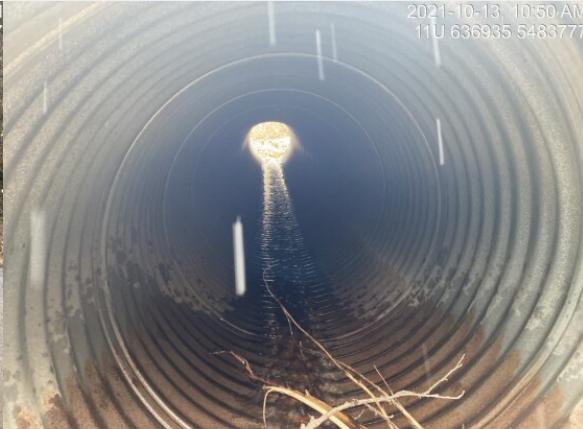
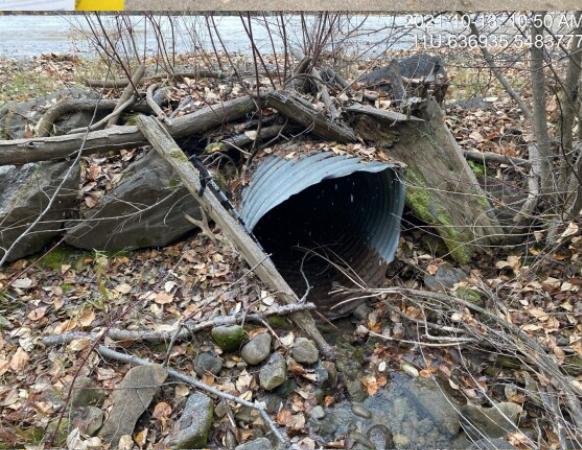
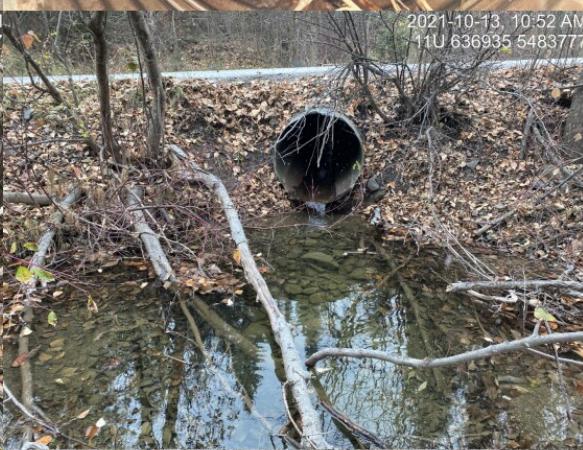
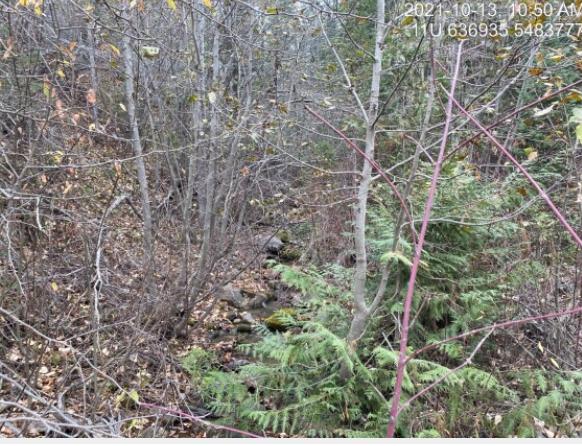
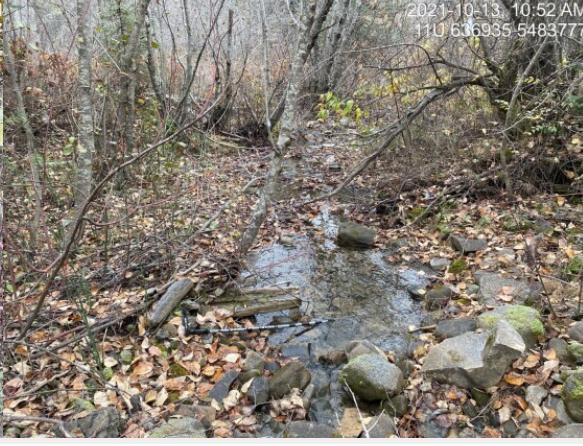
Location and Stream Data	.	Crossing Characteristics	-
Beaver Activity	No	Slope (%)	5
Habitat Value	Medium	Valley Fill	Deep Fill
Final score	31	Barrier Result	Barrier
Fix type	Replace with New Open Bottom Structure	Fix Span / Diameter	12
Comments:	Very close to Lizard Creek mainstem. 10:43		
Photos:	From top left clockwise: Road/Site Card, Barrel, Outlet, Downstream, Upstream, Inlet.

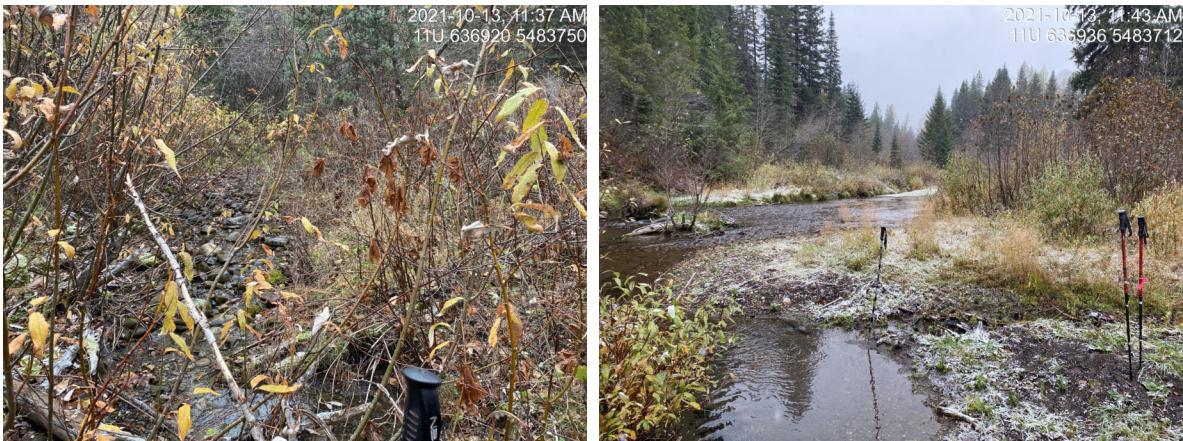
Figure 5.6: Left: Habitat downstream of crossing 62505. Right: Confluence with Lizard Creek located ~70m downstream of crossing 62505.

The stream was surveyed downstream from the culvert for 75m to the confluence with Lizard Creek (Figure 5.6). Total cover amount was rated as moderate with undercut banks dominant. Cover was also present as small woody debris and overhanging vegetation (Table 5.13). The average channel width was 2.5m and the average gradient was 4.8%. The dominant substrate was gravels with cobbles subdominant. No barriers were noted downstream and there were gravels suitable for spawning westslope cutthroat trout throughout. The habitat was rated as medium value for resident salmonid rearing due to a lack of water.

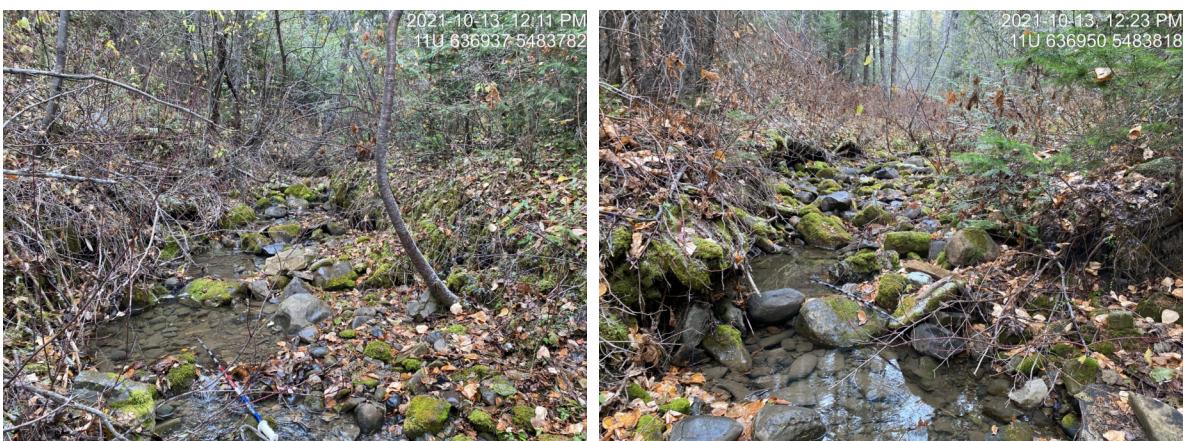
Figure 5.7: Left: Habitat upstream of PSCIS crossing 62505. Right: Habitat upstream of PSCIS crossing 62505.

The stream was surveyed immediately upstream from 62505 for approximately 700m to ~60m above PSCIS culvert 197863 (Figure 5.7). Immediately above culvert 197863 the stream became very steep with gradients exceeding 20%. Within the area surveyed, total cover amount was rated

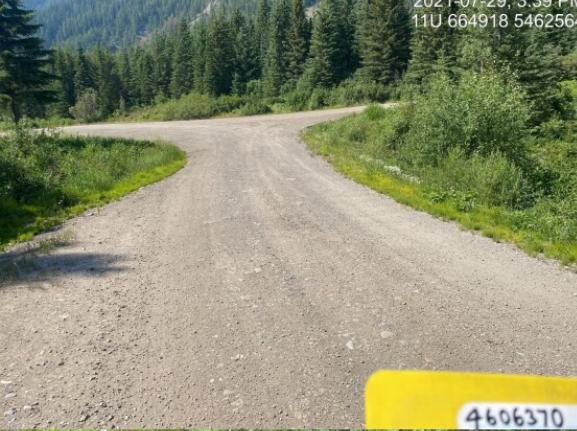
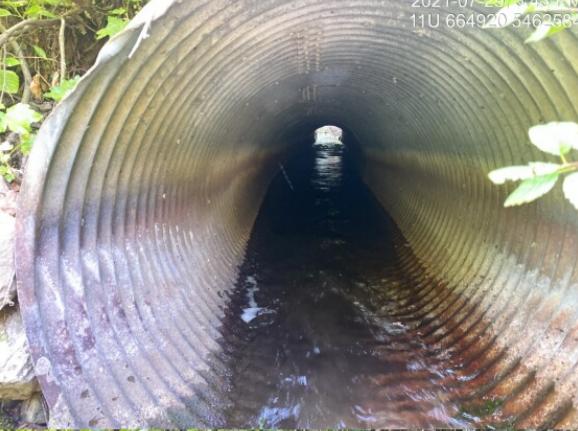
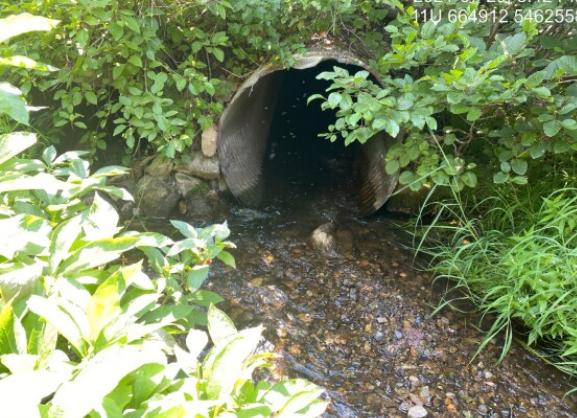
Location and Stream Data	Crossing Characteristics
Comments: Two pipes (1m each) but one blocked with debris. Because height of outlets equivalent widths were added together for input to stream width ratio. Large beaver dams upstream between culvert and Lodgepole Lake. 15:37

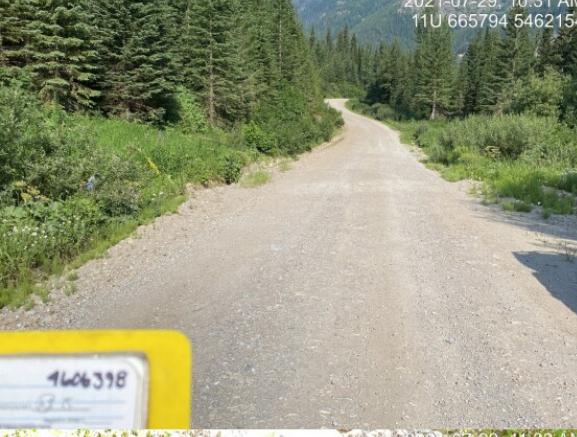
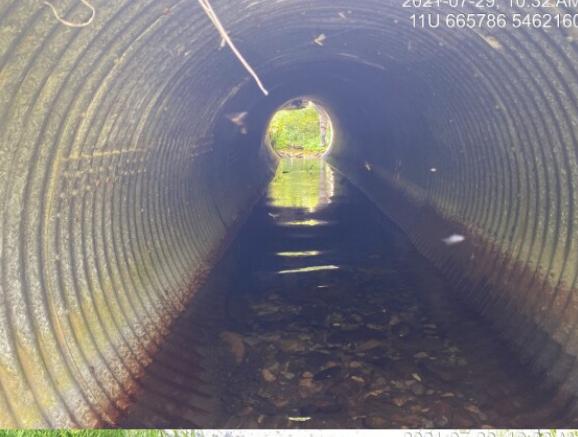
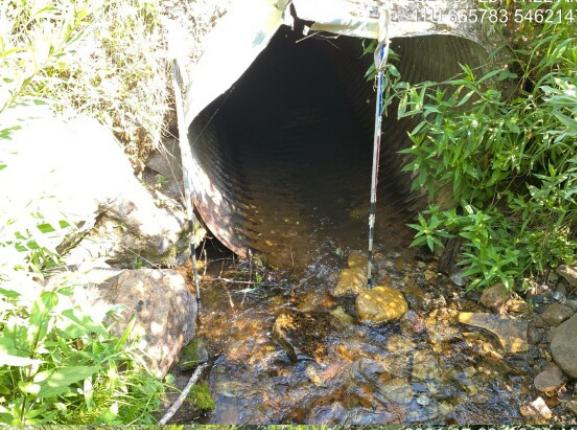
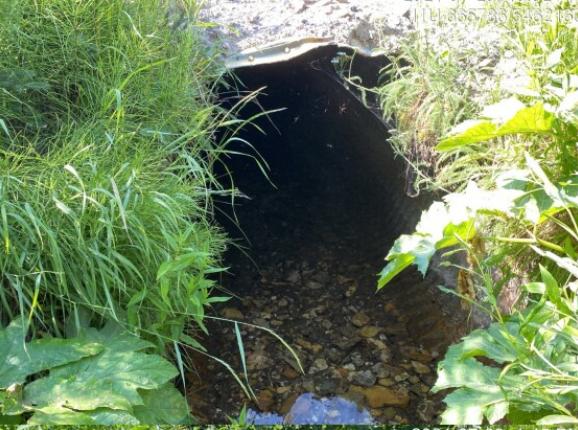
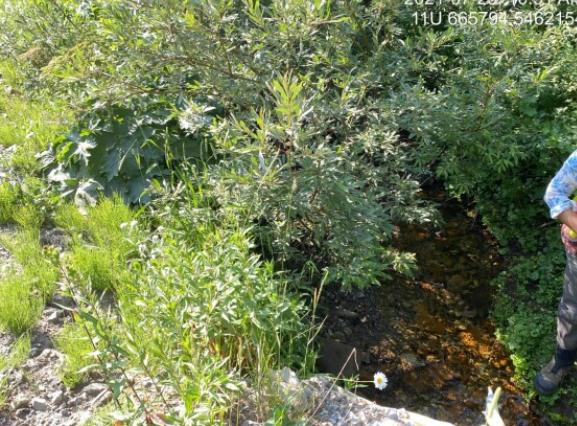
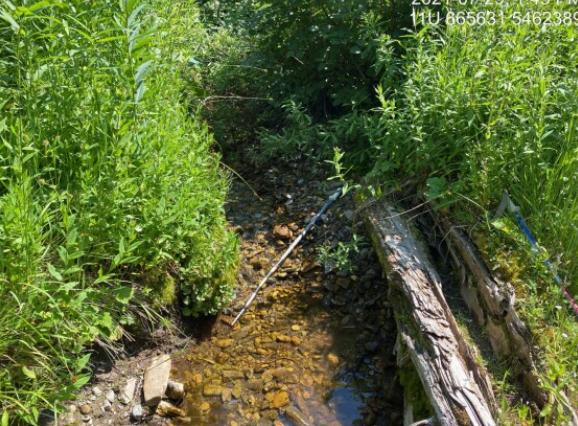
Location and Stream Data		Crossing Characteristics –	
Date	2021-07-29	Crossing Sub Type	Round Culvert
PSCIS ID	197786	Diameter (m)	1.2
External ID	–	Length (m)	10
Crew	AI TS	Embedded	No
UTM Zone	11	Depth Embedded (m)	–
Easting	665796.1	Resemble Channel	No
Northing	5462152	Backwatered	No
Stream	Lodgepole Creek	Percent Backwatered	–
Road	Harvey FSR	Fill Depth (m)	0.1
Road Tenure	FLNR DRM 5466	Outlet Drop (m)	0
Channel Width (m)	2	Outlet Pool Depth (m)	0.1
Stream Slope (%)	3.8	Inlet Drop	Yes
Beaver Activity	No	Slope (%)	1.7
Habitat Value	Medium	Valley Fill	Deep Fill
Final score	21	Barrier Result	Barrier
Fix type	Replace with New Open Bottom Structure	Fix Span / Diameter	12
Photos: From top left clockwise: Road/Site Card, Barrel, Outlet, Downstream, Upstream, Inlet.

Location and Stream Data	• Crossing Characteristics
Comments: Small stream with good flow. Abundant gravels just upstream with gradients increasing to 6-7% near 540m upstream of culvert where large (~30m high) waterfall is located. 10:18

Structure replacement with a bridge (12m span) was recommended to provide access to the habitat located upstream of PSCIS crossing 197786. The cost of the work was estimated at \$240,000 for a cost benefit of 2.4 linear m/\$1000 and 4.8m²/\$1000.

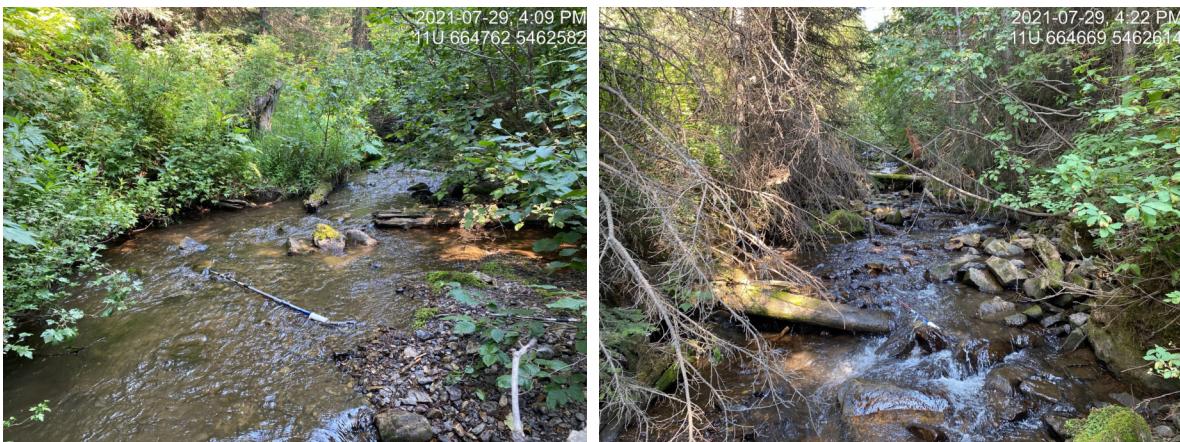
The stream was surveyed downstream from 197787 for 285m (Figure 5.8). Overall, total cover amount was rated as moderate with deep pools dominant. Cover was also present as small woody debris, large woody debris, boulders, undercut banks, and overhanging vegetation (Table 5.18). The average channel width was 4.4m, the average wetted width was 3.2m and the average gradient was 6.2%. The dominant substrate was boulders with gravels subdominant. Habitat value was rated

Figure 5.8: Left: Typical habitat downstream of PSCIS crossing 197787. Right: Typical habitat downstream of PSCIS crossing 197786.

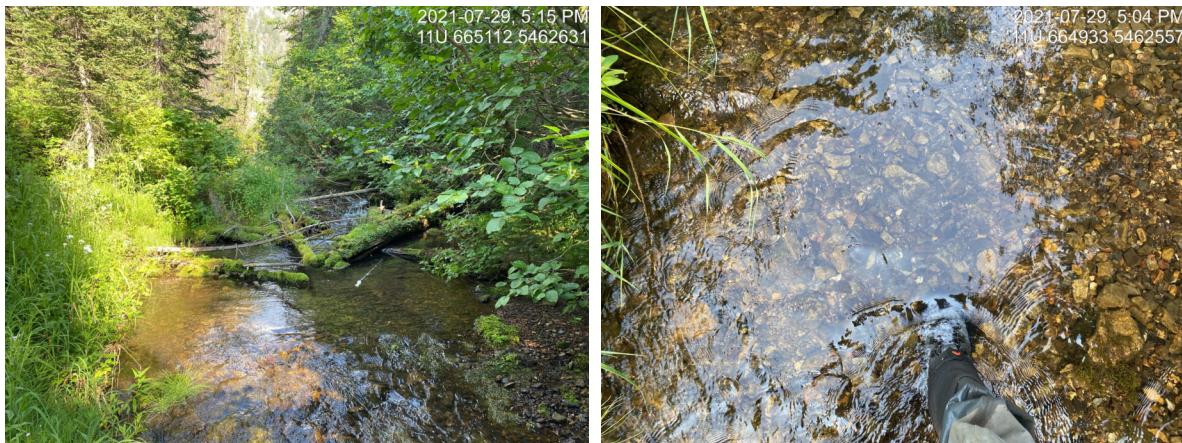
Figure 5.9: Left: Typical habitat upstream of PSCIS crossing 197787. Right: Gravels suitable for spawning located upstream of PSCIS crossing 197787.

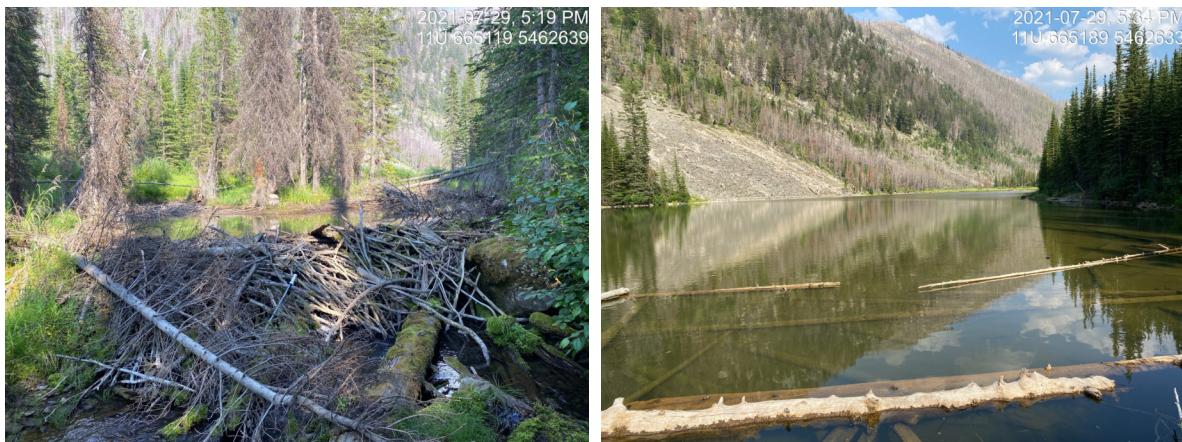
Figure 5.10: Left: Beaver dam located upstream of PSCIS crossing 197787 and just below Lodgepole Lake. Right: Lodgepole Lake located upstream of PSCIS crossing 197787.

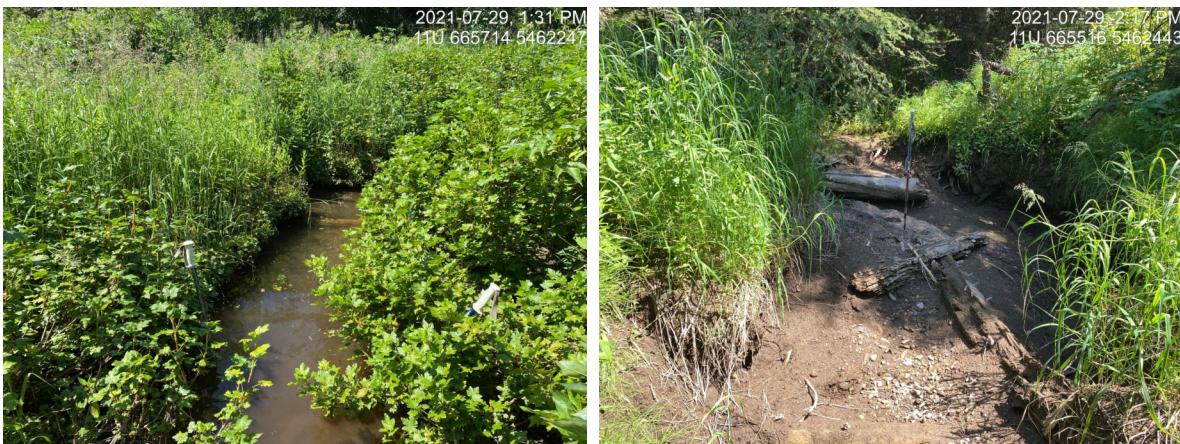
Figure 5.11: Left: Habitat downstream of PSCIS crossing 197786. Right: Dewatered habitat downstream of PSCIS crossing 197786.

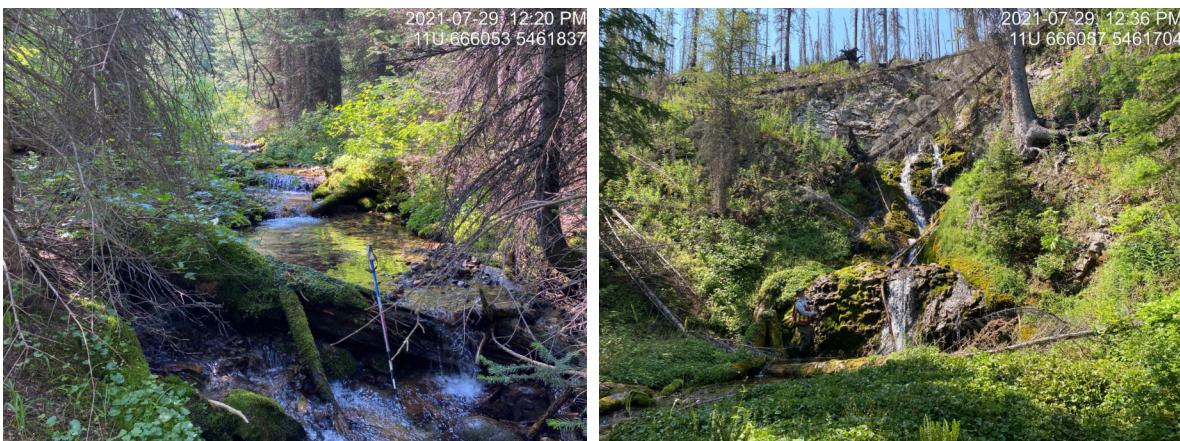
Figure 5.12: Left: Typical habitat upstream of PSCIS crossing 197786. Right: Large falls located ~550m upstream of PSCIS crossing 197786.

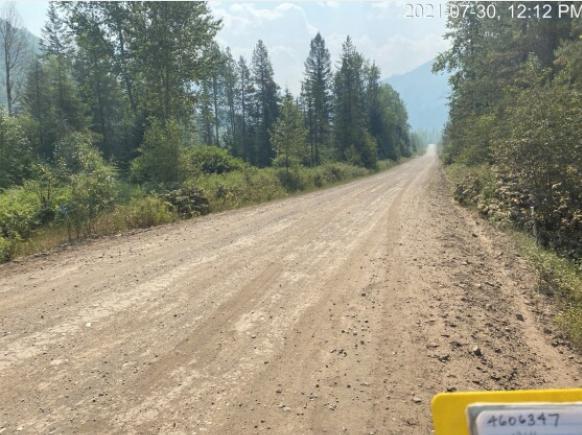
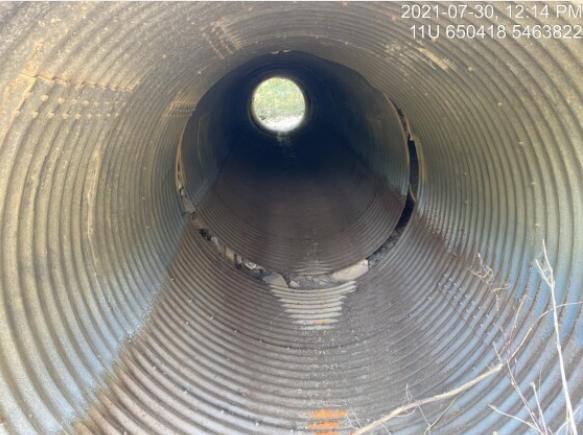
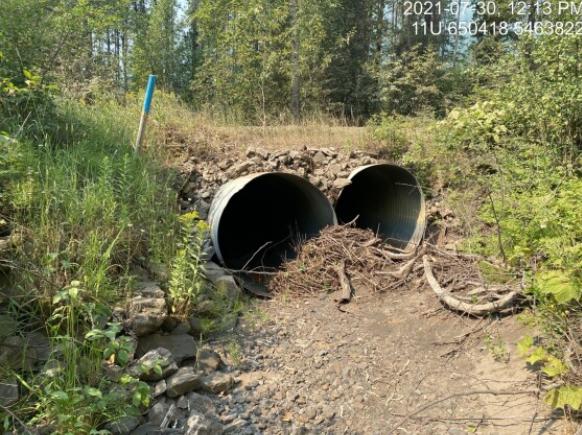
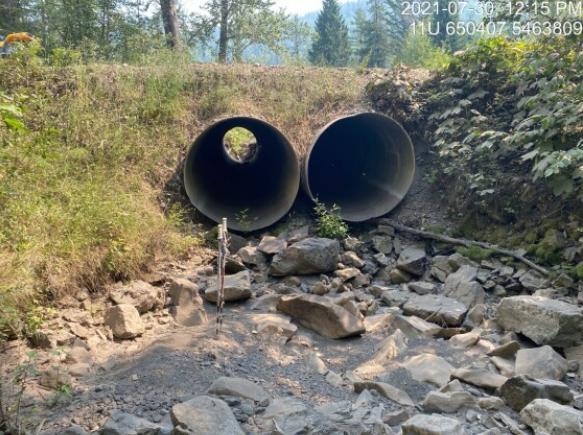
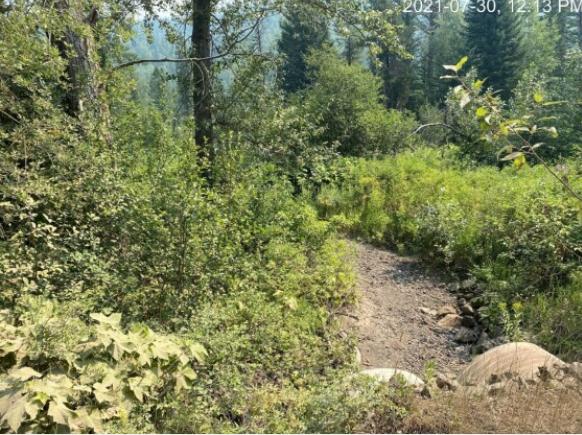
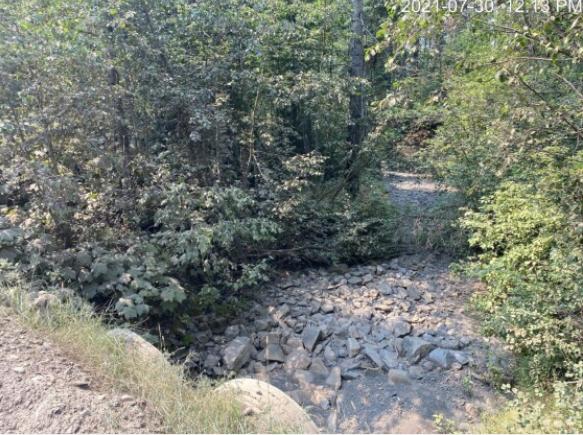
Appendix - 197793 - Bean Creek

At the time of the survey, the two culverts under Lodgepole FSR were un-embedded, non-backwatered and ranked as a barrier to upstream fish passage according to the provincial protocol (MoE 2011b). The pipes were 1.5m in diameter with lengths of 14m, a culvert slope of 2.5%, a stream width ratio of 3.5 and an outlet drop of 0m (Table 5.22). Significant damage to the crossing was apparent with the pipe split vertically through the entire culvert near the centre of the southern most pipe (Figure 5.13). The stream was completely dry at the time of the survey and the freshwater atlas stream layer indicates intermittent flow (FLNRORD 2021). Of note, the culverts are located approximately 840m upstream from the confluence with a tributary to Bean Creek and a bridge of stream of the confluence (PSCIS 197792) was assessed on this tributary. The tributary was flowing at the bridge site at the time of the survey (2021-07-30).

Location and Stream Data	.	Crossing Characteristics	-
Beaver Activity	No	Slope (%)	2.5
Habitat Value	Low	Valley Fill	Deep Fill
Final score	21	Barrier Result	Barrier
Fix type	Replace with New Open Bottom Structure	Fix Span / Diameter	12
Comments:	Large channel but stream is completely dry. 12:11		
Photos:	From top left clockwise: Road/Site Card, Barrel, Outlet, Downstream, Upstream, Inlet.

Should restoration/maintenance activities proceed at the site, replacement of PSCIS crossing 197793 with a bridge (12m span) is recommended. The cost of the work is estimated at \$240,000 for a cost benefit of 7.5 linear m/\$1000 and 39.8m²/\$1000.

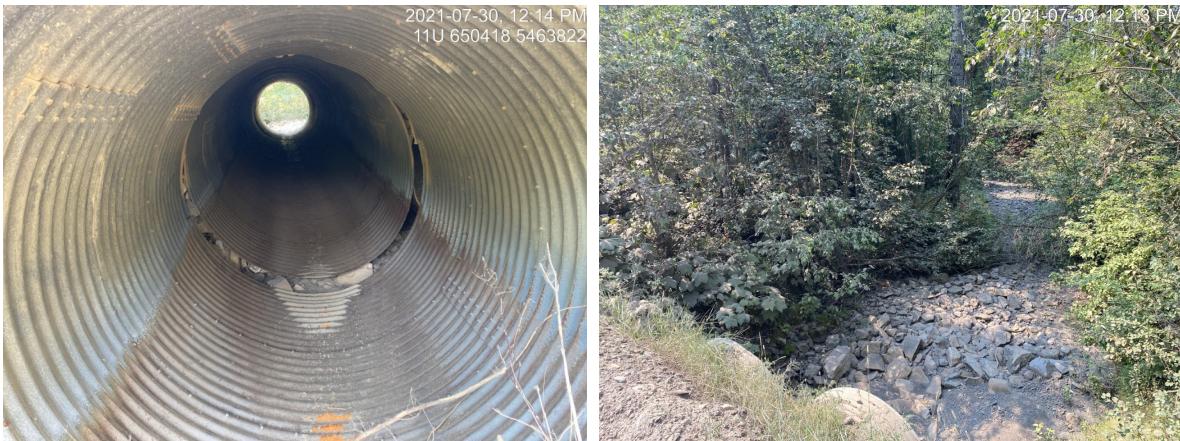
Figure 5.13: Left: Damage within PSCIS crossing 197793. Right: Habitat downstream of crossing 197793.

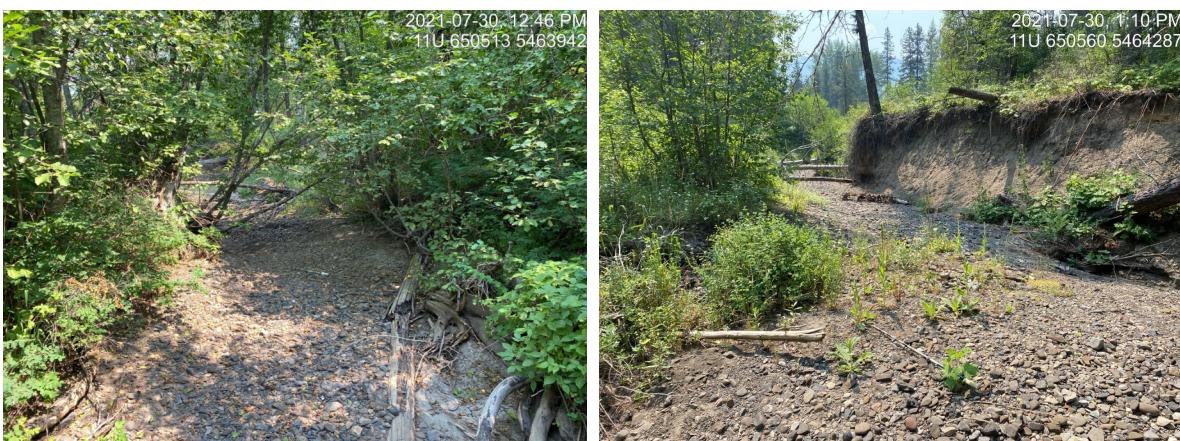
A conservative estimate of mainstem habitat upstream of crossing 197793 is 1.8km. Habitat in the areas surveyed upstream of the culvert were rated as low value for salmonid rearing and spawning due to likely annual seasonal dewatering within the rocky south-west facing watershed. Lodgepole FSR is the responsibility of the Ministry of Forests, Lands, Natural Resource Operations and Rural Development - Rocky Mountain Forest District. Crossing 197793 was ranked as a low priority for proceeding to design for replacement.

Figure 5.14: Left: Habitat upstream of PSCIS crossing 197793. Right: Habitat upstream of PSCIS crossing 197793.

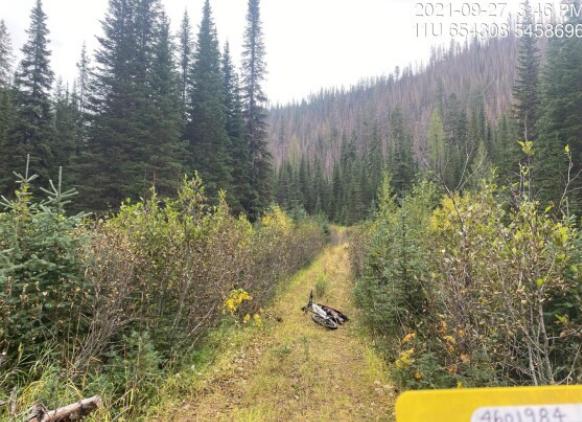
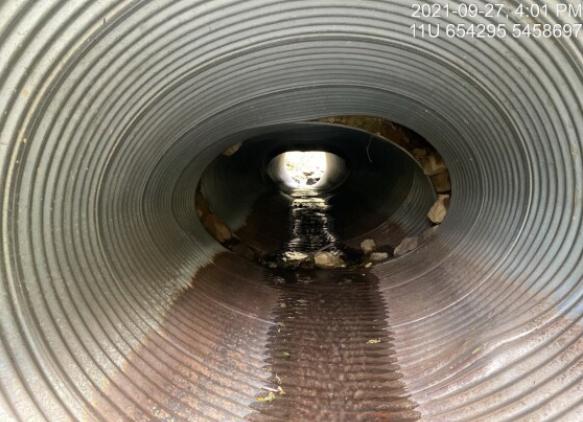
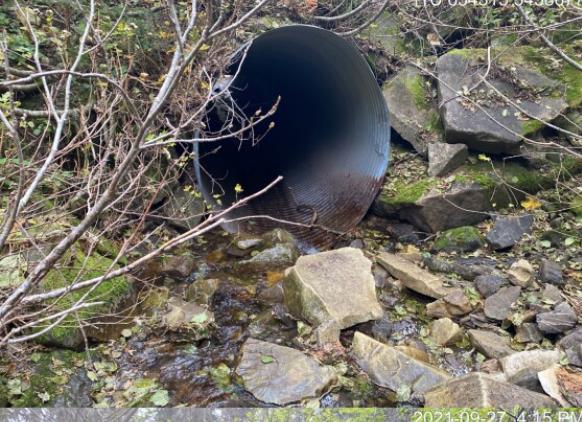
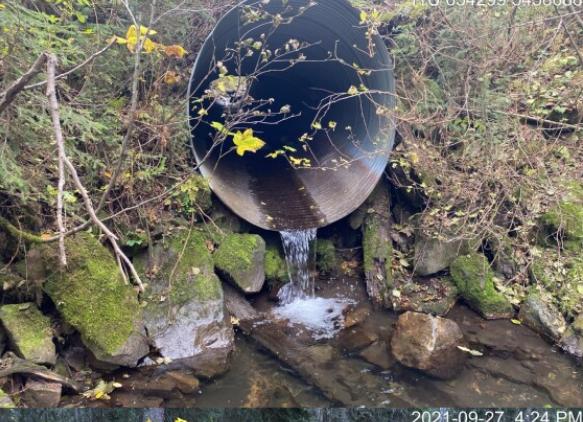
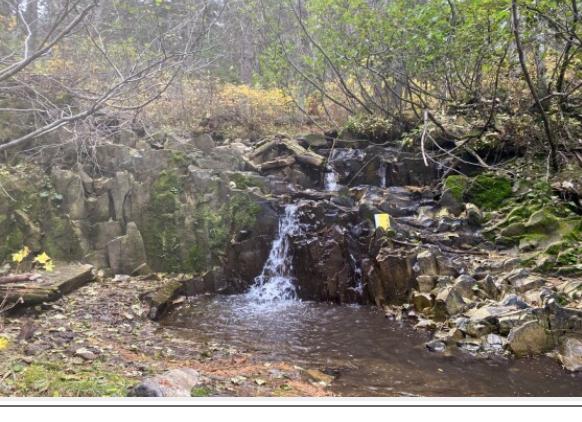
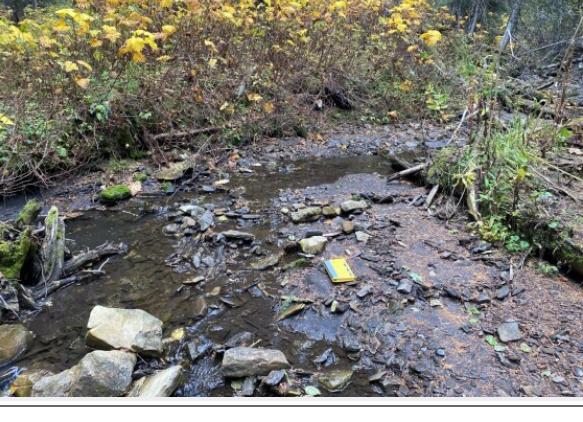
Appendix - 197796 - Tributary to Lodg...

At the time of the survey, the culvert was un-embedded, non-backwatered and ranked as a barrier to upstream fish passage according to the provincial protocol (MoE 2011b). The pipe was extensively damaged (separating within the centre of the road), 1.6m in diameter with a length of 14m, a culvert slope of 5%, a stream width ratio of 2.4 and an outlet drop of 0.6m (Table 5.26).

Location and Stream Data	•	Crossing Characteristics	-
Comments: Gated access management area. Falls located ~60m upstream of the crossing. 15:45

Should restoration/maintenance activities proceed at the site, replacement of PSCIS crossing 197796 with a bridge (12m span) is recommended. The cost of the work is estimated at \$240,000 for a cost benefit of 0.2 linear m/\$1000 and 0.9m²/\$1000.

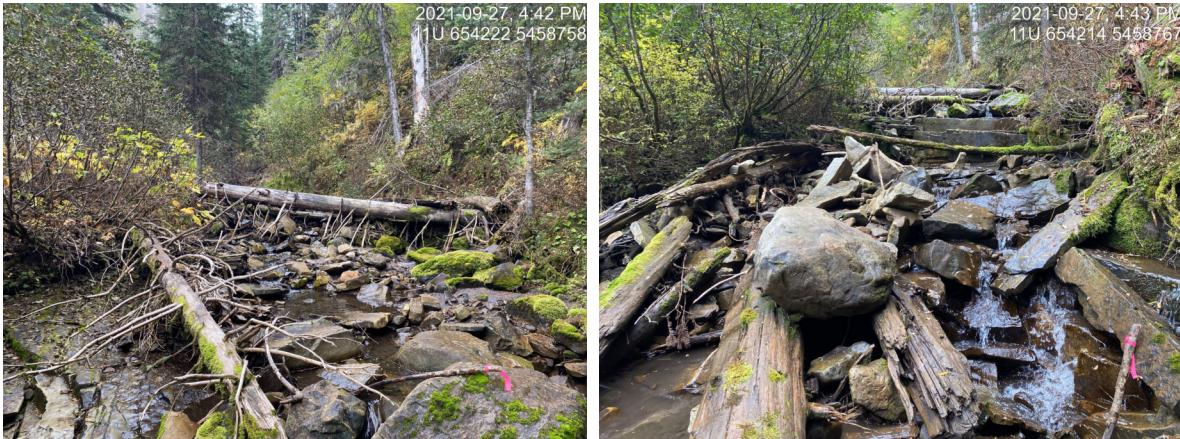
The stream was surveyed downstream from the culvert for 125m (Figure 5.15). Total cover amount was rated as NA with large woody debris dominant. Cover was also present as small woody debris, boulders, undercut banks, deep pools, and overhanging vegetation (Table 5.27). The average channel width was 4.1m and the average gradient was 7%. The dominant substrate was large rock/bedrock with boulders subdominant. There steep sections to ~15% with steps to 1.8m in height created by large woody debris and bedrock throughout the area surveyed. The habitat was rated as low value for resident salmonid rearing due primarily to the steep grades.

Figure 5.15: Left: Typical habitat downstream of PSCIS crossing 197796. Right: Habitat downstream of crossing 197796.

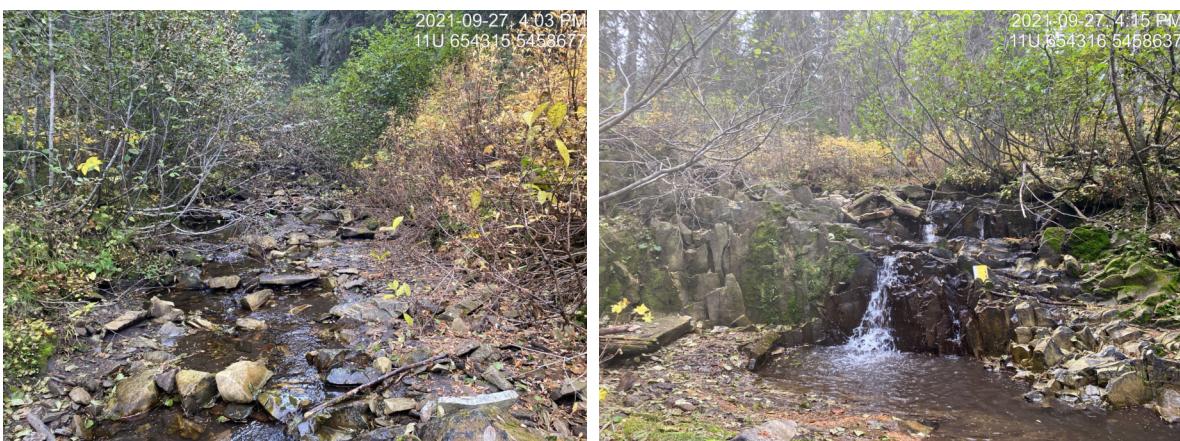
Figure 5.16: Left: Habitat upstream of PSCIS crossing 197796. Right: 2.4m high rock falls located ~60m upstream of PSCIS crossing 197796.
