Elk River Watershed Group Fish Passage Restoration Planning 2021

Prepared for
Nupqua Resource Limited Partnership

Prepared by
Al Irvine, B.Sc., R.P.Bio.
New Graph Environment Ltd.

Version 1.0.2
2022-04-28

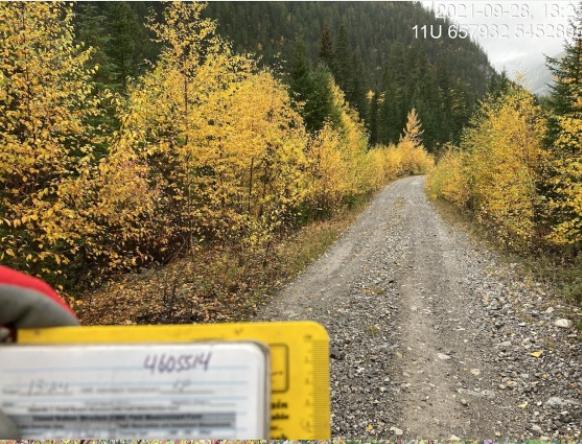
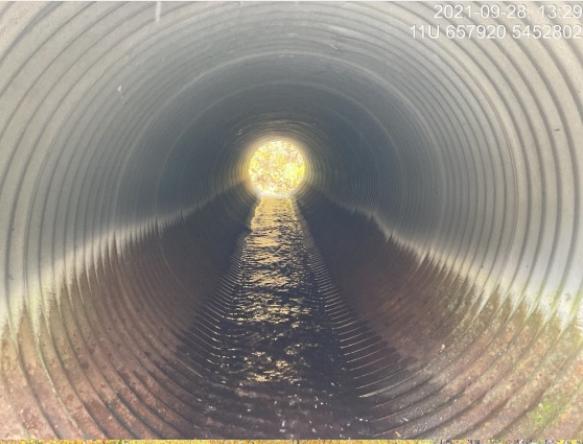
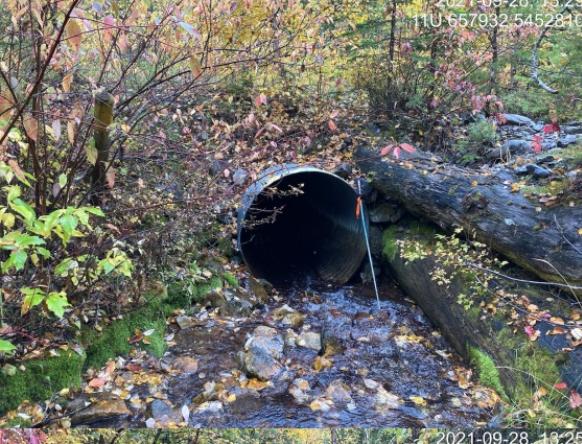
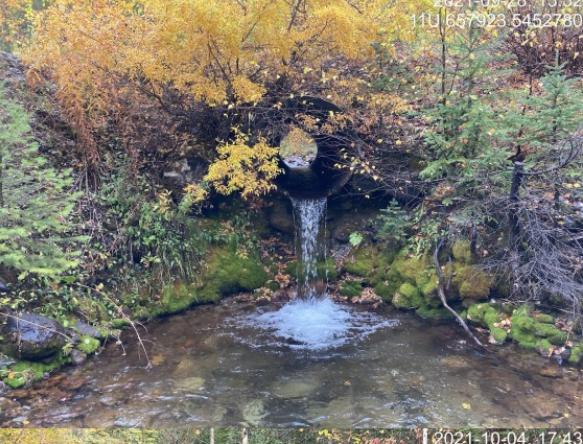
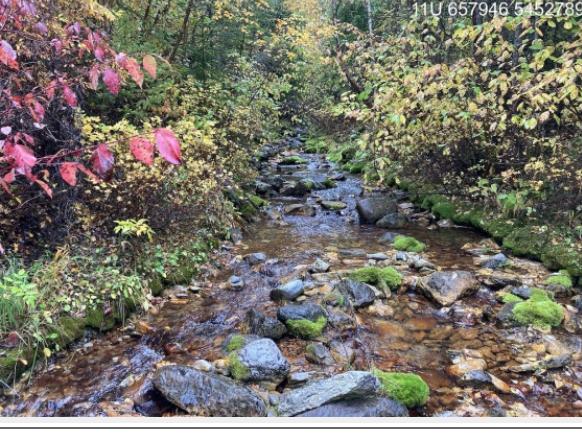
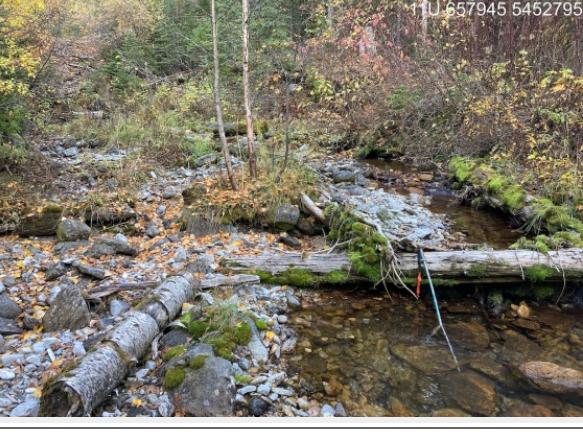
Location and Stream Data	.	Crossing Characteristics	-
Habitat Value	Medium	Valley Fill	Deep Fill
Final score	36	Barrier Result	Barrier
Fix type	Replace with New Open Bottom Structure	Fix Span / Diameter	12
Comments: Cobble substrate and abundant overhanging vegetation. Decent sized stream. 13:24			
Photos: From top left clockwise: Road/Site Card, Barrel, Outlet, Downstream, Upstream, Inlet.

Should restoration/maintenance activities proceed at the site, replacement of PSCIS crossing 197844 with a bridge (12m span) is recommended. The cost of the work is estimated at \$240,000 for a cost benefit of 3.5 linear m/\$1000 and 11.6m²/\$1000.

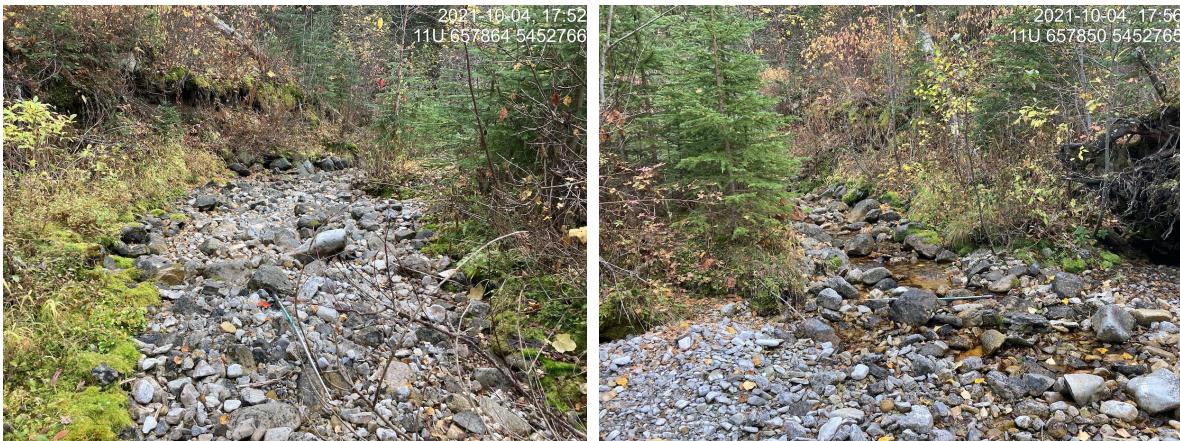
The stream was surveyed downstream from the culvert for 95m to the confluence with Bighorn Creek (Figure 5.17). Total cover amount was rated as moderate with overhanging vegetation dominant. Cover was also present as boulders (Table 5.31). The average channel width was 3.1m and the average gradient was 7.3%. The dominant substrate was cobbles with gravels subdominant. The stream was noted as going subsurface at ~40m downstream of the road then rewatering at ~80m downstream. There was evidence of high velocity/volume flows with a general lack of complexity. The habitat was rated as medium value for salmonid rearing and spawning due to dewatering, as well as a lack of deep pool and undercut bank cover.

Figure 5.17: Left: Habitat downstream of crossing 197844. Right: Habitat downstream of crossing 197844.

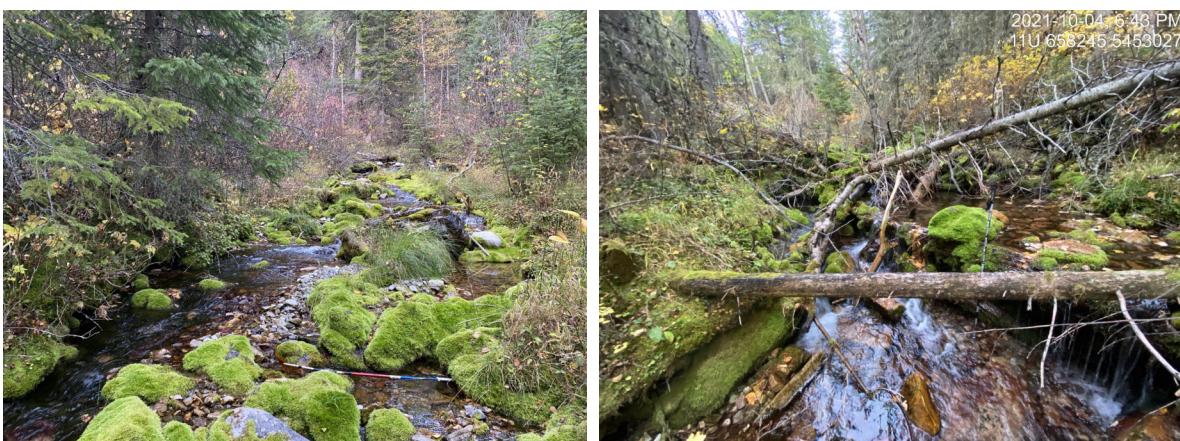
The stream was surveyed upstream from 197844 for approximately 840m to the location of a 1.1m high rock that likely presents a barrier to upstream fish passage (Figure 5.18). A ford (PSCIS

Figure 5.18: Left: Habitat upstream of PSCIS crossing 197844. Right: Habitat upstream of PSCIS crossing 197844.
