SOCIETY FOR ECOSYSTEM RESTORATION IN NORTHERN BRITISH COLUMBIA

Bulkley River and Morice River Watershed Groups Fish Passage Restoration Planning 2021 - DRAFT

Prepared for
Habitat Conservation Trust Foundation - CAT21-6-288
BC Fish Passage Remediation Program
Canadian Wildlife Federation

Version 0.0.8 - DRAFT 2022-04-27

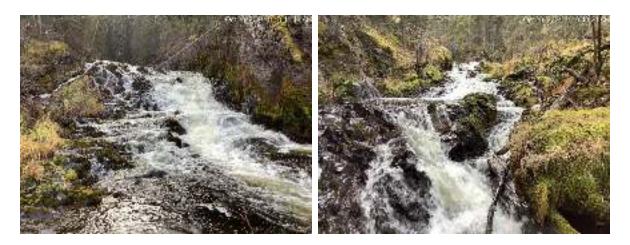
Dyson (1949) and Stokes (1956) report substantial use of habitat above Bulkley Falls by steelhead, chinook, coho and sockeye utilization in the past (pre-1950) based on spawning reports. Both authors concluded that the Bulkley Falls pose a partial obstruction to migrating fish based on flow levels. Chinook, which migrate early in the summer when water levels are high, have been noted as able to ascend the falls in normal to high water years and in high water years it was thought that coho and steelhead could ascend. A. Gottesfeld and Rabnett (2007) report that the falls are almost completely impassable to all salmon during low water flows. Stokes (1956) reports that there was high value spawning habitat located within the first 3km of the Bulkley River from the outlet of Bulkley Lake.

Figure 4.1: Left: Bulkley Falls main channel. Right: Bulkley Falls side channel.

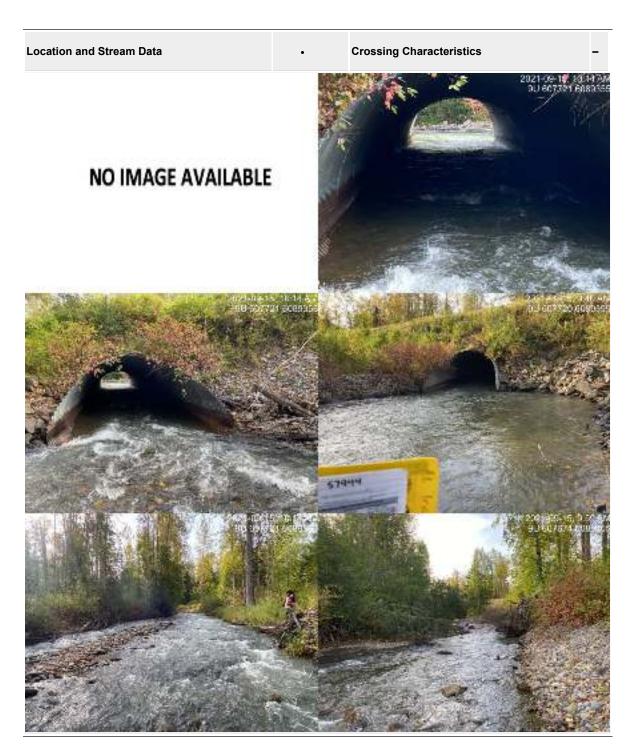
Table 5.3: Summary of fish passage assessment for PSCIS crossing 57944.

, , , , , , , , , , , , , , , , , , , 		<u> </u>
Location and Stream Data	•	Crossing Characteristics	-
Date	2021-09-15	Crossing Sub Type	Oval Culvert
PSCIS ID	57944	Diameter (m)	7
External ID	_	Length (m)	30
Crew	Al	Embedded	No
UTM Zone	9	Depth Embedded (m)	_
Easting	607729	Resemble Channel	No
Northing	6089383	Backwatered	No
Stream	Toboggan Creek	Percent Backwatered	_
Road	Highway 16	Fill Depth (m)	2
Road Tenure	Highway	Outlet Drop (m)	0
Channel Width (m)	8.5	Outlet Pool Depth (m)	2
Stream Slope (%)	2.1	Inlet Drop	No
Beaver Activity	No	Slope (%)	3
Habitat Value	High	Valley Fill	Deep Fill
Final score	29	Barrier Result	Barrier
Fix type	Replace with New Open Bottom Structure	Fix Span / Diameter	13.5
Photos: From top left clockw	rise: Road/Site Card, Barrel, Outlet, Downs	tream, Upstream, Inlet.

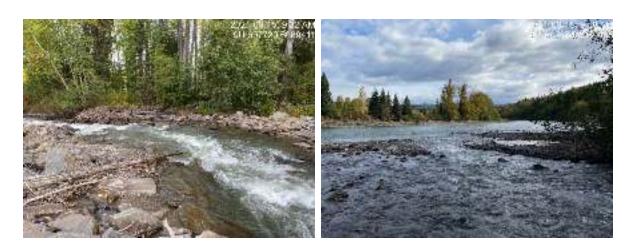
Figure 5.1: Left: Typical habitat downstream of PSCIS crossing 57944. Right: Typical habitat downstream of PSCIS crossing 57944.

The stream was surveyed downstream from crossing 57944 for 140m to the conflence with the Bulkley River (Figure <u>5.1</u>). Total cover amount was rated as moderate with undercut banks dominant. Cover was also present as small woody debris, large woody debris, boulders, and overhanging vegetation. The average channel width was 13.9m, the average wetted width was

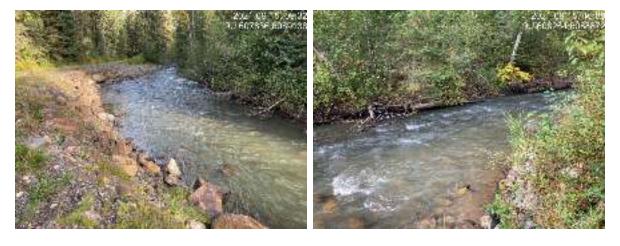
Figure 5.2: Left: Typical habitat upstream of PSCIS crossing 57944. Right: Typical habitat upstream of PSCIS crossing 57944.

The stream was surveyed upstream from crossing 57944 for 880m (Figure 5.2). Total cover amount was rated as moderate with large woody debris dominant. Cover was also present as small woody debris and boulders., Total cover amount was rated as moderate with overhanging vegetation dominant. Cover was also present as small woody debris and boulders. The average channel width was 8.5m, the average wetted width was 6.7m and the average gradient was 2.1%. The dominant substrate was cobbles with gravels subdominant. The first 50 - 100m upstream of crossing channel and banks were noted as armoured with riprap. Abundant gravels suitable for resident and anadromous salmonids were noted throughout. The habitat was rated as high value as an important migration corridor containing suitable spawning habitat and having moderate rearing potential.

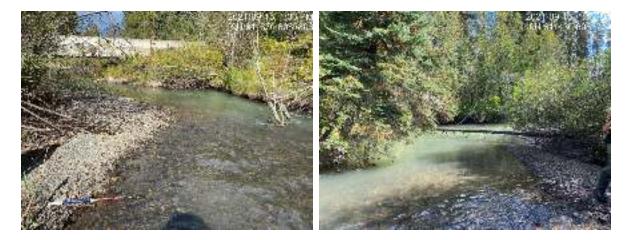
Figure 5.3: Left: Typical habitat upstream of PSCIS crossing 57944. Right: Typical habitat upstream of PSCIS crossing 57944.

The stream was also surveyed at a second location upstream of the hatchery adjacent to the Owen Road bridge for 150m (Figure 5.3). Total cover amount was rated as abundant with deep pools dominant. Cover was also present as small woody debris, undercut banks, and overhanging vegetation. The average channel width was 12.6m, the average wetted width was 10.5m and the average gradient was 0.5%. The dominant substrate was gravels with fines subdominant. The habitat was rated as high value for salmon rearing and spawning.

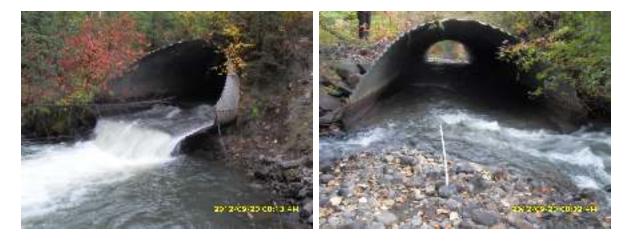
Works to remediate fish passage issues at PSCIS stream crossing 57944 were conducted in 2015 with backwatering completed through installation of boulders downstream of the crossing (McCarthy and Fernando 2015). Comparison of historic PSCIS photos and data between 2021 and 2012 indicate that the historical recorded outlet drop of 90cm has been reduced to 0cm as a result of the works. Sandra Devcic, DFO Restoration Engineer (pers. comm.) has noted that developing a design to replace the crossing with an open bottom structure presents challenges due to the stream crossing location at the bottom of a hill and on a corner of the highway.

Figure 5.4: Left: Outlet of PSCIS crossing 57944 in 2012. Photo from PSCIS. Right: Inlet of PSCIS crossing 57944 in 2012. Photo from PSCIS.

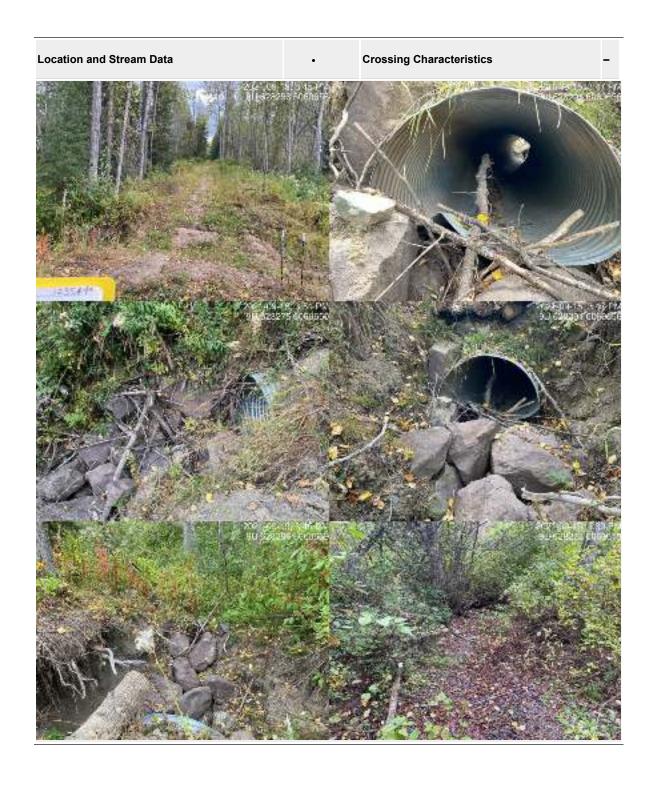
Table 5.8: Summary of fish passage assessment for PSCIS crossing 123544.

Location and Stream Data	•	Crossing Characteristics	-
Date	2021-09-13	Crossing Sub Type	Round Culvert
PSCIS ID	123544	Diameter (m)	1.5
External ID	_	Length (m)	14
Crew	Al	Embedded	No
UTM Zone	9	Depth Embedded (m)	_
Easting	628286.7	Resemble Channel	No
Northing	6060648	Backwatered	No
Stream	McDowell Creek	Percent Backwatered	-
Road	Private Road	Fill Depth (m)	1.5
Road Tenure	Unclassified	Outlet Drop (m)	0
Channel Width (m)	2.7	Outlet Pool Depth (m)	0
Stream Slope (%)	1	Inlet Drop	No
Beaver Activity	No	Slope (%)	18.5
Habitat Value	Medium	Valley Fill	Deep Fill
Final score	26	Barrier Result	Barrier
Fix type	Replace with New Open Bottom Structure	Fix Span / Diameter	10
Photos: From top left clockw	rise: Road/Site Card, Barrel, Outlet, Downs	tream, Upstream, Inlet.

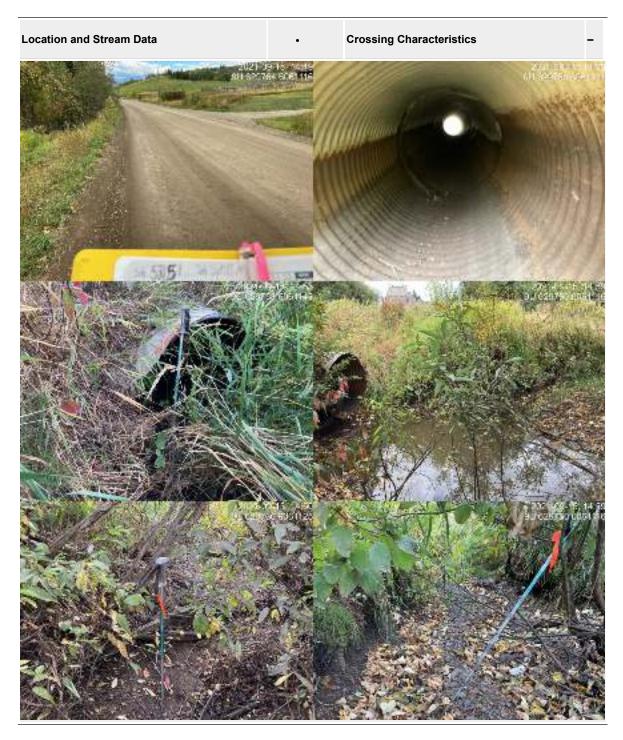
Location and Stream Data		Crossing Characteristics	-
Date	2021-09-15	Crossing Sub Type	Round Culvert
PSCIS ID	58151	Diameter (m)	1
External ID	-	Length (m)	14
Crew	KP	Embedded	No
UTM Zone	9	Depth Embedded (m)	_
Easting	629753.3	Resemble Channel	No
Northing	6061126	Backwatered	No
Stream	McDowell Creek	Percent Backwatered	-
Road	Woodmere Road	Fill Depth (m)	0.5
Road Tenure	MoTi Local	Outlet Drop (m)	0.25
Channel Width (m)	1.8	Outlet Pool Depth (m)	0.64
Stream Slope (%)	1.5	Inlet Drop	No
Beaver Activity	No	Slope (%)	5
Habitat Value	Medium	Valley Fill	Deep Fill
Final score	31	Barrier Result	Barrier
Fix type	Replace Structure with Streambed Simulation CBS	Fix Span / Diameter	3
Photos: From top left clock	wise: Road/Site Card, Barrel, Outlet, Downstream,	Upstream, Inlet.

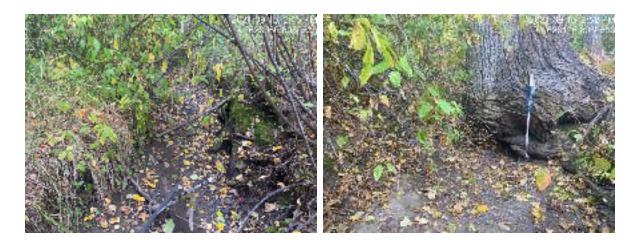
Figure 5.5: Left: Habitat downstream of PSCIS crossing 123544. Right: Habitat downstream of PSCIS crossing 123544.

The stream was surveyed downstream from crossing 123544 for NAm (Figure <u>5.5</u>). The dominant substrate was gravels with fines sub-dominant., The average channel width was 2.6m, the average wetted width was NAm, and the average gradient was 2%., Total cover amount was rated as abundant with undercut banks dominant. Cover was also present as small woody debris, large

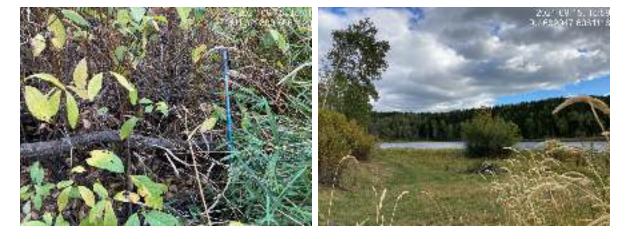
Figure 5.7: Left: Typical habitat upstream of PSCIS crossing 58151. Right: Typical habitat upstream of PSCIS crossing 58151.

The stream was surveyed upstream from crossing 58151 for 70m (Figure 5.7). The average channel width was 1.7m, the average wetted width was NAm, and the average gradient was 2%., The dominant substrate was fines with gravels sub-dominant., Total cover amount was rated as abundant with overhanging vegetation dominant. Cover was also present as small woody debris and undercut banks. Immediately upstream of the crossing for ~80m, extensive anthropogenic damage was noted due to dredging of the channel. Heavy cattle grazing was also observed on the left bank. Juvenile salmonids were observed occasionally throughout the area surveyed. Fencing was located across the stream approximately 250m upstream of the culvert. Patches of gravels suitable for spawning were present. Habitat value was rated as low as the surveyed area was considered an important migration corridor containing suitable spawning habitat and having moderate rearing potential.

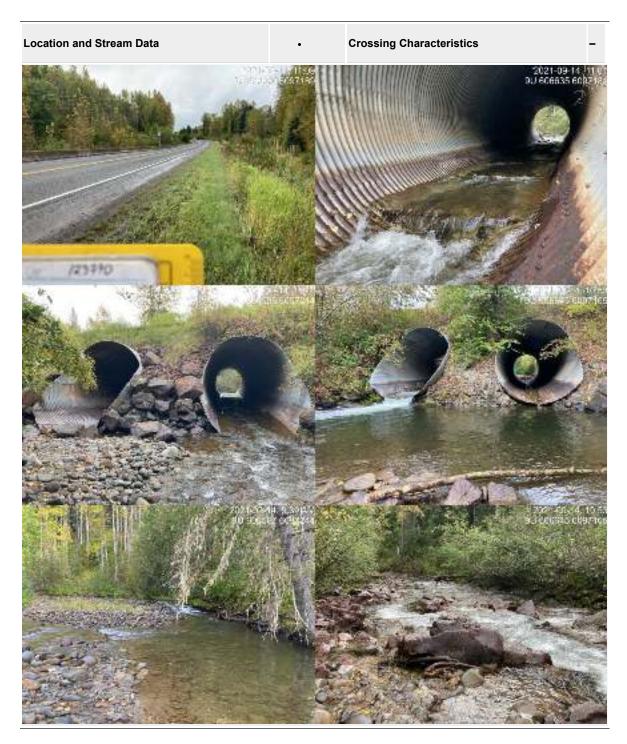
crossing 123770.

Location and Stream Data	•	Crossing Characteristics	_
Location and Stream Data	•	Crossing Characteristics	-
Date	2021-09-07	Crossing Sub Type	Round Culvert
PSCIS ID	123770	Diameter (m)	4
External ID	_	Length (m)	36
Crew	KP AN	Embedded	No
UTM Zone	9	Depth Embedded (m)	_
Easting	606626.5	Resemble Channel	No
Northing	6097185	Backwatered	No
Stream	John Brown	Percent Backwatered	_
Road	Highway 16	Fill Depth (m)	3.5
Road Tenure	MoTi Arterial	Outlet Drop (m)	0.64
Channel Width (m)	12.3	Outlet Pool Depth (m)	1.5
Stream Slope (%)	2.9	Inlet Drop	Yes
Beaver Activity	No	Slope (%)	2
Habitat Value	Medium	Valley Fill	Deep Fill
Final score	37	Barrier Result	Barrier
Fix type	Replace with New Open Bottom Structure	Fix Span / Diameter	19
Photos: From top left clockw	ise: Road/Site Card, Barrel, Outlet, Downs	tream, Upstream, Inlet.

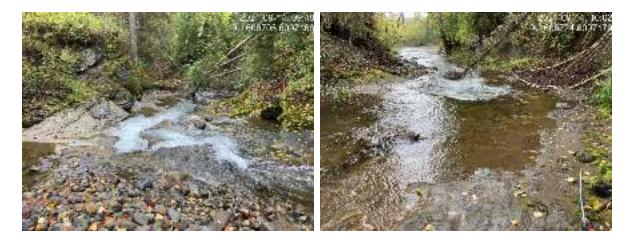
Figure 5.9: Left: Typical habitat downstream of PSCIS crossing 123770. Right: Typical habitat downstream of PSCIS crossing 123770.

The stream was surveyed downstream from crossing 123770 for 230m to the conflence with the Bulkley River (Figure 5.9). Total cover amount was rated as moderate with boulders dominant. Cover was also present as deep pools and overhanging vegetation. The average channel width was 13.6m, the average wetted width was 8.3m and the average gradient was 4.1%. The dominant

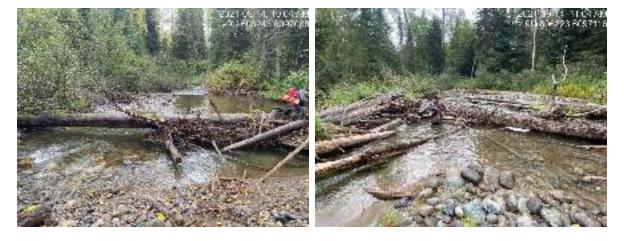
Figure 5.10: Left: Typical habitat upstream of PSCIS crossing 123770. Right: Typical habitat upstream of PSCIS crossing 123770.

The stream was surveyed upstream from crossing 123770 for 1000m (Figure 5.10). Total cover amount was rated as moderate with undercut banks dominant. Cover was also present as small woody debris, large woody debris, boulders, deep pools, and overhanging vegetation. The average channel width was 12.2m, the average wetted width was 8.3m and the average gradient was 2.9%. The dominant substrate was cobbles with gravels subdominant. The first 50 - 100m upstream of crossing channel and banks were noted as armoured with riprap. Abundant gravels suitable for resident and anadromous salmonids were noted throughout. The habitat was rated as high value as an important migration corridor containing suitable spawning habitat and having moderate rearing potential.

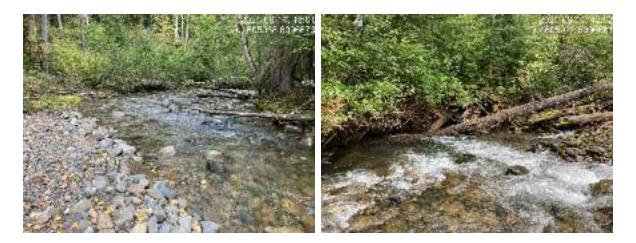
Figure 5.11: Left: Typical habitat upstream of PSCIS crossing 123770. Right: Typical habitat upstream of PSCIS crossing 123770.

The stream was also surveyed immediately upstream of PSCIS ford 198043 for 350m (Figure 5.11). Total cover amount was rated as moderate with boulders dominant. Cover was also present as small woody debris and overhanging vegetation.. The average channel width was 11.2m, the average wetted width was 9.1m and the average gradient was 3%. The dominant substrate was cobbles with boulders subdominant. The habitat was rated as high value for salmon rearing and spawning.

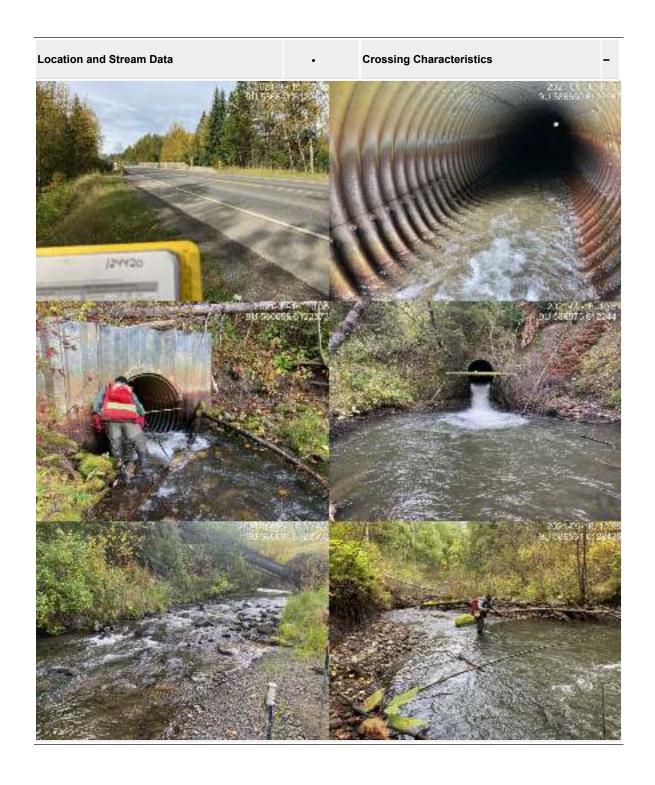
Location and Stream Data	•	Crossing Characteristics	-
Date	2021-09-16	Crossing Sub Type	Round Culvert
PSCIS ID	124420	Diameter (m)	1.6
External ID	-	Length (m)	90
Crew	KP DN	Embedded	No
UTM Zone	9	Depth Embedded (m)	_

Location and Stream Data		Crossing Characteristics	-
Easting	586632.3	Resemble Channel	No
Northing	6122395	Backwatered	No
Stream	Mission Creek	Percent Backwatered	_
Road	Highway 16	Fill Depth (m)	9.99
Road Tenure	New Hazelton Highway	Outlet Drop (m)	8.0
Channel Width (m)	5.6	Outlet Pool Depth (m)	1.6
Stream Slope (%)	2	Inlet Drop	Yes
Beaver Activity	No	Slope (%)	3.5
Habitat Value	Medium	Valley Fill	Deep Fill
Final score	42	Barrier Result	Barrier
Fix type	Replace with New Open Bottom Structure	Fix Span / Diameter	30
Photos: From top left clockw	rise: Road/Site Card, Barrel, Outlet, Downs	tream, Upstream, Inlet.

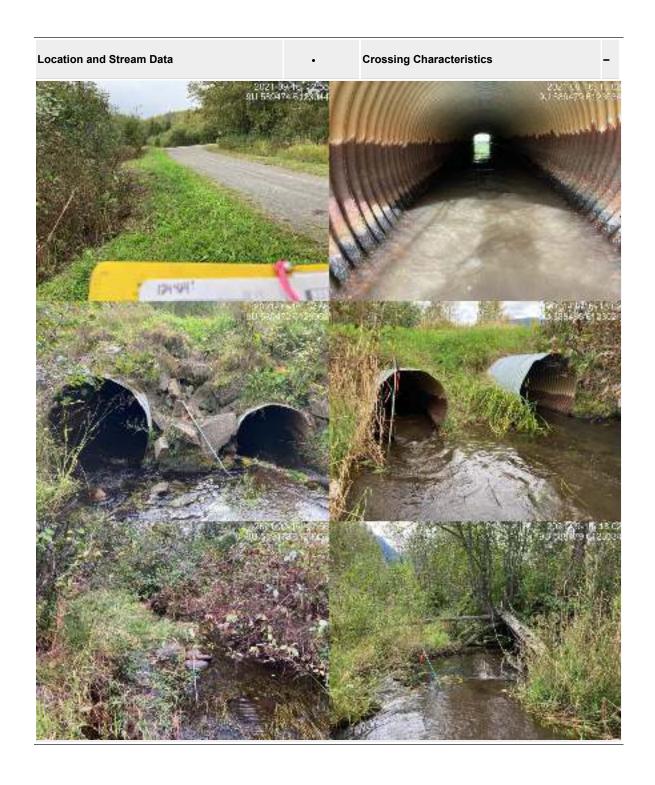
Location and Stream Data		Crossing Characteristics	_
Date	2021-09-16	Crossing Sub Type	Round Culvert
PSCIS ID	124421	Diameter (m)	1
External ID	_	Length (m)	15
Crew	KP	Embedded	No
UTM Zone	9	Depth Embedded (m)	_
Easting	589466.5	Resemble Channel	No
Northing	6123042	Backwatered	No
Stream	Tributary to Waterfall Creek	Percent Backwatered	_
Road	11th Ave	Fill Depth (m)	1.5
Road Tenure	New Hazelton Local	Outlet Drop (m)	0.3
Channel Width (m)	2.6	Outlet Pool Depth (m)	0.27
Stream Slope (%)	1	Inlet Drop	Yes
Beaver Activity	No	Slope (%)	1
Habitat Value	Medium	Valley Fill	Deep Fill
Final score	34	Barrier Result	Barrier
Fix type	Replace with New Open Bottom Structure	Fix Span / Diameter	10
Photos: From top left clockw	rise: Road/Site Card, Barrel, Outlet, Downs	tream, Upstream, Inlet.

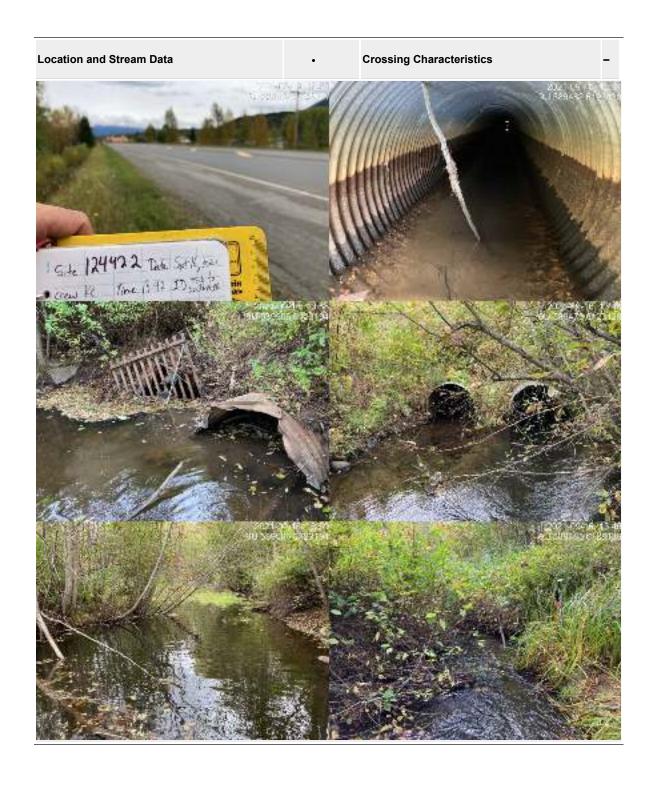
Location and Stream Data	•	Crossing Characteristics	_				
Date	2021-09-16	Crossing Sub Type	Round Culvert				
PSCIS ID	124422	Diameter (m)	1.2				
External ID	_	Length (m)	45				
Crew	KP	Embedded	No				
UTM Zone	9	Depth Embedded (m)	_				
Easting	589499.9	Resemble Channel	No				
Northing	6123162	Backwatered	Yes				
Stream	Tributary to Waterfall Creek	Percent Backwatered	100				
Road	Highway 16	Fill Depth (m)	6				
Road Tenure	New Hazelton Arterial	Outlet Drop (m)	0				
Channel Width (m)	5.2	Outlet Pool Depth (m)	0				
Stream Slope (%)	5.2	Inlet Drop	Yes				
Beaver Activity	Yes	Slope (%)	1.5				
Habitat Value	Medium	Valley Fill	Deep Fill				
Final score	27	Barrier Result	Barrier				
Fix type	Replace with New Open Bottom Structure	Fix Span / Diameter	19				
Photos: From top left clockw	rise: Road/Site Card, Barrel, Outlet, Downs	tream, Upstream, Inlet.	Photos: From top left clockwise: Road/Site Card, Barrel, Outlet, Downstream, Upstream, Inlet.

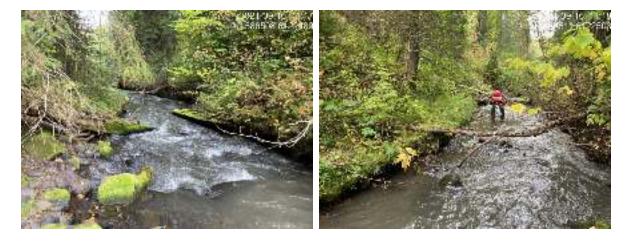
Figure 5.12: Left: Typical habitat downstream of PSCIS crossing 124420. Right: Typical habitat downstream of PSCIS crossing 124420.

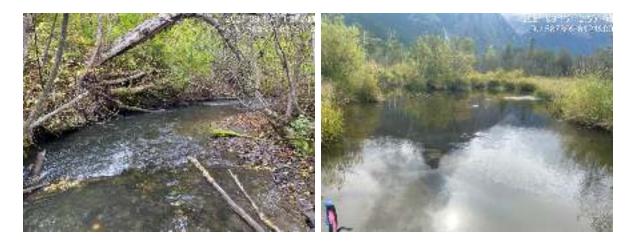
The stream was surveyed immediately upstream from 124420 for approximately 370m (Figure 5.13). Within the area surveyed, total cover amount was rated as with large woody debris dominant. Cover was also present as small woody debris, undercut banks, deep pools, and overhanging vegetation (Table 5.22). The average channel width was 5.7m, the average wetted width was 4.7m and the average gradient was 2%. The dominant substrate was cobbles with gravels subdominant. Habitat value was rated as high value for resident salmonid rearing and spawning.

Figure 5.13: Left: Typical habitat upstream of PSCIS crossing 124420. Right: Typical habitat upstream of PSCIS crossing 124420.

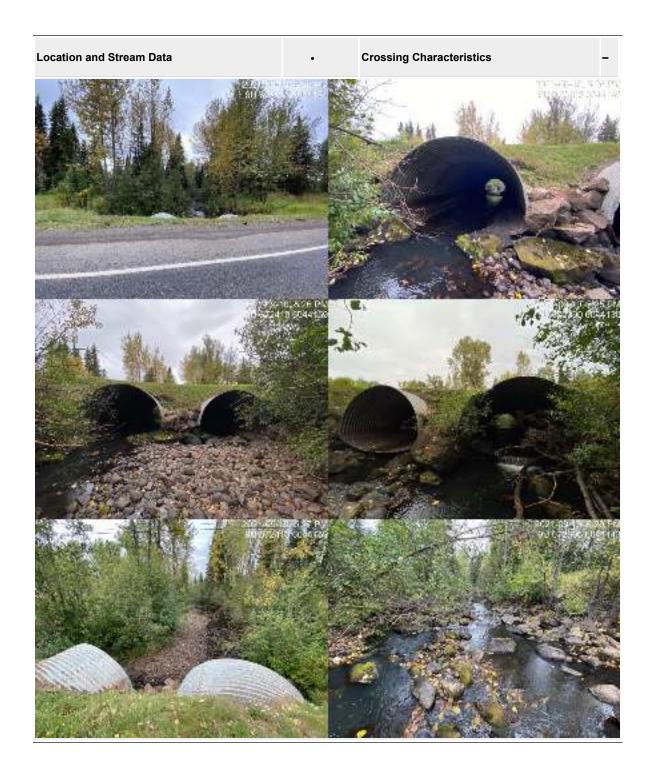
Location and Stream Data	•	Crossing Characteristics	-
Date	2021-09-10	Crossing Sub Type	Round Culvert
PSCIS ID	197662	Diameter (m)	4.2
External ID	_	Length (m)	24
Crew	Al	Embedded	No
UTM Zone	9	Depth Embedded (m)	_
Easting	672404.7	Resemble Channel	No
Northing	6044146	Backwatered	No
Stream	Richfield Creek	Percent Backwatered	_

Location and Stream Data	•	Crossing Characteristics	-			
Road	Highway 16	Fill Depth (m)	1			
Road Tenure	MoTi highway	Outlet Drop (m)	0.2			
Channel Width (m)	12.5	Outlet Pool Depth (m)	1			
Stream Slope (%)	1.5	Inlet Drop	No			
Beaver Activity	No	Slope (%)	2			
Habitat Value	High	Valley Fill	Deep Fill			
Final score	29	Barrier Result	Barrier			
Fix type	Replace with New Open Bottom Structure	Fix Span / Diameter	16.5			
Photos: From top left clockwise: Road/Site Card, Barrel, Outlet, Downstream, Upstream, Inlet.

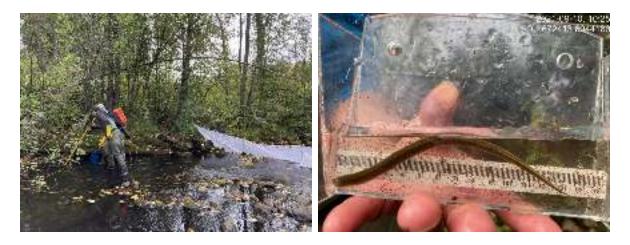
Figure 5.15: Left: Habitat downstream of PSCIS crossing 197662. Right: Lamprey captured downstream of PSCIS crossing 197662.

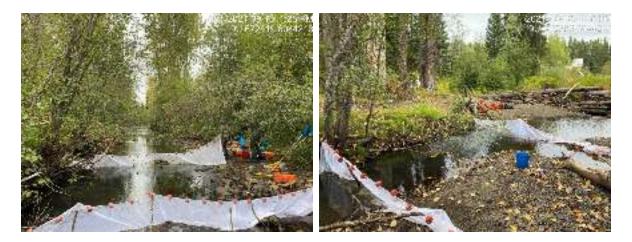
Figure 5.16: Left: Habitat upstream of PSCIS crossing 197662. Right: Habitat upstream of PSCIS crossing 197662.

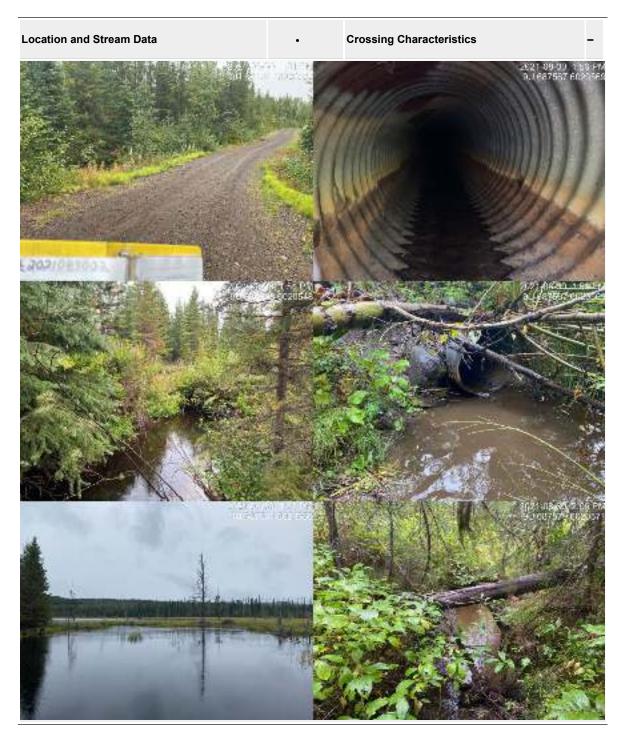
Table 5.30: Summary of fish passage assessment for PSCIS crossing 197909.

Location and Stream Data	•	Crossing Characteristics	-			
Date	2021-08-30	Crossing Sub Type	Round Culvert			
PSCIS ID	197909	Diameter (m)	0.6			
External ID	_	Length (m)	16			
Crew	AI KP	Embedded	No			
UTM Zone	9	Depth Embedded (m)	_			
Easting	687557	Resemble Channel	No			
Northing	6020572	Backwatered	No			
Stream	Tributary to Maxan Creek	Percent Backwatered	_			
Road	Maxan Creek FSR	Fill Depth (m)	2.5			
Road Tenure	FLNR DND 7735	Outlet Drop (m)	0			
Channel Width (m)	0.9	Outlet Pool Depth (m)	0.65			
Stream Slope (%)	4	Inlet Drop	Yes			
Beaver Activity	Yes	Slope (%)	3			
Habitat Value	Medium	Valley Fill	Deep Fill			
Final score	29	Barrier Result	Barrier			
Fix type	Replace Structure with Streambed Simulation CBS	Fix Span / Diameter	3			
Photos: From top left clockwise: Road/Site Card, Barrel, Outlet, Downstream, Upstream, Inlet.

Should restoration/maintenance activities proceed at the site, removal of PSCIS crossing 197909 is recommended. In addition to removal of the collapsed bridge, resloping of banks and the installation of live cuttings/pegboarding is recommended in three areas downstream where cattle trampling is resulting in significant erosion. A map of the erosion areas and associated prescriptions for rehabilitation of the downstream corners is provided as Figure ??. The cost of the work is estimated at \$40,000 for a cost benefit of 5.6 linear m/\$1000 and 7.3 m²/\$1000.

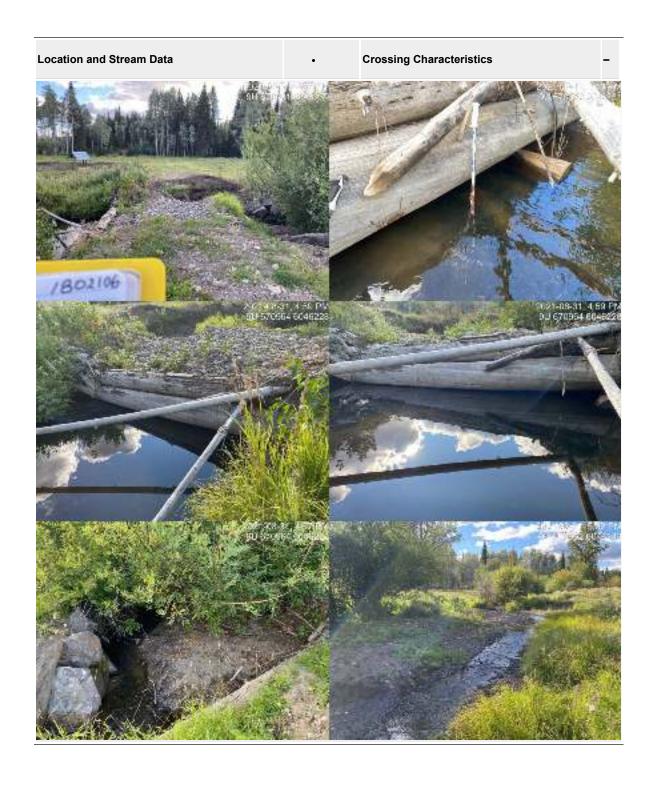
Table 5.34: Summary of fish passage assessment for PSCIS crossing 197912.

Location and Stream Data	•	Crossing Characteristics	-					
Date	2021-08-31	Crossing Sub Type	Bridge					
PSCIS ID	197912	Diameter (m)	12					
External ID	_	Length (m)	7					
Crew	Al	Embedded	_					
UTM Zone	9	Depth Embedded (m)	-					
Easting	670963	Resemble Channel	-					
Northing	6046221	Backwatered	-					
Stream	Robert Hatch Creek	Percent Backwatered	-					
Road	Private	Fill Depth (m)	-					
Road Tenure	Unclassified	Outlet Drop (m)	-					
Channel Width (m)	_	Outlet Pool Depth (m)	-					
Stream Slope (%)	_	Inlet Drop	-					
Beaver Activity	_	Slope (%)	-					
Habitat Value	_	Valley Fill	-					
Final score	0	Barrier Result	Passable					
Fix type	_	Fix Span / Diameter	_					
Photos: From top left clockwis	Photos: From top left clockwise: Road/Site Card, Barrel, Outlet, Downstream, Upstream, Inlet.

Should restoration/maintenance activities proceed at the site, removal of PSCIS crossing 197912 is recommended. In addition to removal of the collapsed bridge, resloping of banks and the installation of live cuttings/pegboarding is recommended in three areas downstream where cattle trampling is resulting in significant erosion. A map of the erosion areas and associated prescriptions for rehabilitation of the downstream corners is provided as Figure ??. The cost of the work is estimated at \$30,000 for a cost benefit of 924 linear m/\$1000 and 3973.2 m²/\$1000.

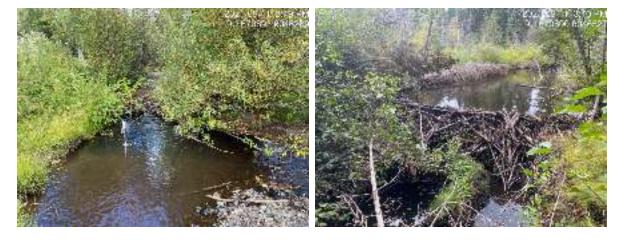
The stream was surveyed immediately upstream from 197912 for approximately 340m to the location of a large beaver dam (Figure 5.19). Within the area surveyed, total cover amount was rated as with deep pools dominant. Cover was also present as small woody debris, large woody debris, undercut banks, overhanging vegetation, and instream vegetation (Table 5.35). The average channel width was 4.3m, the average wetted width was 2.5m and the average gradient was 1.5%. The dominant substrate was gravels with fines subdominant. Habitat value was rated as high value for resident salmonid rearing and spawning.

Figure 5.19: Left: Typical habitat upstream of PSCIS crossing 197912. Right: Typical habitat upstream of PSCIS crossing 197912.

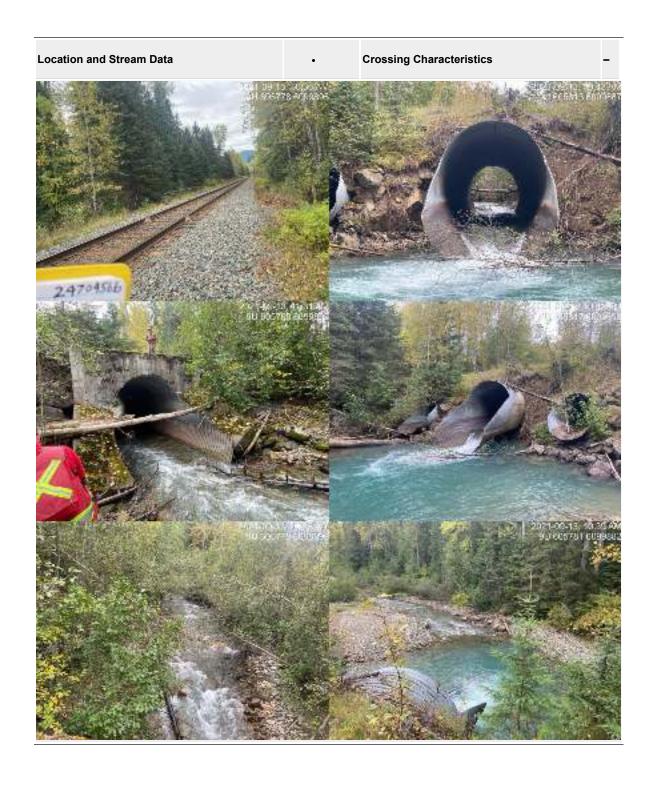
Table 5.40: Summary of fish passage assessment for PSCIS crossing 197960.

, ,		9
Location and Stream Data	•	Crossing Characteristics	_
Date	2021-09-13	Crossing Sub Type	Round Culvert
PSCIS ID	197960	Diameter (m)	3.4
External ID	_	Length (m)	24
Crew	AI KP	Embedded	No
UTM Zone	9	Depth Embedded (m)	_
Easting	605785.6	Resemble Channel	No
Northing	6099884	Backwatered	No
Stream	Corya Creek	Percent Backwatered	-
Road	CN Railway	Fill Depth (m)	1.5
Road Tenure	Canadian National	Outlet Drop (m)	0.65
Channel Width (m)	18	Outlet Pool Depth (m)	3
Stream Slope (%)	2.8	Inlet Drop	No
Beaver Activity	Yes	Slope (%)	2.5
Habitat Value	High	Valley Fill	Deep Fill
Final score	34	Barrier Result	Barrier
Fix type	Replace with New Open Bottom Structure	Fix Span / Diameter	23
Photos: From top left clockw	rise: Road/Site Card, Barrel, Outlet, Downs	tream, Upstream, Inlet.

Should restoration/maintenance activities proceed, replacement of PSCIS crossing 197960 with a bridge (23m span) is recommended. The cost of the work is estimated at \$13,800,000 for a cost benefit of 0.7 linear m/\$1000 and 13 m²/\$1000.

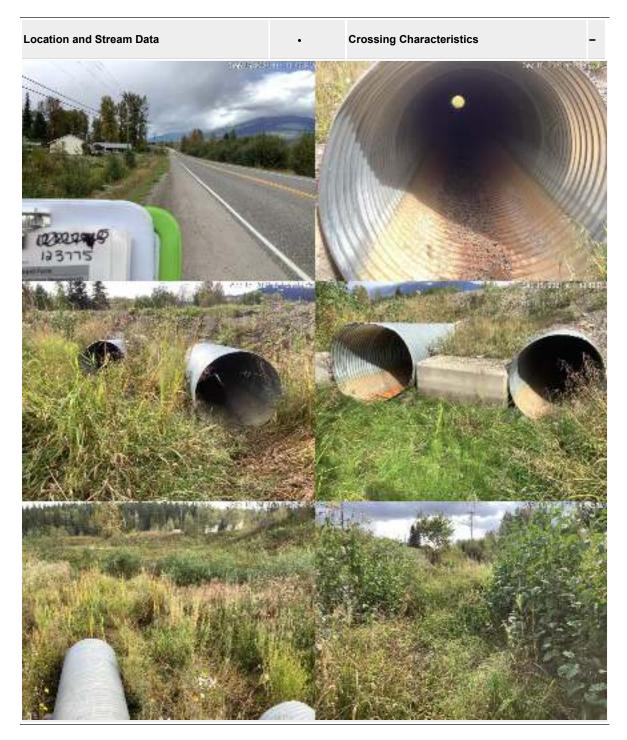
Location and Stream Data	•	Crossing Characteristics	-
Date	2021-09-15	Crossing Sub Type	Round Culvert
PSCIS ID	123775	Diameter (m)	1.22
External ID	_	Length (m)	32
Crew	DN AN	Embedded	No
UTM Zone	9	Depth Embedded (m)	_
Easting	606445.5	Resemble Channel	No
Northing	6099726	Backwatered	No
Stream	Witset Creek	Percent Backwatered	_
Road	Highway 16	Fill Depth (m)	0.3
Road Tenure	MoTi Arterial	Outlet Drop (m)	0
Channel Width (m)	0.5	Outlet Pool Depth (m)	0
Stream Slope (%)	1	Inlet Drop	No
Beaver Activity	No	Slope (%)	0.5
Habitat Value	Low	Valley Fill	Deep Fill
Final score	16	Barrier Result	Potential
Fix type	Replace Structure with Streambed Simulation CBS	Fix Span / Diameter	3
Photos: From top left cloc	kwise: Road/Site Card, Barrel, Outlet, Downstream	, Upstream, Inlet.

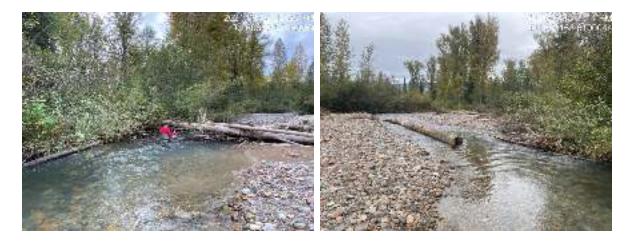
The stream was surveyed downstream from crossing 197960 for 450m (Figure <u>5.21</u>). Total cover amount was rated as moderate with overhanging vegetation dominant. Cover was also present as small woody debris, large woody debris, undercut banks, and deep pools. The average channel width was 25.4m, the average wetted width was 8.9m and the average gradient was 1.7%. The

dominant substrate was cobbles with gravels subdominant. The stream was moderately turbid due to glacial flour with abundant quantities of gravels suitably sized for trout and salmon species present. The stream channel was noted as riffle dominated with a lack of complexity due to adjacent riparian clearing and dyke installation. The habitat was rated as medium value for salmonid rearing and spawning.

Figure 5.21: Left: Typical habitat downstream of PSCIS crossing 197960. Right: Typical habitat downstream of PSCIS crossing 197960.

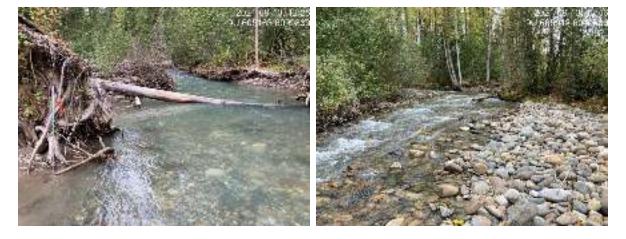
The stream was surveyed upstream from crossing 197960 for 1000m (Figure <u>5.22</u>). Total cover amount was rated as moderate with overhanging vegetation dominant. Cover was also present as small woody debris, large woody debris, boulders, and undercut banks. The average channel width was 18m, the average wetted width was 8.9m and the average gradient was 2.8%. The dominant substrate was cobbles with gravels subdominant. The first 50 - 100m upstream of crossing channel and banks were noted as armoured with riprap. Abundant gravels suitable for resident and anadromous salmonids were noted throughout. The habitat was rated as medium value as an important migration corridor containing suitable spawning habitat and having moderate rearing potential.

Figure 5.22: Left: Typical habitat upstream of PSCIS crossing 197960. Right: Typical habitat upstream of PSCIS crossing 197960.

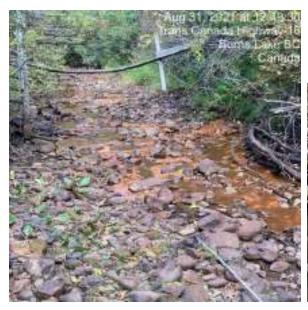
The stream was surveyed downstream from crossing 197967 for NAm to the bridge (PSCIS 197966) located on Ross Lake Cutoff Rd (Figure <u>5.23</u>). The dominant substrate was cobbles with fines sub-dominant., Total cover amount was rated as trace with overhanging vegetation dominant. Cover was also present as deep pools and instream vegetation., The average channel width was

5.7m, the average wetted width was 3.1m, and the average gradient was 2.5%. The site was noted as having significant amounts of thick red colored algae for the majority of survey. Flow was very low with uncommon pools. Fence material was noted in or across channel in two locations and and riparian vegetation had been removed where an agricultural field and fence line were close. Although considered an important migration corridor, the habitat was rated as medium value for salmonid rearing and spawning due to limited complexity resulting from adjacent agricultural activities.

Figure 5.23: Left: Habitat downstream of PSCIS crossing 197967. Right: Habitat downstream of PSCIS crossing 197967.

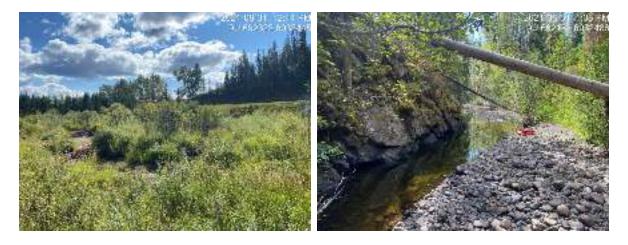
The stream was surveyed upstream from crossing 197967 for NAm (Figure <u>5.24</u>). The dominant substrate was gravels with cobbles sub-dominant., Total cover amount was rated as moderate with deep pools dominant. Cover was also present as large woody debris and overhanging vegetation., The average channel width was 5.3m, the average wetted width was 2.3m, and the average

gradient was 2.5%. The first ~250m of channel upstream of the highway were noted as beaver influenced wetland with extensive dry sections at the time of the survey. Frequent pockets of gravels and small cobbles suitable for rainbow trout and coho salmon spawning were noted throughout the area surveyed. A canyon section of stream was located upstream of the crossing approximately 300m contained deep bedrock pools with small fish present and no large woody debris. One deep pool upstream of the canyon section contained likely 2-3 year old juveniles (coloring indicated rainbow trout, unverified). The habitat was rated as medium value as an important migration corridor containing suitable spawning habitat and having moderate rearing potential.

Figure 5.24: Left: Habitat upstream of PSCIS crossing 197967. Right: Habitat upstream of PSCIS crossing 197967.

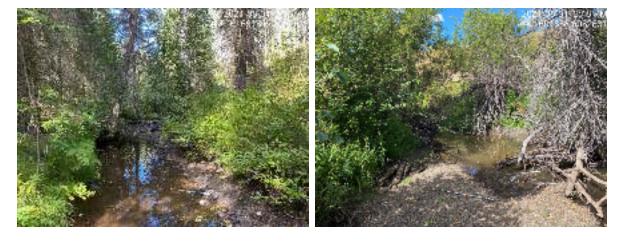
Taman Creek was surveyed for 375m above where it joins the Bulkley River mainstem upstream of PSCIS crossing 197967 (Figure 5.25). The average channel width was 3.8m, the average wetted width was 2.2m, and the average gradient was 2.5%., The dominant substrate was gravels with cobbles sub-dominant., Total cover amount was rated as moderate with deep pools dominant. Cover was also present as small woody debris, large woody debris, undercut banks, and overhanging vegetation. The water in Taman Creek during the survey was noted as turbid with numerous samlonid fry present at the downstream end of the site. Algae was abundant throughout the system and eroding banks were common. Abundant gravels suitable for resident rainbow trout and coho salmon spawning were present and habitat was rated as NA value for salmon rearing and spawning.

Figure 5.25: Left: Habitat upstream of PSCIS crossing 197967. Right: Habitat upstream of PSCIS crossing 197967.

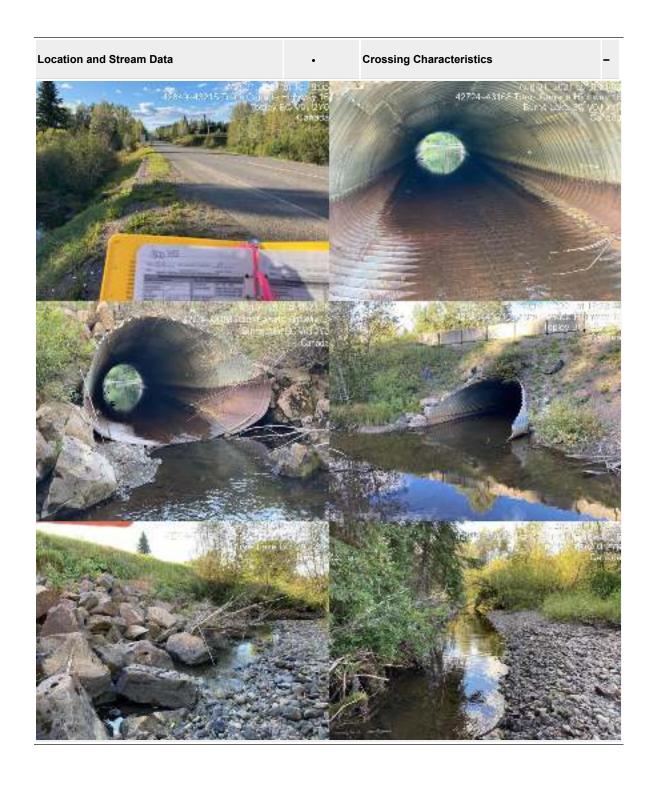
Table 5.53: Summary of fish passage assessment for PSCIS crossing 197976.

At the time of the survey, PSCIS crossing 197976 was 50% backwatered, un-embedded and ranked as a barrier to upstream fish passage according to the provincial protocol (MoE 2011b) (Table $\underline{5.53}$). A juvenile fish (~140 cm) was noted as easily swimming upstream through the culvert during the survey. PSCIS crossing 197976 was not backwatered, not embedded and ranked as a barrier to upstream fish passage according to the provincial protocol (Table $\underline{5.54}$). Water temperature was 11° C, pH was 7 and conductivity was 248uS/cm.

Location and Stream Data	•	Crossing Characteristics	_			
Date	2021-08-31	Crossing Sub Type	Oval Culvert			
PSCIS ID	197976	Diameter (m)	3.5			
External ID	_	Length (m)	23			
Crew	KP	Embedded	No			
UTM Zone	9	Depth Embedded (m)	_			
Easting	680644.8	Resemble Channel	No			
Northing	6039756	Backwatered	Yes			
Stream	Ailport Creek	Percent Backwatered	50			
Road	Highway 16	Fill Depth (m)	3			
Road Tenure	Highway	Outlet Drop (m)	_			
Channel Width (m)	7.5	Outlet Pool Depth (m)	0.55			
Stream Slope (%)	4	Inlet Drop	No			
Beaver Activity	No	Slope (%)	2			
Habitat Value	High	Valley Fill	Deep Fill			
Final score	24	Barrier Result	Barrier			
Fix type Replace with New Open Bottom Structure Fix Span / Diameter 12.5						
Photos: From top left clockw	rise: Road/Site Card, Barrel, Outlet, Downs	tream, Upstream, Inlet.

Should restoration/maintenance activities proceed, replacement of PSCIS crossing 197976 with a bridge (12.5m span) is recommended. The cost of the work is estimated at \$7,500,000 for a cost benefit of 3.3 linear m/\$1000 and 27.1 m²/\$1000. As the crossing partially backwaters naturally, a plan to backwater the crossing could also be of consideration in the short term with a rough cost estimate to complete of \$25,000.

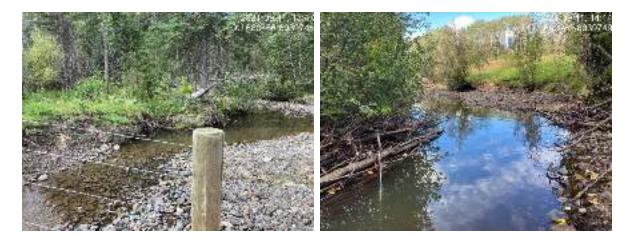
The stream was surveyed downstream from crossing 197976 for 575m (Figure <u>5.27</u>). The dominant substrate was cobbles with gravels sub-dominant., Total cover amount was rated as moderate with deep pools dominant. Cover was also present as small woody debris, undercut banks, overhanging vegetation, and instream vegetation., The average channel width was 7.7m, the average wetted

width was 3.4m, and the average gradient was 1%. Although side channels continued to flow throughout the area surveyed, approximately 160m downstream of the crossing the main channel was dewatered below the location of a beaver dam. Areas of riparian and bank degradation from cattle trampling were noted throughout the area surveyed and there was fencing spanning the channel. Large deposits of substrate and clumped large woody debris piles were observed within widened channel areas indicating disturbance and high flow events. There were abundant gravels presetn suitable for spawning resident and anadromous salmonids. Habitat was rated as high value for salmonid rearing and spawning with numerous fish observed and numerous deep pools to 0.95m deep.

Figure 5.27: Left: Typical habitat downstream of PSCIS crossing 197976. Right: Typical habitat downstream of PSCIS crossing 197976.

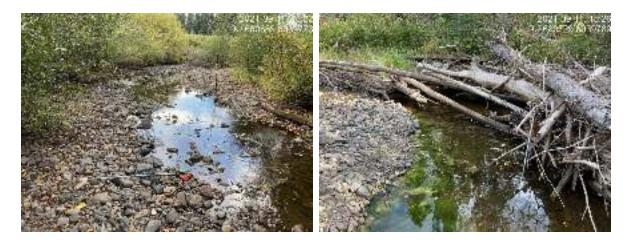
Figure 5.28: Left: Typical habitat upstream of PSCIS crossing 197976. Right: Typical habitat upstream of PSCIS crossing 197976.

The stream was surveyed upstream from crossing 197976 for 345m (Figure <u>5.28</u>). Total cover amount was rated as moderate with deep pools dominant. Cover was also present as small woody debris, undercut banks, and overhanging vegetation., The dominant substrate was cobbles with gravels sub-dominant., The average channel width was 8.1m, the average wetted width was 4.2m, and the average gradient was 1%. Fish were observed throughout the area surveyed and extensive algae growth was present on stream substrates. Large woody debris was rare and riparian/bank damage due to livestock was minimal and located at what appeared to be watering sites. Fencing was located across the stream in multiple locations. Patches of gravels suitable for spawning were present. Habitat value was rated as medium as the surveyed area was considered an important migration corridor containing suitable spawning habitat and having moderate rearing potential.

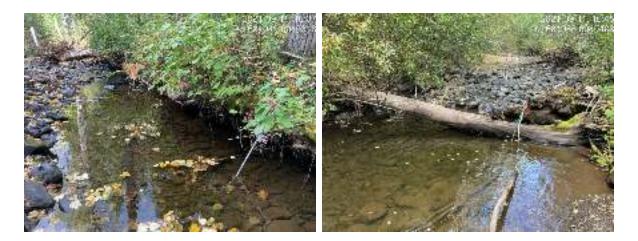
Figure 5.29: Left: Typical habitat upstream of PSCIS crossing 197975. Right: Typical habitat upstream of PSCIS crossing 197975.

The stream was surveyed upstream from crossing 197975 for 550m (Figure 5.29). The average channel width was 7.7m, the average wetted width was 3.5m, and the average gradient was 1%., Total cover amount was rated as moderate with deep pools dominant. Cover was also present as small woody debris, boulders, undercut banks, and overhanging vegetation., The dominant substrate was cobbles with gravels sub-dominant. Immediately upstream of the crossing for ~80m, extensive anthropogenic damage was noted due to dredging of the channel. Heavy cattle grazing was also observed on the left bank. Juvenile salmonids were observed occasionally throughout the area surveyed. Fencing was located across the stream approximately 250m upstream of the culvert. Patches of gravels suitable for spawning were present. Habitat value was rated as medium as the surveyed area was considered an important migration corridor containing suitable spawning habitat and having moderate rearing potential.

Should restoration/maintenance activities proceed, replacement of PSCIS crossing 197975 with a bridge (11.5m span) is recommended. The cost of the work is estimated at \$230,000 for a cost benefit of 107.3 linear m/\$1000 and 826.6 m²/\$1000. Relocation of the driveway accessing the private land from the other side of the stream and removal of the crossing could also be considered.

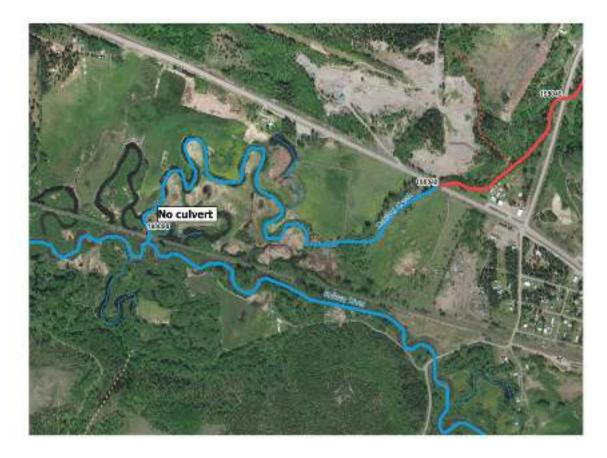
Figure 5.30: Location of potential location of crossing 198090 which was not present in the field.

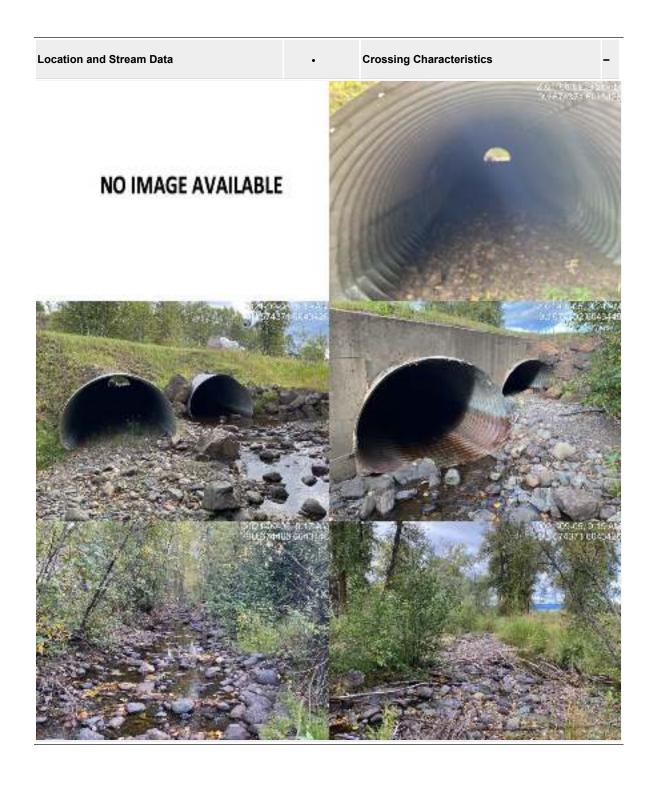
Location and Stream Data	•	Crossing Characteristics	-		
Stream	Cesford Creek	Percent Backwatered	30		
Road	Highway 16	Fill Depth (m)	1		
Road Tenure	MoTi Arterial	Outlet Drop (m)	0		
Channel Width (m)	5.48	Outlet Pool Depth (m)	0.09		
Stream Slope (%)	3.5	Inlet Drop	Yes		
Beaver Activity	No	Slope (%)	1.5		
Habitat Value	High	Valley Fill	Deep Fill		
Final score	24	Barrier Result	Barrier		
Fix type	Replace with New Open Bottom Structure Fix Span / Diameter 10				
Photos: From top left clockw	rise: Road/Site Card, Barrel, Outlet, Downs	tream, Upstream, Inlet.

Should restoration/maintenance activities proceed at the site, replacement of PSCIS crossing 198048 with a bridge (10m span) is recommended.

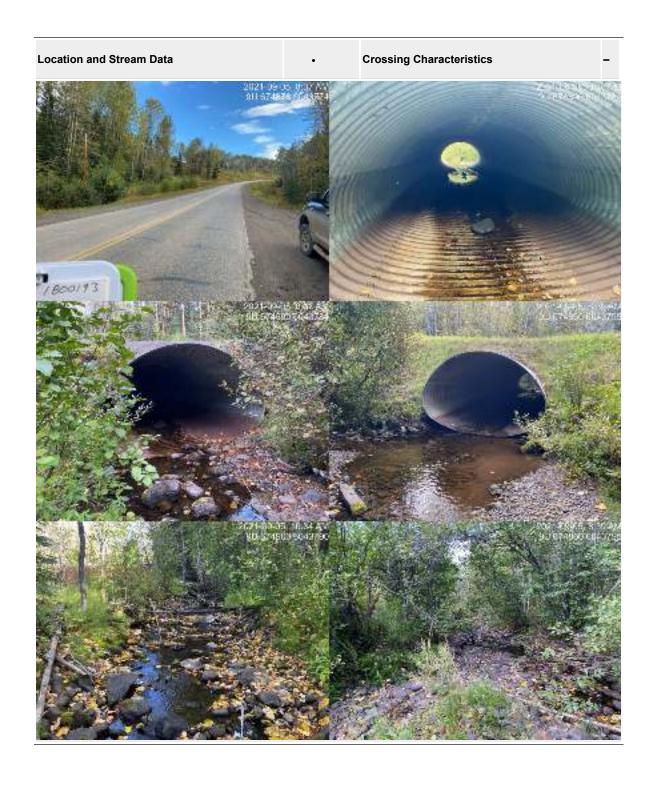
Location and Stream Data		Crossing Characteristics	_
Date	2021-09-05	Crossing Sub Type	Round Culvert
PSCIS ID	198049	Diameter (m)	3.7
External ID	_	Length (m)	21
Crew	Al	Embedded	No
UTM Zone	9	Depth Embedded (m)	_
Easting	674875.4	Resemble Channel	No
Northing	6043782	Backwatered	No
Stream	Cesford Creek	Percent Backwatered	_
Road	Highway 118	Fill Depth (m)	1
Road Tenure	MoTi Arterial	Outlet Drop (m)	0.5
Channel Width (m)	4.9	Outlet Pool Depth (m)	0.25
Stream Slope (%)	2.83	Inlet Drop	No
Beaver Activity	No	Slope (%)	1.5
Habitat Value	High	Valley Fill	Deep Fill
Final score	34	Barrier Result	Barrier
Fix type	Replace with New Open Bottom Structure	Fix Span / Diameter	10
Photos: From top left clockw	rise: Road/Site Card, Barrel, Outlet, Downs	tream, Upstream, Inlet.

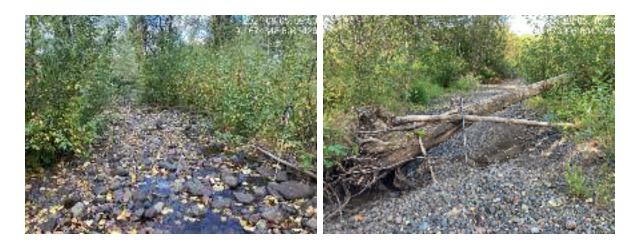
Figure 5.31: Left: Typical habitat downstream of PSCIS crossing 198048. Right: Typical habitat downstream of PSCIS crossing 198048.

The stream was surveyed downstream from the culvert for NAm (Figure $\underline{5.31}$). Total cover amount was rated as with overhanging vegetation dominant. Cover was also present as small woody debris and undercut banks (Table $\underline{5.63}$). The average channel width was 5.5m, the average wetted width

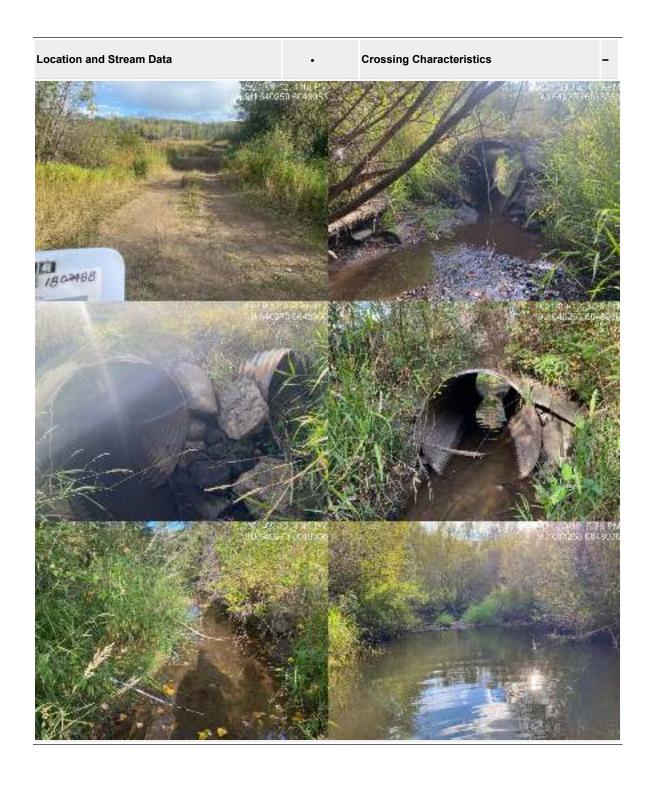
Location and Stream Data	•	Crossing Characteristics	-
Northing	6048061	Backwatered	Yes
Stream	Thompson Creek	Percent Backwatered	95
Road	Private Road	Fill Depth (m)	0.2
Road Tenure	Unclassified	Outlet Drop (m)	0
Channel Width (m)	2.77	Outlet Pool Depth (m)	0.1
Stream Slope (%)	0.5	Inlet Drop	No
Beaver Activity	No	Slope (%)	0.4
Habitat Value	High	Valley Fill	Deep Fill
Final score	16	Barrier Result	Potential
Fix type	Replace with New Open Bottom Structure	Fix Span / Diameter	10
Photos: From top left clockw	rise: Road/Site Card, Barrel, Outlet, Downst	tream, Upstream, Inlet.

Should restoration/maintenance activities proceed at the site, replacement of PSCIS crossing 198066 with a bridge (10m span) is recommended.

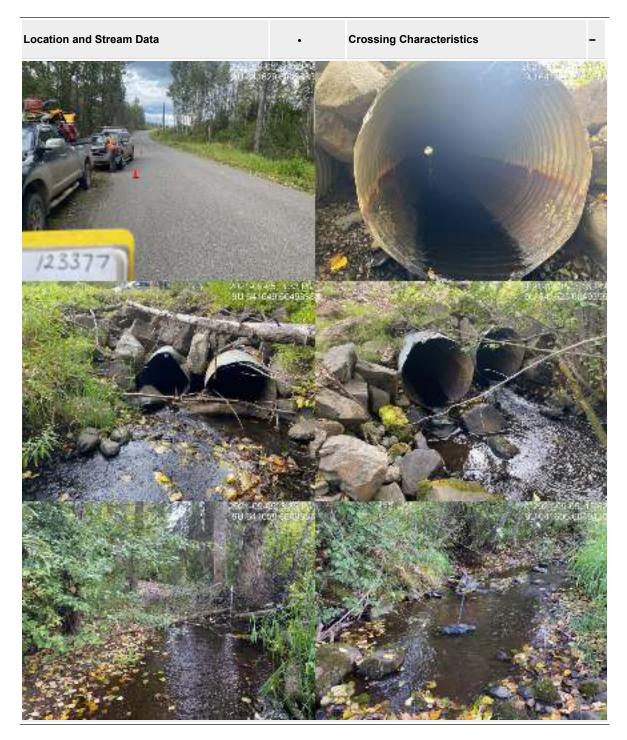
Location and Stream Data		Crossing Characteristics	_
Date	2021-09-05	Crossing Sub Type	Round Culvert
PSCIS ID	123377	Diameter (m)	1.05
External ID	_	Length (m)	29
Crew	Al	Embedded	No
UTM Zone	9	Depth Embedded (m)	_
Easting	641632.6	Resemble Channel	No
Northing	6049398	Backwatered	No
Stream	Thompson Creek	Percent Backwatered	_
Road	Walcott Road	Fill Depth (m)	1.5
Road Tenure	MoTi Local	Outlet Drop (m)	0.25
Channel Width (m)	4.8	Outlet Pool Depth (m)	0.3
Stream Slope (%)	2.7	Inlet Drop	No
Beaver Activity	No	Slope (%)	3
Habitat Value	High	Valley Fill	Deep Fill
Final score	34	Barrier Result	Barrier
Fix type	Replace with New Open Bottom Structure	Fix Span / Diameter	10
Photos: From top left clockw	rise: Road/Site Card, Barrel, Outlet, Downs	tream, Upstream, Inlet.
