SOCIETY FOR ECOSYSTEM RESTORATION IN NORTHERN BRITISH COLUMBIA

Bulkley River and Morice River Watershed Groups Fish Passage Restoration Planning 2021 - DRAFT

Prepared for
Habitat Conservation Trust Foundation - CAT21-6-288
BC Fish Passage Remediation Program
Canadian Wildlife Federation

Version 0.0.8 - DRAFT 2022-04-27

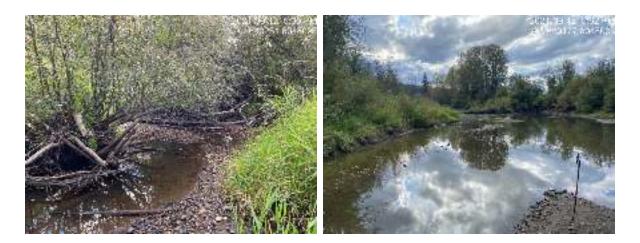
The stream was surveyed downstream from the culvert for NAm (Figure $\underline{5.33}$). Total cover amount was rated as with overhanging vegetation dominant. Cover was also present as (Table $\underline{5.68}$). The average channel width was 3.3m, the average wetted width was 2.5m and the average gradient

Figure 5.33: Left: Typical habitat downstream of PSCIS crossing 198066. Right: Habitat on side channel of Bulkley River downstream of crossing 198066.

Should restoration/maintenance activities proceed at the site, replacement of PSCIS crossing 198066 with a bridge (10m span) is recommended.

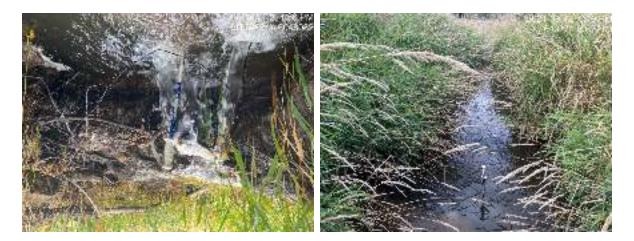
Figure 5.34: Left: Small drop (50cm high) located ~20m upstream of PSCIS crossing 198066. Right: Habitat immediately upstream of PSCIS crossing 198066 that flows through a hay field within an excavated trench for approximately 350m.
