## DEMO BIOFOULING HULL INSPECTION

**SRI LANKA - DOCKYARD VESSEL**

**WEDNESDAY 24TH JUNE 2026**

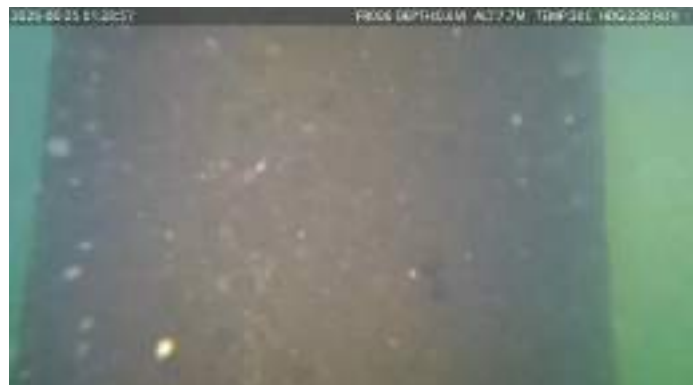
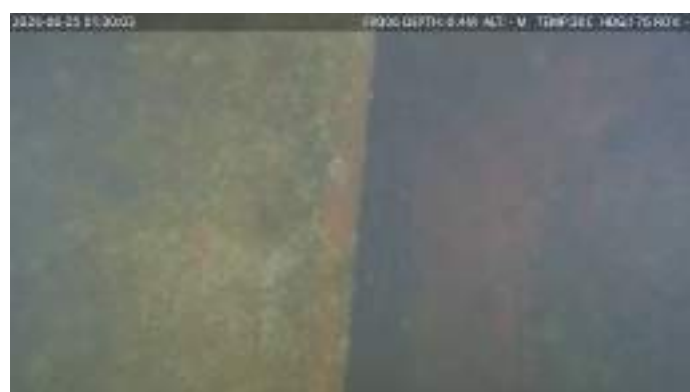
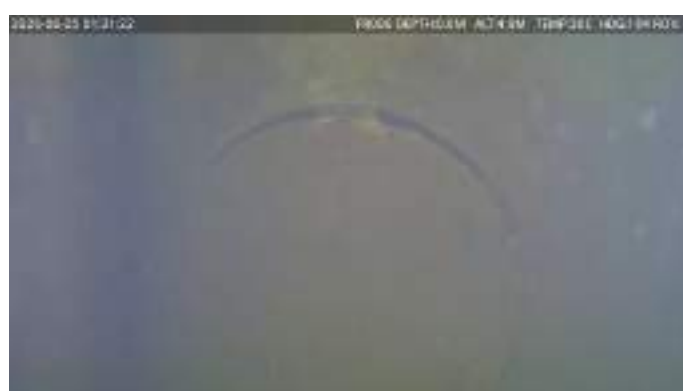
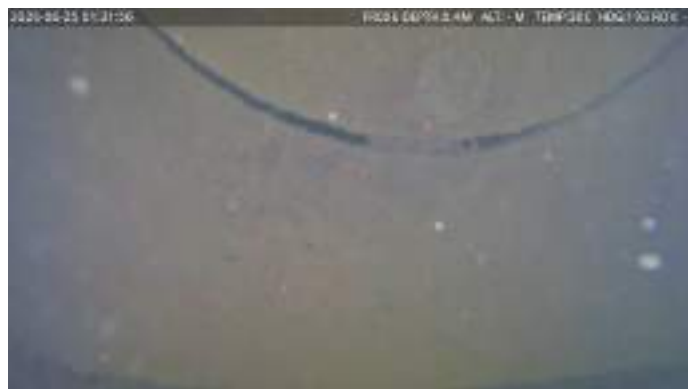
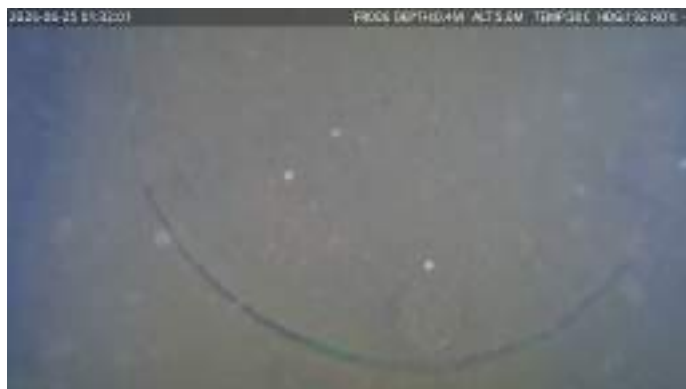
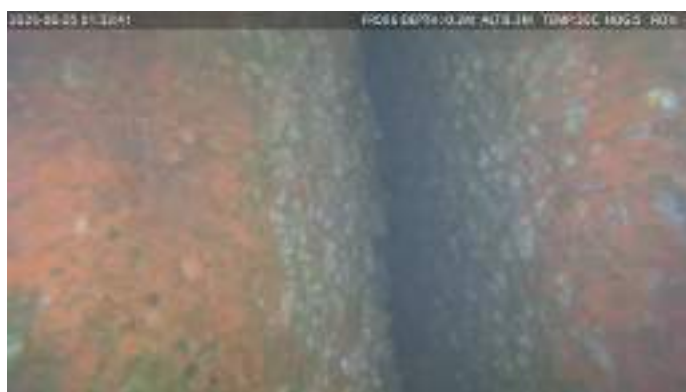
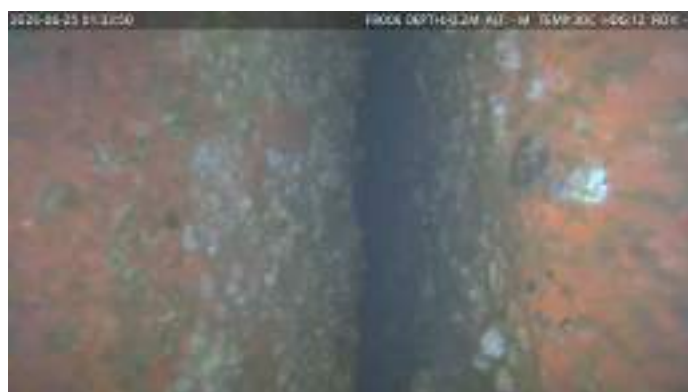
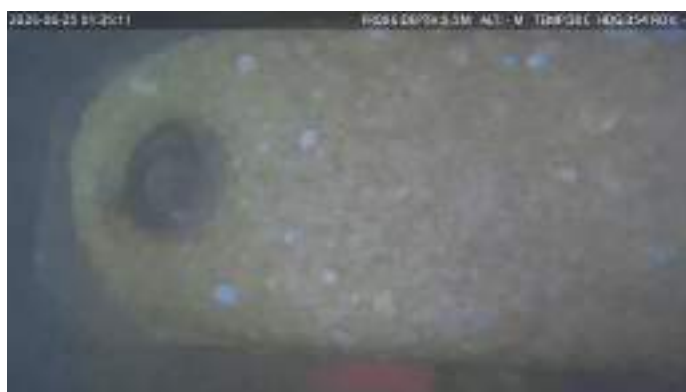
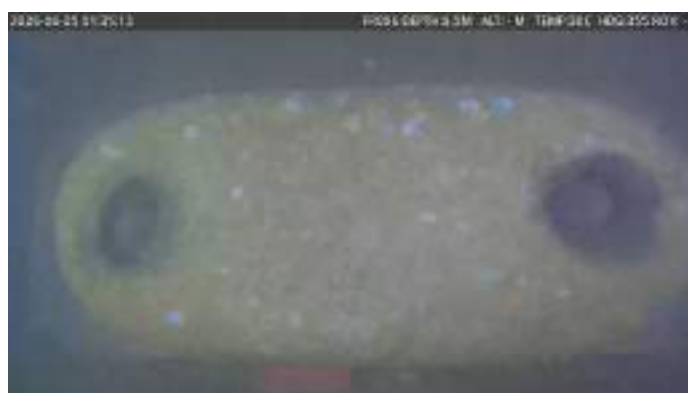
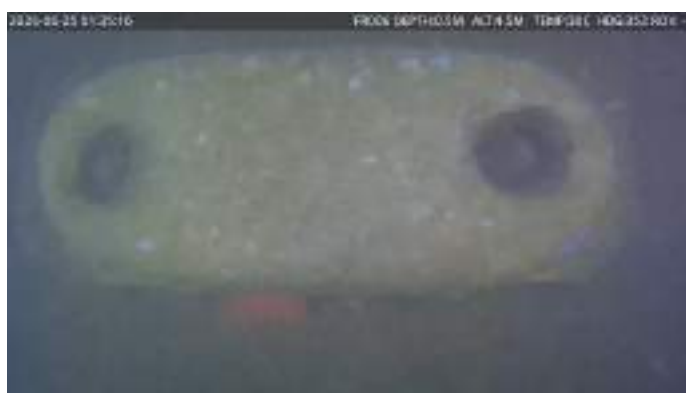
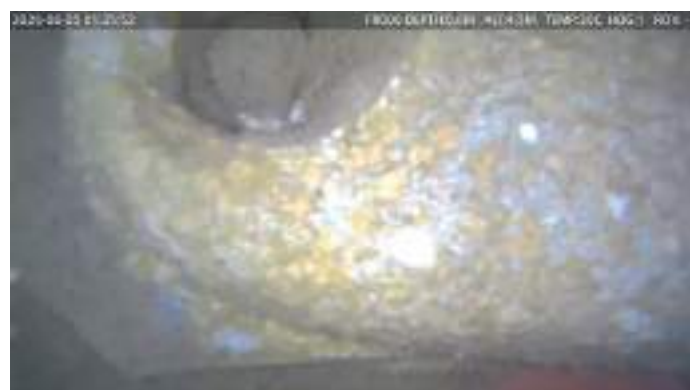
## 5.1 RUDDER

Rudder inspected in poor visibility. Top of rudder, pintle bearings (port and starboard), rudder hinges (port and starboard), leading edge, rudder flat plates (port and starboard) and inspection ports (port and starboard) all exhibited considerable macrofouling (LoF Rank 3, 6–15% coverage), with antifouling missing from edges, corners, seams, welds and fixings to expose anticorrosion undercoat (PDR 20). Anodes clean (Rank 1) with antifouling intact (PDR 10); all anodes located.

The rudder carries the highest fouling level recorded on the vessel. Coating breakdown is limited to edges, seams and points of mechanical movement rather than the main plate, so the antifouling system is still performing across the body — the exposed undercoat is a maintenance flag for the next docking, not an active corrosion concern. Biosecurity risk for this niche is moderate given the developed macrofouling; it should be prioritised for cleaning. No invasive marine species identified.

1. Proceed with targeted in-water cleaning of the rudder and propeller to remove the recorded macrofouling and restore propulsive efficiency.
2. Inspect the internal sea chest spaces and gratings by diver or improved-access ROV pass to confirm fouling extent and IMS status before final clearance.
3. Schedule rudder antifouling repair at the next dry dock opportunity at the edges, seams, fixings and movement points where undercoat is exposed (PDR 20).
4. Establish a 6-month inspection interval to monitor fouling reaccumulation on the running gear.

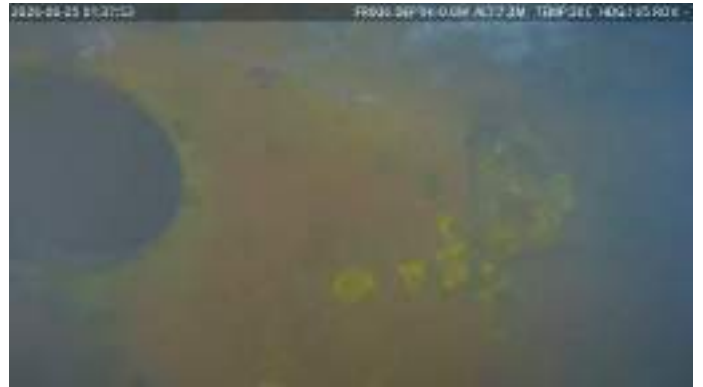
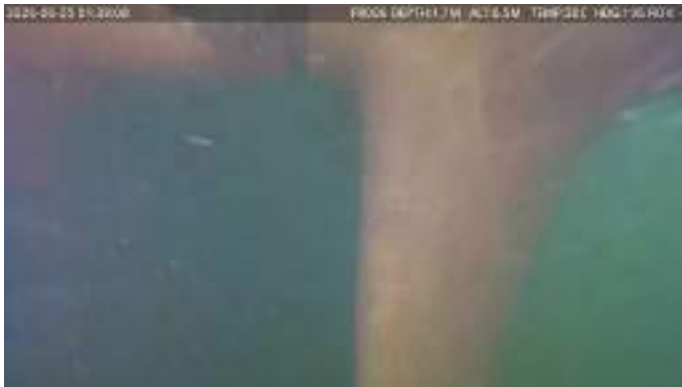
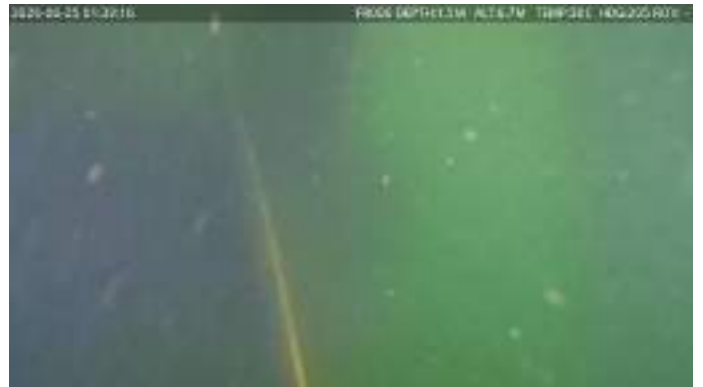
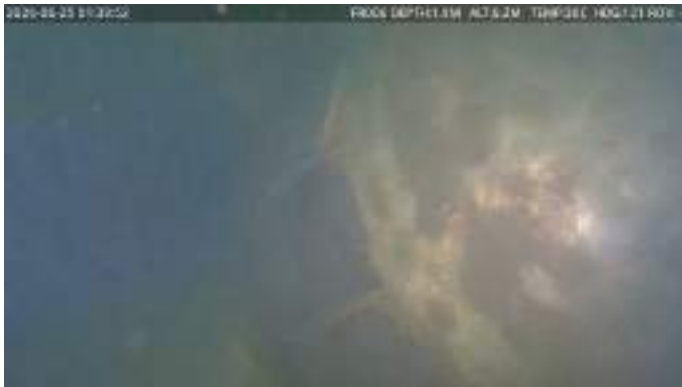
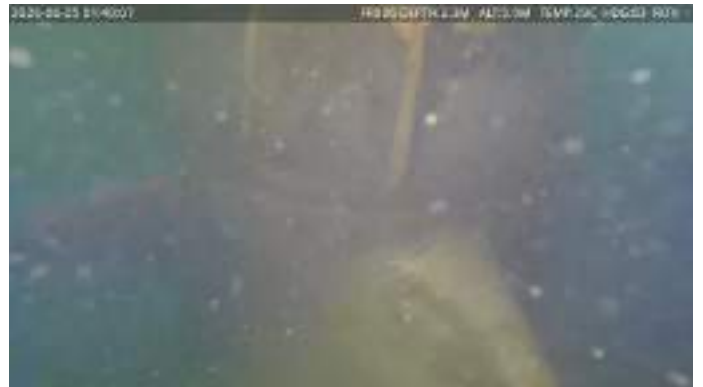
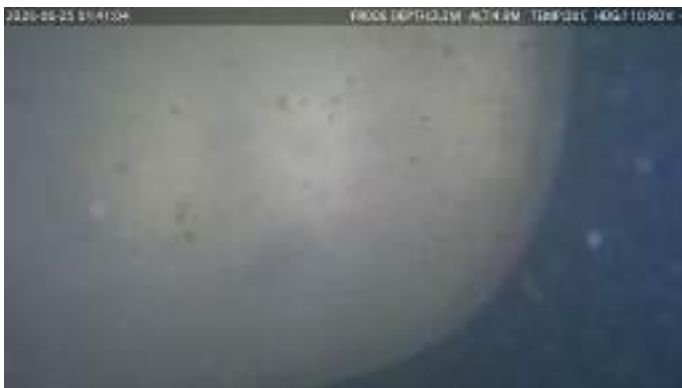
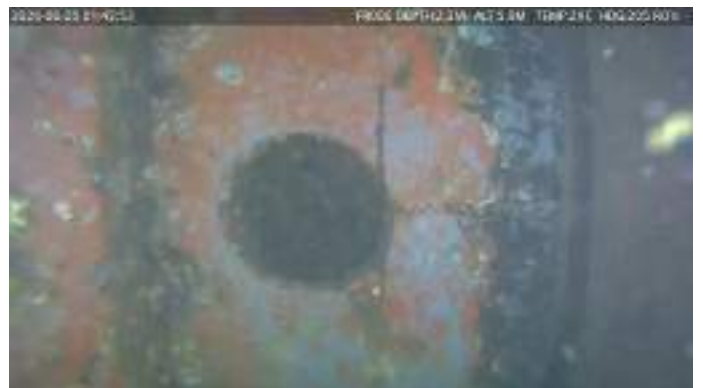
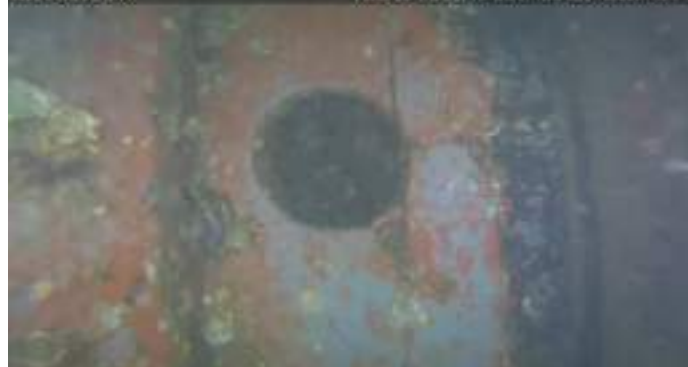
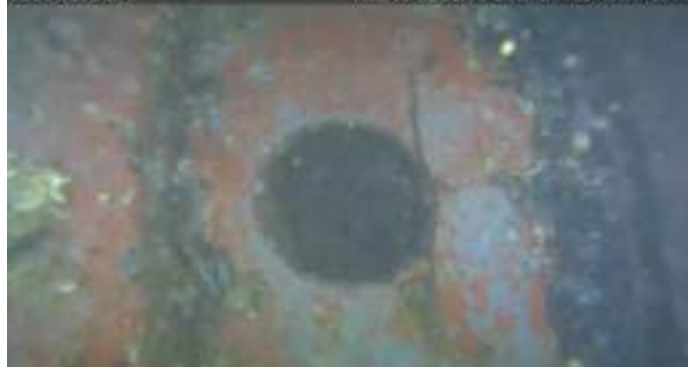
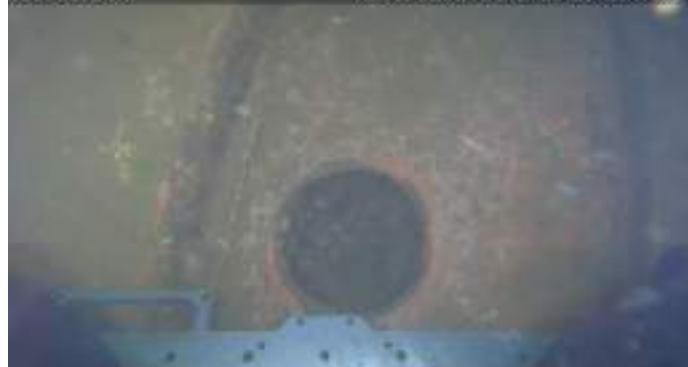
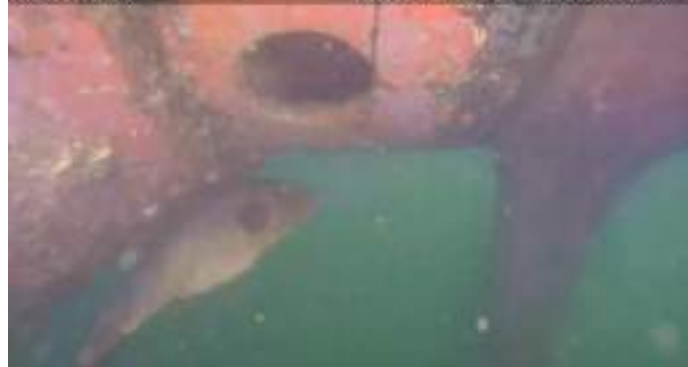
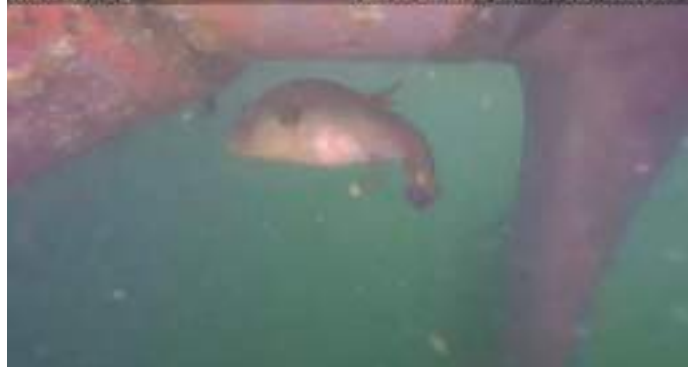
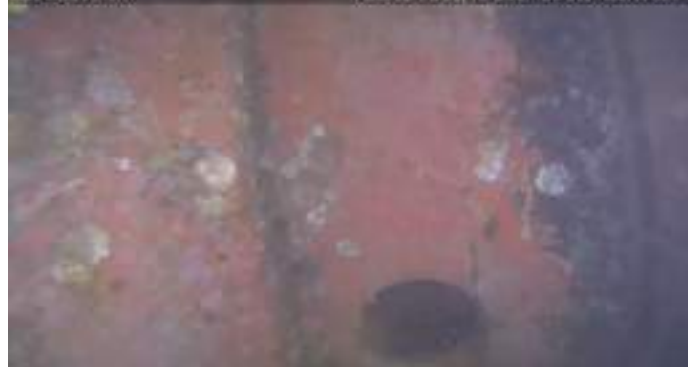
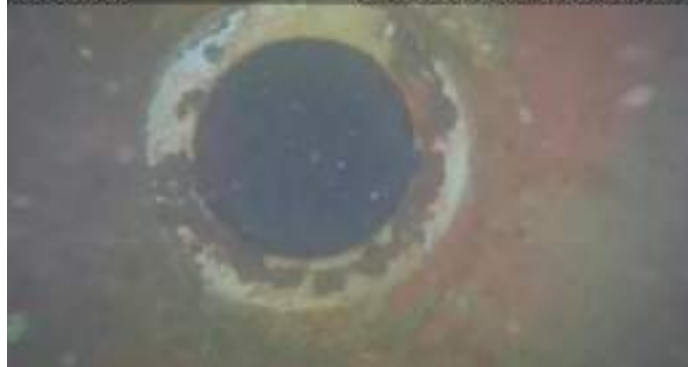
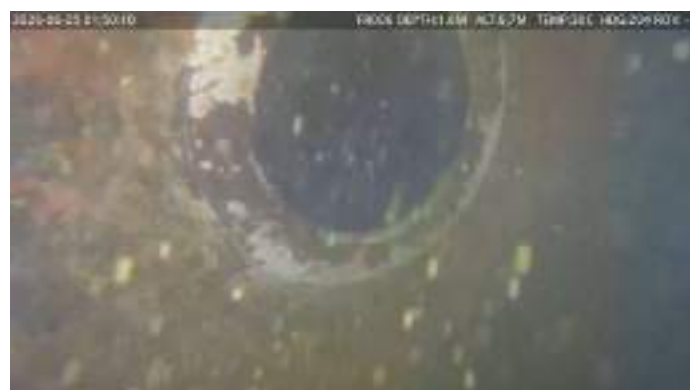
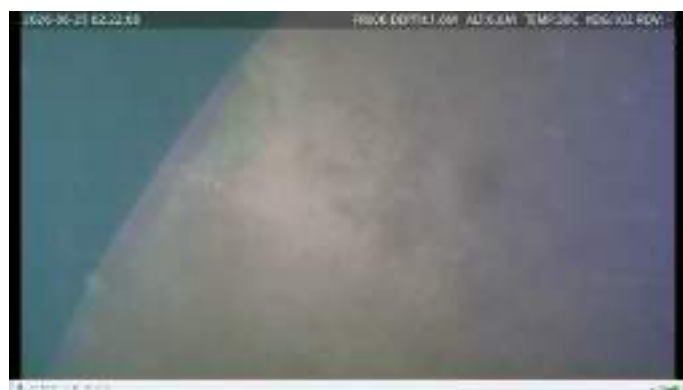
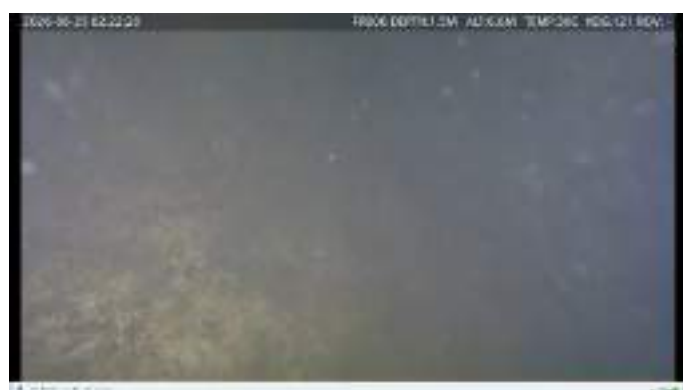
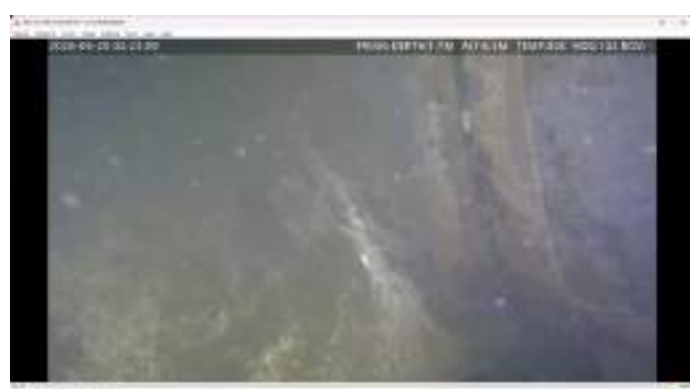
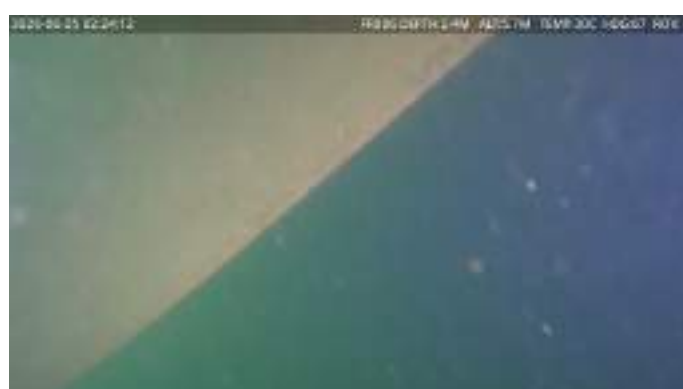
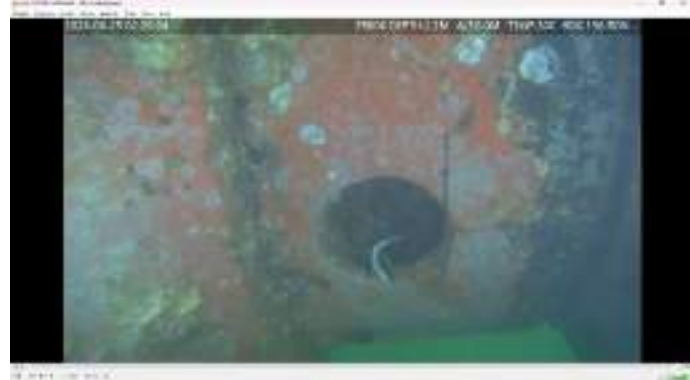
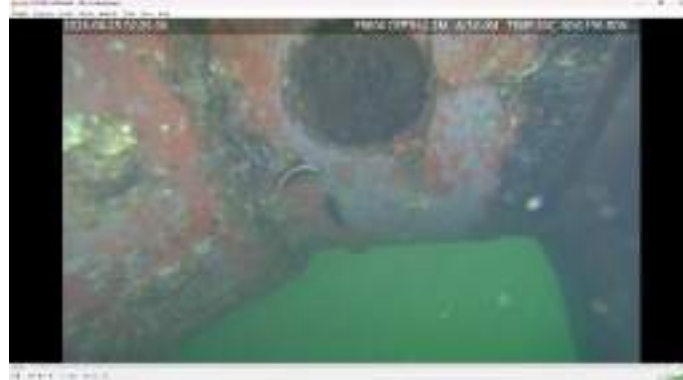
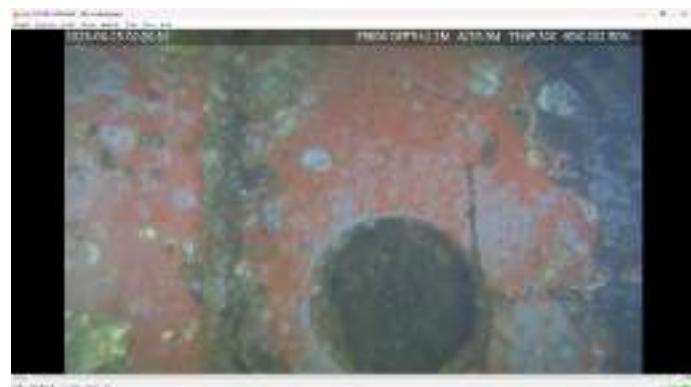
## 5.2 PROPELLER

Propeller inspected in approximately 3 m visibility. Boss clean with no fouling (LoF Rank 0). Blades 1 to 5 each showed scattered macrofouling in small patches (LoF Rank 2, 1–5% coverage). No antifouling coating present on the propeller.

Light, even fouling across all five blades is consistent with a bare bronze propeller and the expected reaccumulation pattern. The burden is to propulsive efficiency rather than coating integrity; a polish during the next clean will restore performance. Biosecurity risk low. No invasive marine species identified.

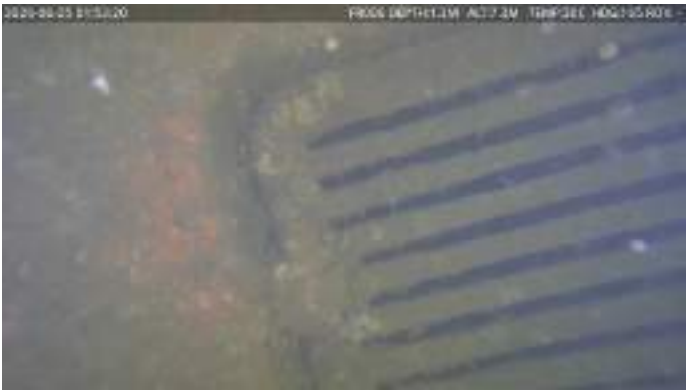
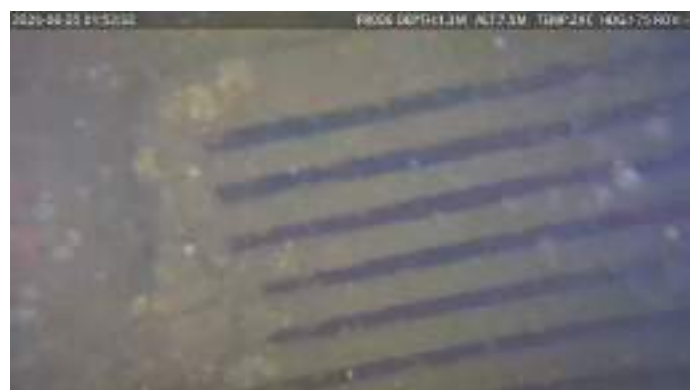
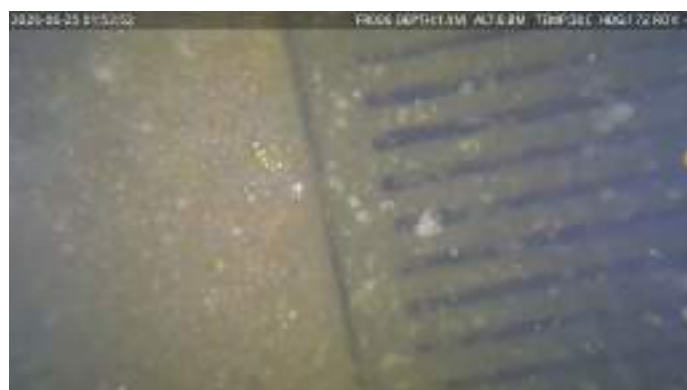
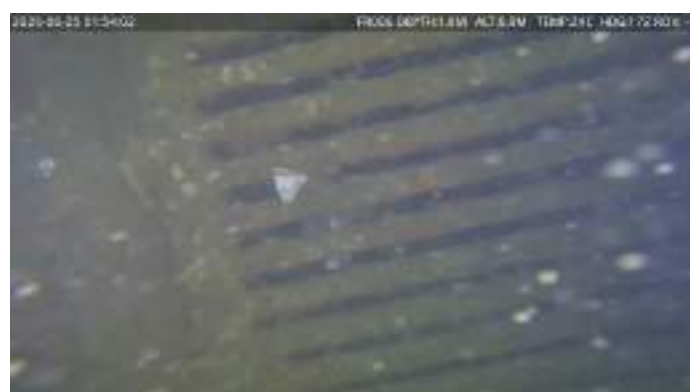
### 5.3 SEA CHEST 1

External face inspected with light scattered macrofouling (LoF Rank 2, 1–5% coverage) and minor antifouling loss with visible brush swirl marks in the outermost layer (PDR 30). Internal sea chest not visible; internal grating reported as fouled. Internal surfaces recorded clean (Rank 0, PDR 10) on the basis of no access — not directly assessed.

External condition is sound with only incipient fouling and cosmetic coating wear. The significant item is the internal space, which could not be inspected and the grating of which was reported fouled — this is the one outstanding biosecurity uncertainty for the vessel and should be confirmed before clearance. No invasive marine species identified on the accessible surfaces.

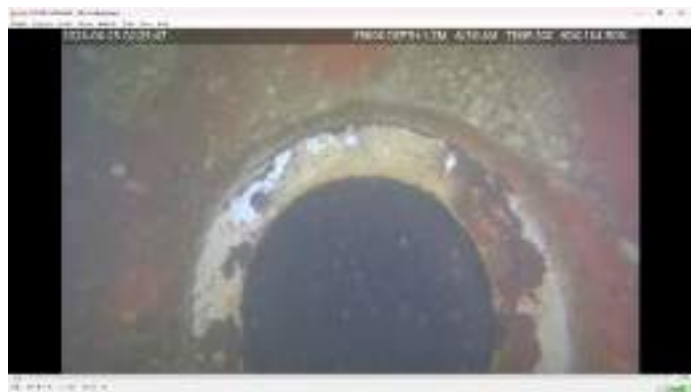
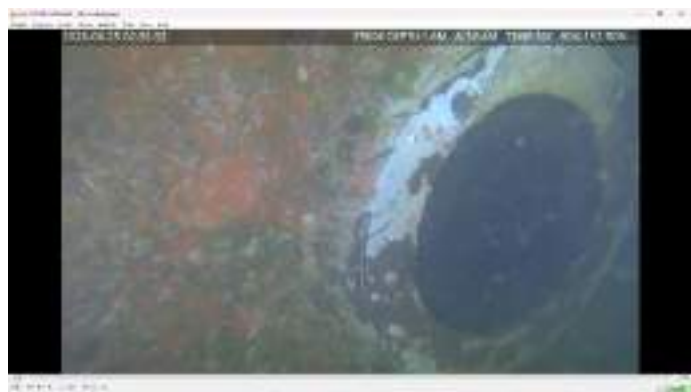
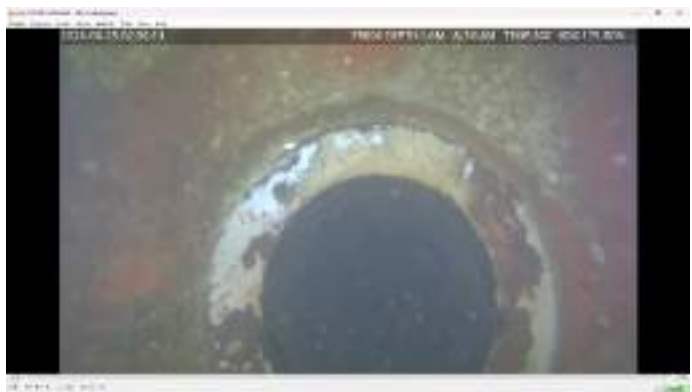
### 5.4 TRANSDUCERS

clear and cleaned recently
