## DEMO BIOFOULING HULL INSPECTION

**SRI LANKA - DOCKYARD VESSEL**

**WEDNESDAY 24TH JUNE 2026**

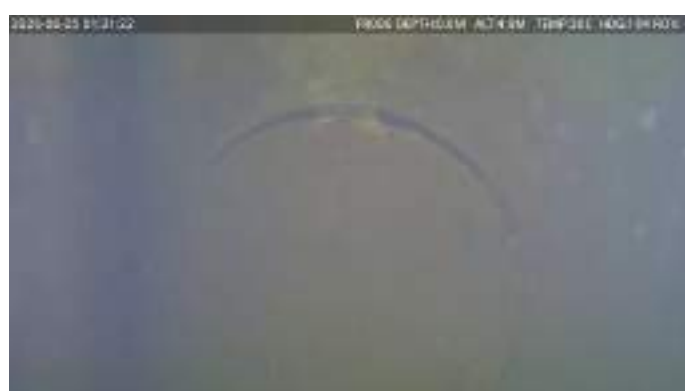
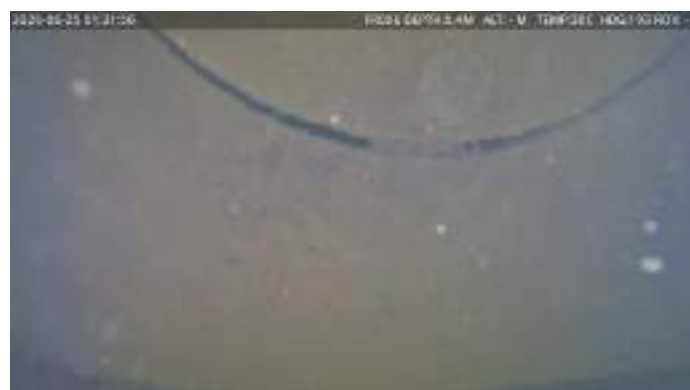
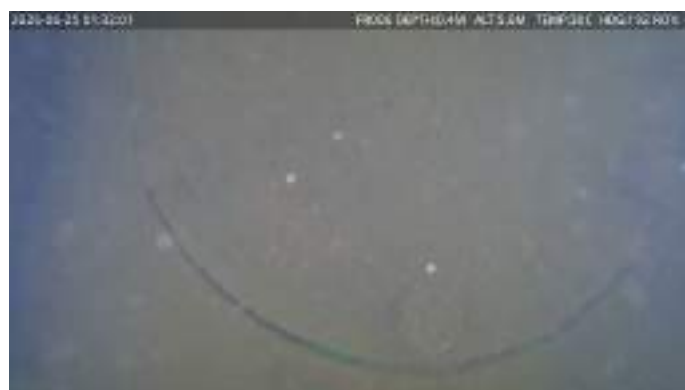
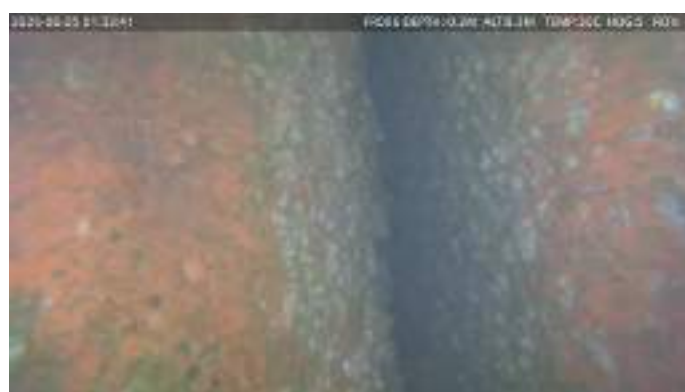
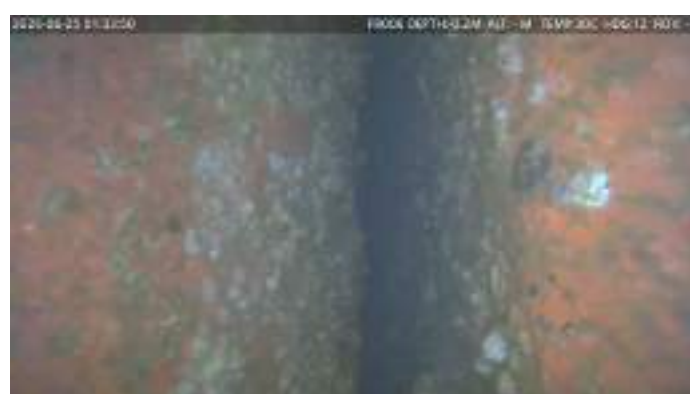
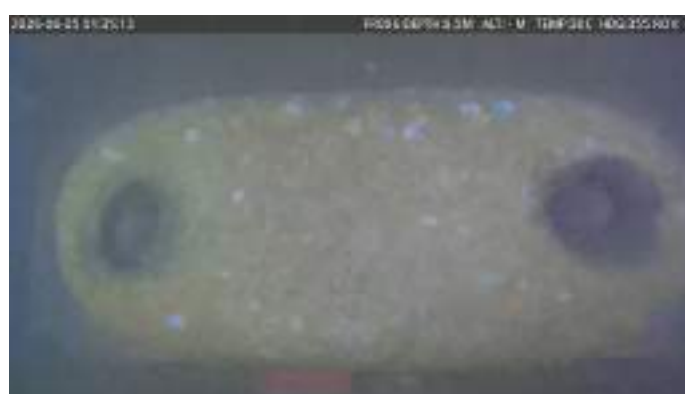
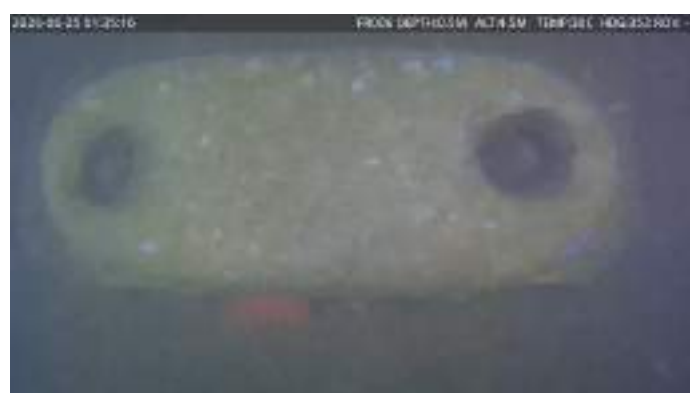
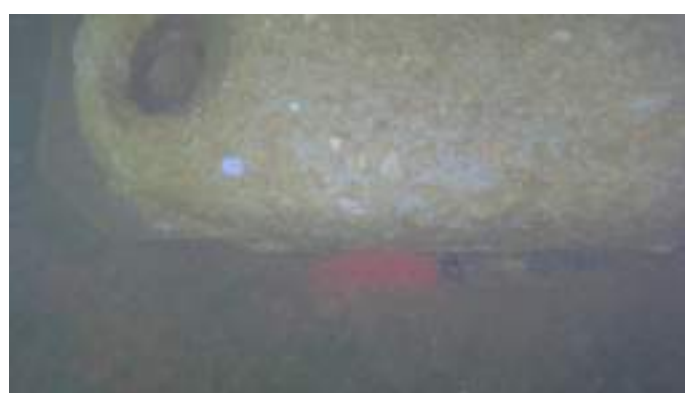
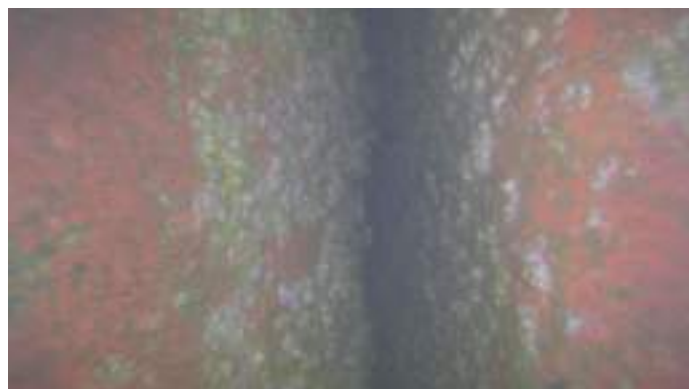
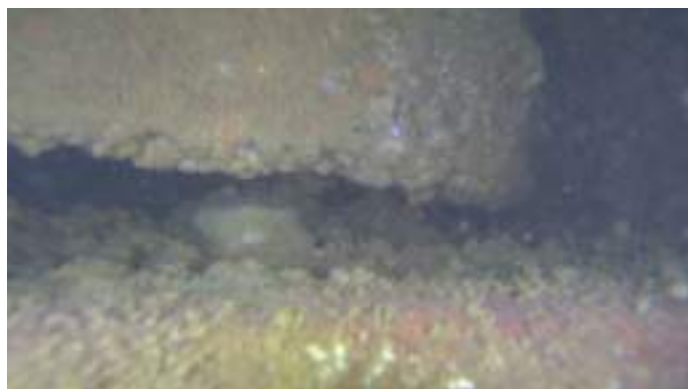
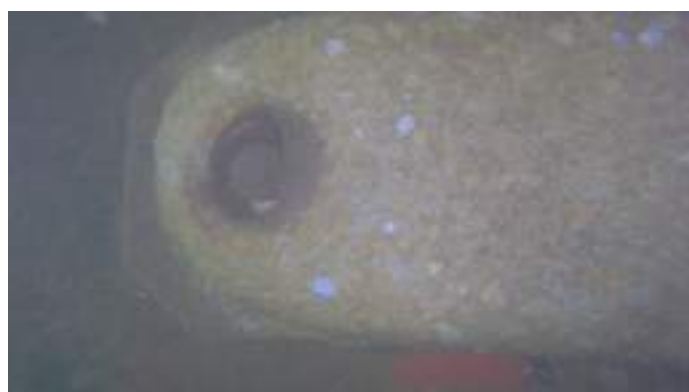
## 5.1 RUDDER

Rudder inspected in poor visibility. Top of rudder, pintle bearings (port and starboard), rudder hinges (port and starboard), leading edge, rudder flat plates (port and starboard) and inspection ports (port and starboard) all exhibited considerable macrofouling (LoF Rank 3, 6–15% coverage), with antifouling missing from edges, corners, seams, welds and fixings to expose anticorrosion undercoat (PDR 20). Anodes clean (Rank 1) with antifouling intact (PDR 10); all anodes located. Inside the pintle were heavy coverage of acorn barnacles as well as filamentous algae.

The rudder carries the highest fouling level recorded on the vessel. Coating breakdown is limited to edges, seams and points of mechanical movement rather than the main plate, so the antifouling system is still performing across the body — the exposed undercoat is a maintenance flag for the next docking, not an active corrosion concern. Biosecurity risk for this niche is moderate given the developed macrofouling; it should be prioritised for cleaning. No invasive marine species identified.

1. Proceed with targeted in-water cleaning of the rudder and propeller to remove the recorded macrofouling and restore propulsive efficiency.
2. Inspect the internal sea chest spaces and gratings by diver or improved-access ROV pass to confirm fouling extent and IMS status before final clearance.
3. Schedule rudder antifouling repair at the next dry dock opportunity at the edges, seams, fixings and movement points where undercoat is exposed (PDR 20).
4. Establish a 6-month inspection interval to monitor fouling reaccumulation on the running gear.

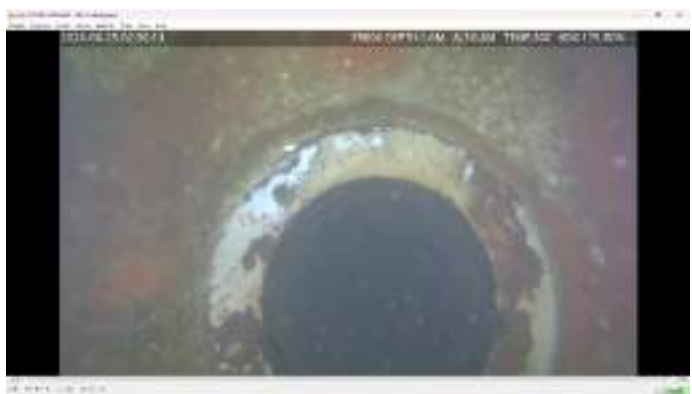
### 5.4 TRANSDUCERS

clear and cleaned recently

| Description | Level of fouling (LOF) | PDR Rating | Comments |
|---|---|---|---|
| No description available | Rank 1 - 0% Slime Layer on some or all surfaces. No macrofouling. | PDR: 40 AF paint missing from intact blisters to expose AC paint or an AF coating with visible brush swirl marks exposing the next underlying layer of AF or AC paint. | No additional comments |
