## DETAILED WIND TURBINE BLADE INSPECTION REPORT

| ◦ <b>TURBINE NUMBER</b> | - 1470026 |
| ◦ <b>MODEL</b> | - G52 (VESTAS) |

| Turbine | Details |
|---|---|
| Report Number | IV-120226-004 |

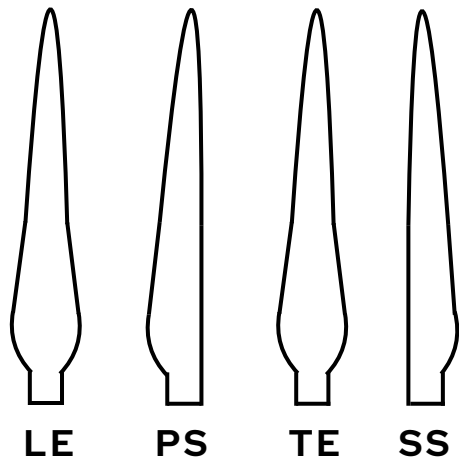
Blade A Overview

| Damage ID | Blade side | Material | Damage Type | Subtype | Severity |
|---|---|---|---|---|---|
| 120DA01 | LE | Auxiliary Component | LEP | Damaged | 2 |
| 120DA02 | LE | Auxiliary Component | LEP | Peeling | 2 |
| 120DA03 | SS | Auxiliary Component | Drainage System | Damaged or Obstructed | 3 |

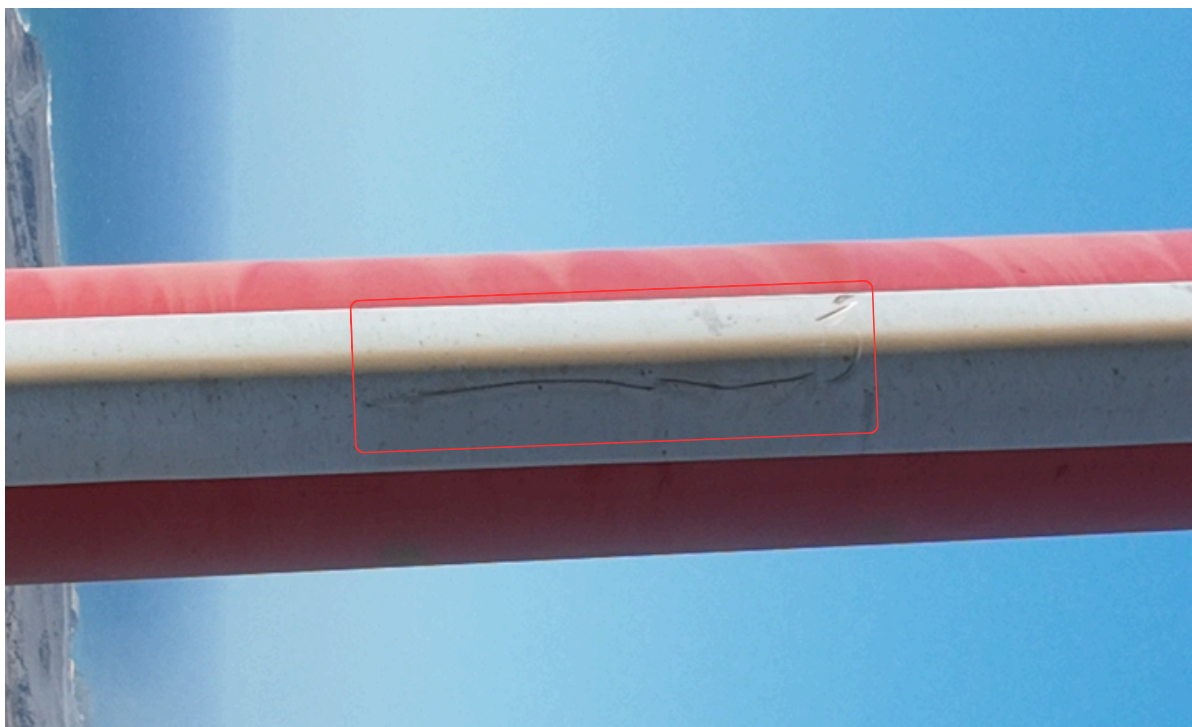
Damage 2

| Blade | A |
|---|---|
| Side | Leading Edge |
| Type | Leading Edge Protection |
| Subtype | Damaged |
| Severity | 2 |

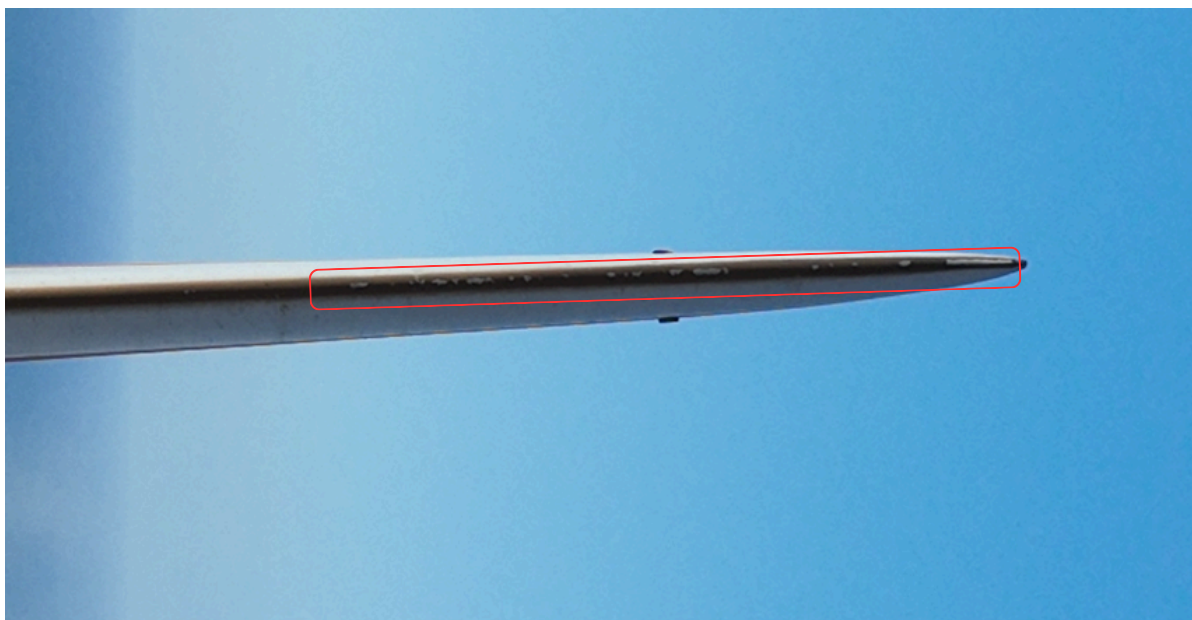
Damage 3

| Blade | A |
|---|---|
| Side | Leading Edge |
| Type | Leading Edge Protection |
| Subtype | Peeling |
| Severity | 2 |

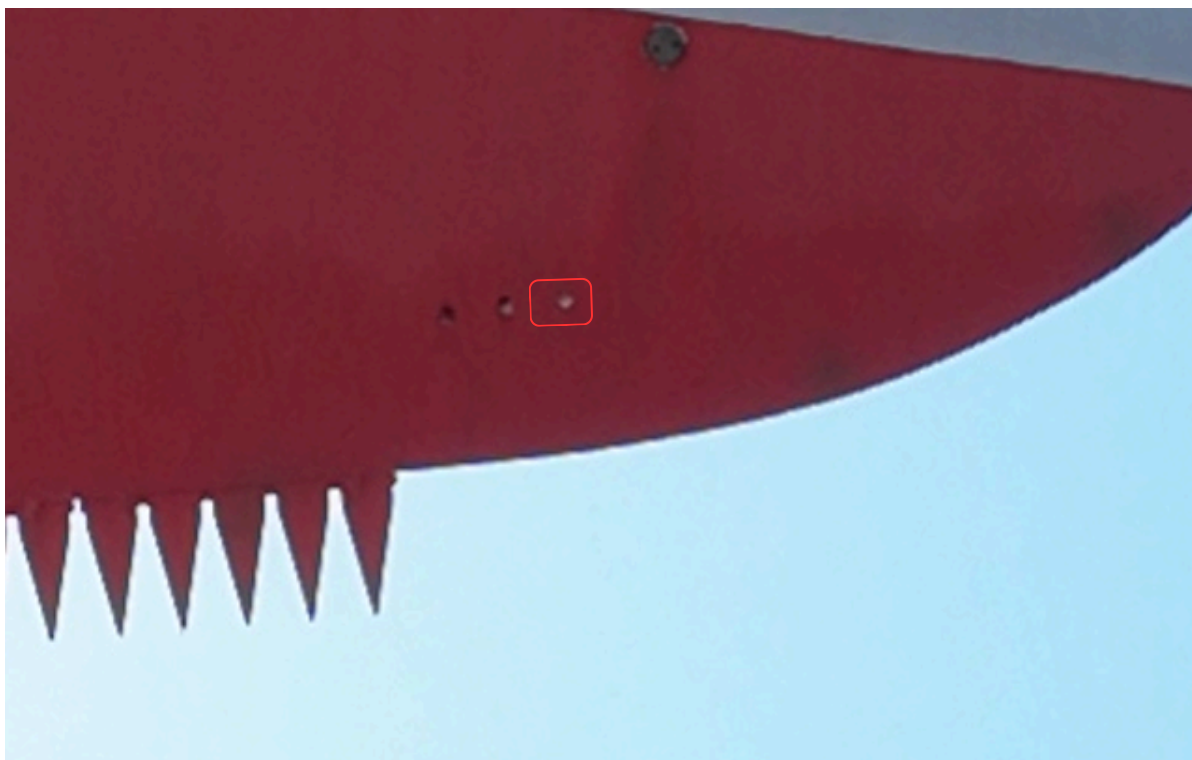
| Blade | A |
|---|---|
| Side | Suction Side |
| Type | Drainage System |
| Subtype | Damaged or Obstructed |
| Severity | 3 |

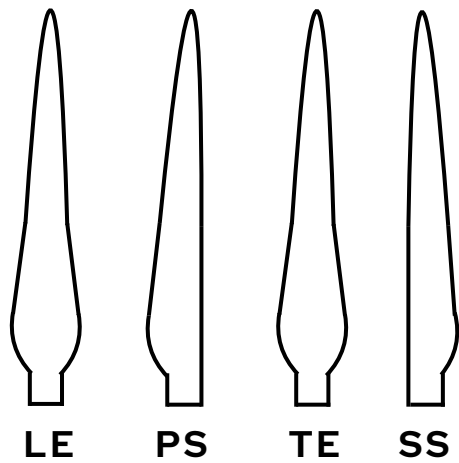
Blade B Overview

| Damage ID | Blade side | Material | Damage Type | Subtype | Severity |
|---|---|---|---|---|---|
| 120DB01 | LE | Auxiliary Component | LEP | Damaged | 2 |
| 120DB02 | LE | Auxiliary Component | LEP | Peeling | 2 |
| 120DB03 | PS | Laminate | Delamination | none | 3 |
| 120DB04 | SS | Auxiliary Component | Drainage System | Damaged or Obstructed | 3 |

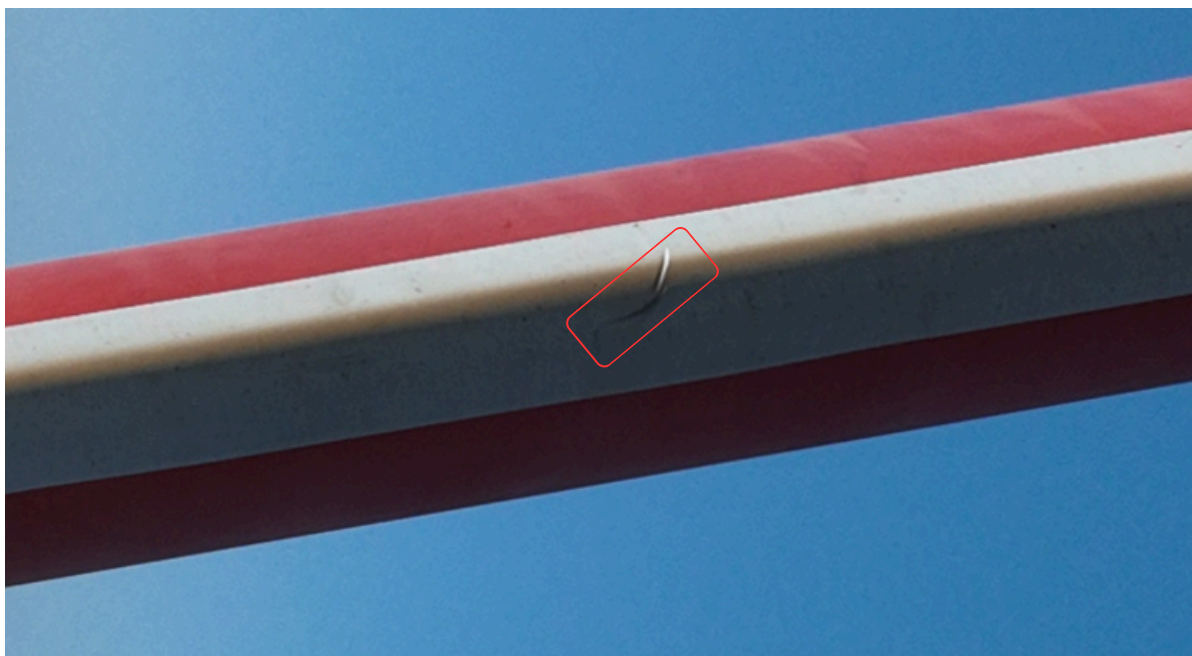
Damage 1

| Blade | B |
|---|---|
| Side | Leading Edge |
| Type | Leading Edge Protection |
| Subtype | Damaged |
| Severity | 2 |

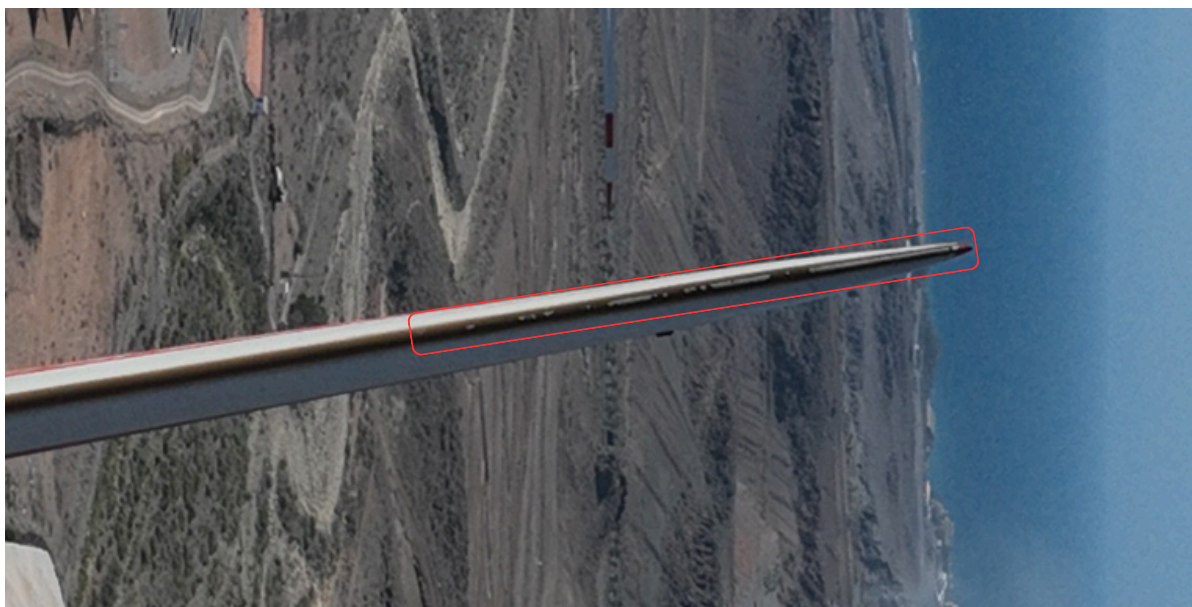
Damage 2

| Blade | B |
|---|---|
| Side | Leading Edge |
| Type | Leading Edge Protection |
| Subtype | Peeling |
| Severity | 2 |

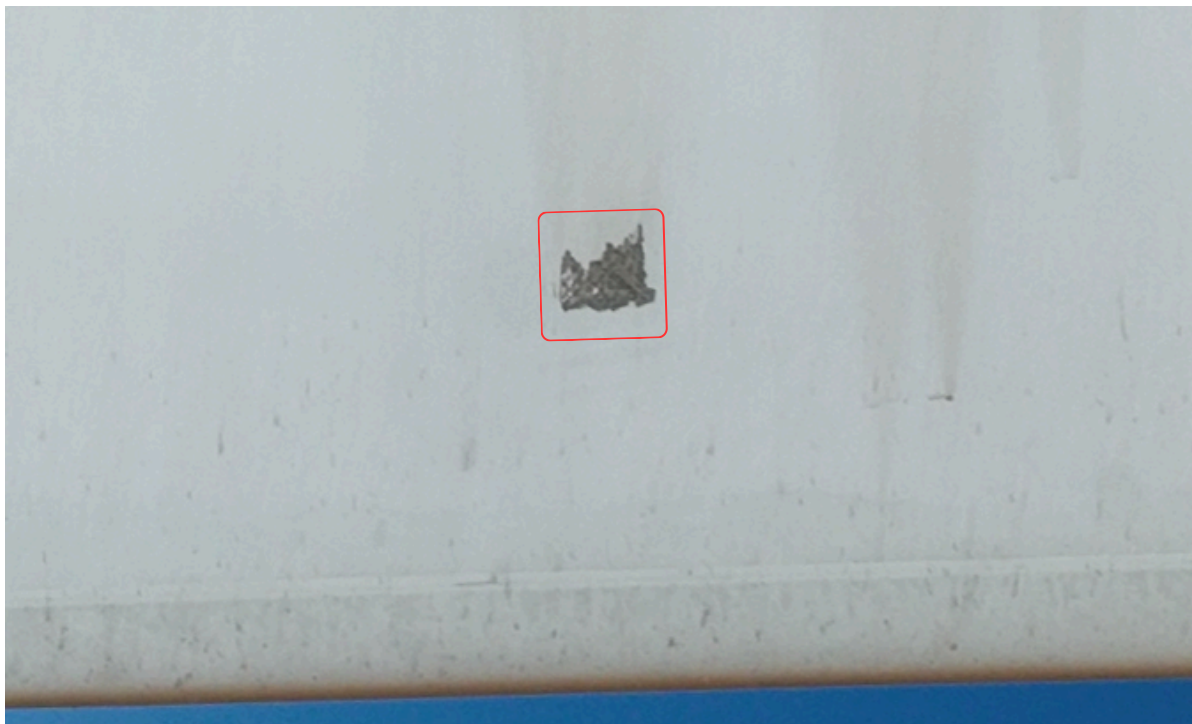
Damage 3

| Blade | B |
|---|---|
| Side | Pressure Side |
| Material | Laminate |
| Type | Delamination |
| Severity | 3 |

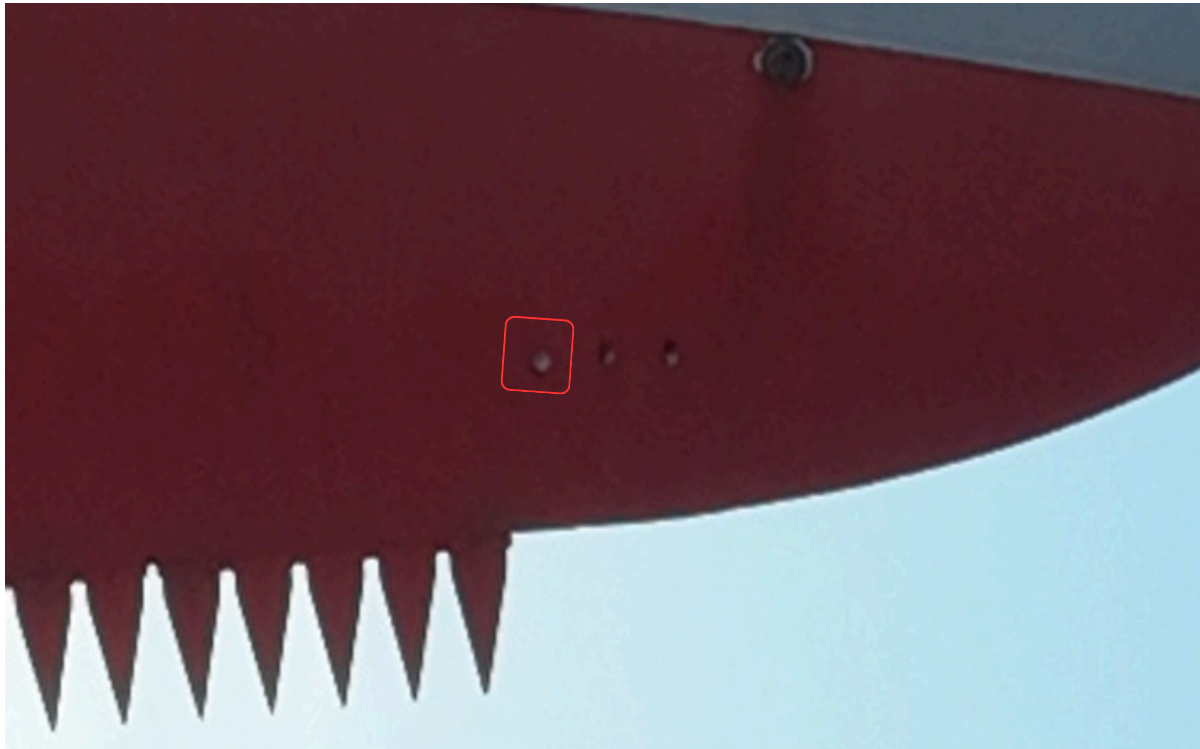
Damage 4

| Blade | B |
|---|---|
| Side | Leading Edge |
| Type | Drainage System |
| Subtype | Damaged or Obstructed |
| Severity | 3 |

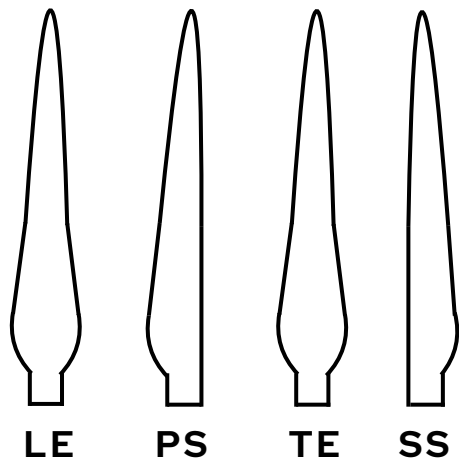
Blade C Overview

| Damage ID | Blade side | Material | Damage Type | Subtype | Severity |
|---|---|---|---|---|---|
| 120DC01 | LE | Auxiliary Component | LEP | Damaged | 2 |
| 120DC02 | LE | Auxiliary Component | LEP | Peeling | 2 |
| 120DC03 | PS | Auxiliary Component | LEP | Peeling | 2 |
| 120DC04 | SS | Auxiliary Component | Drainage System | Damaged or Obstructed | 3 |

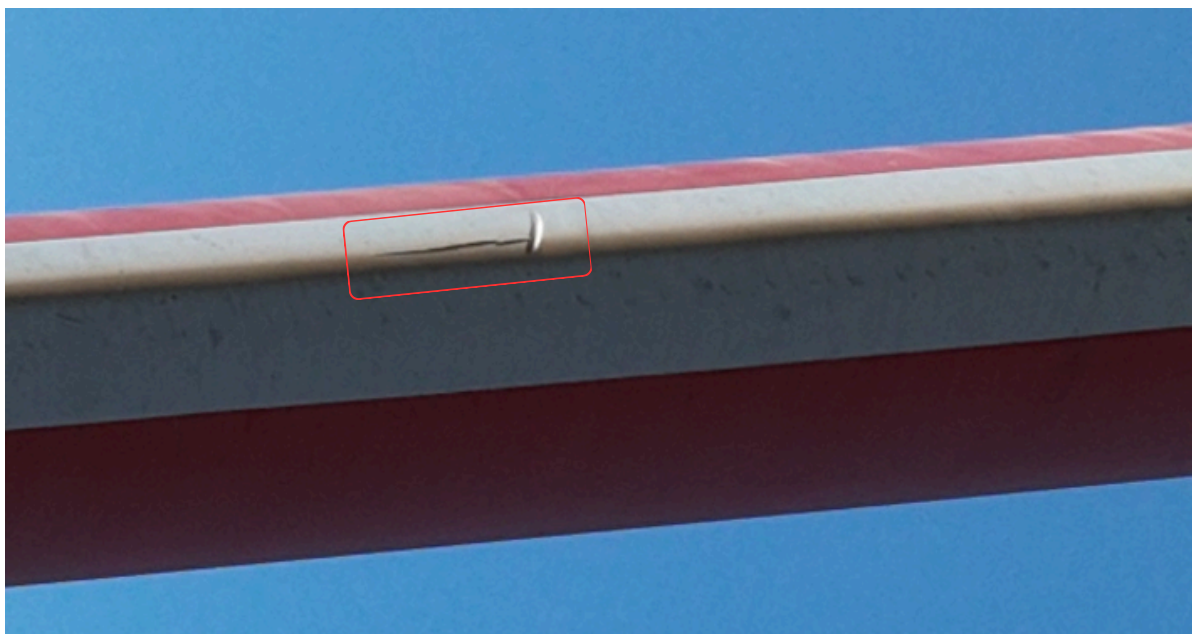
Damage 1

| Blade | C |
|---|---|
| Side | Leading Edge |
| Type | Leading Edge Protection |
| Subtype | Damaged |
| Severity | 2 |

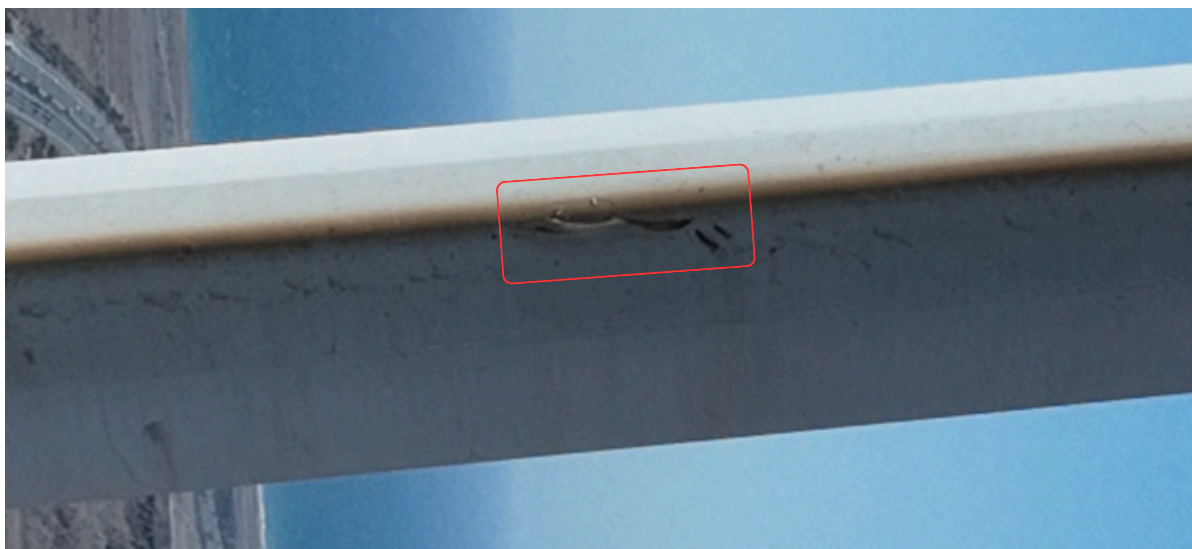
Damage 2

| Blade | C |
|---|---|
| Side | Leading Edge |
| Type | Leading Edge Protection |
| Subtype | Peeling |
| Severity | 2 |

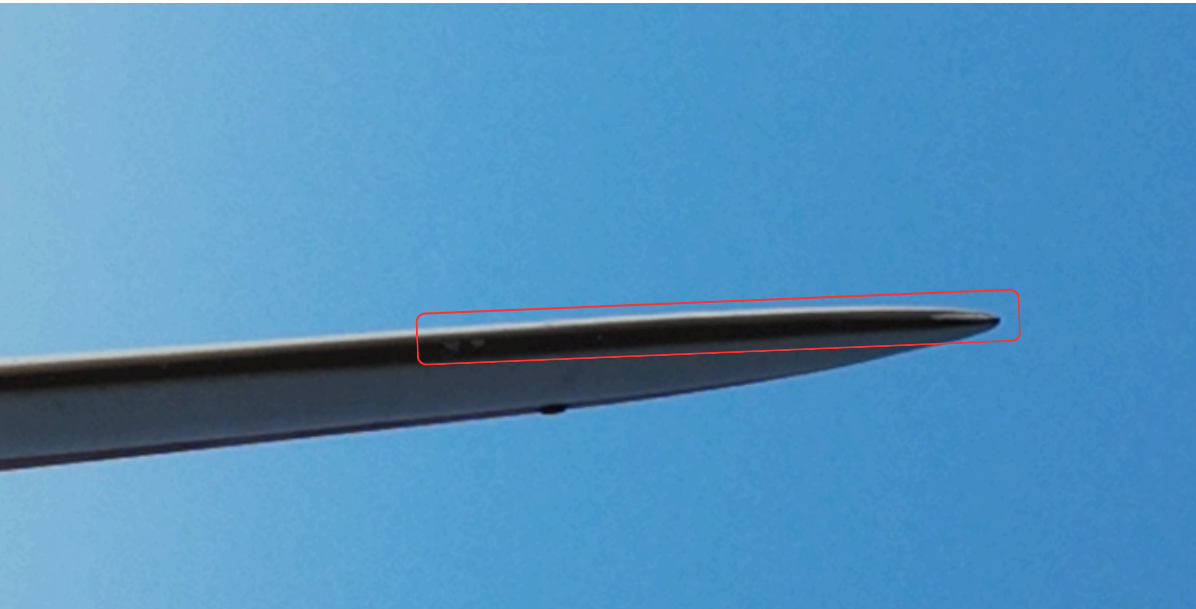
Damage 3

| Blade | C |
|---|---|
| Side | Leading Edge |
| Type | Leading Edge Protection |
| Subtype | Peeling |
| Severity | 2 |

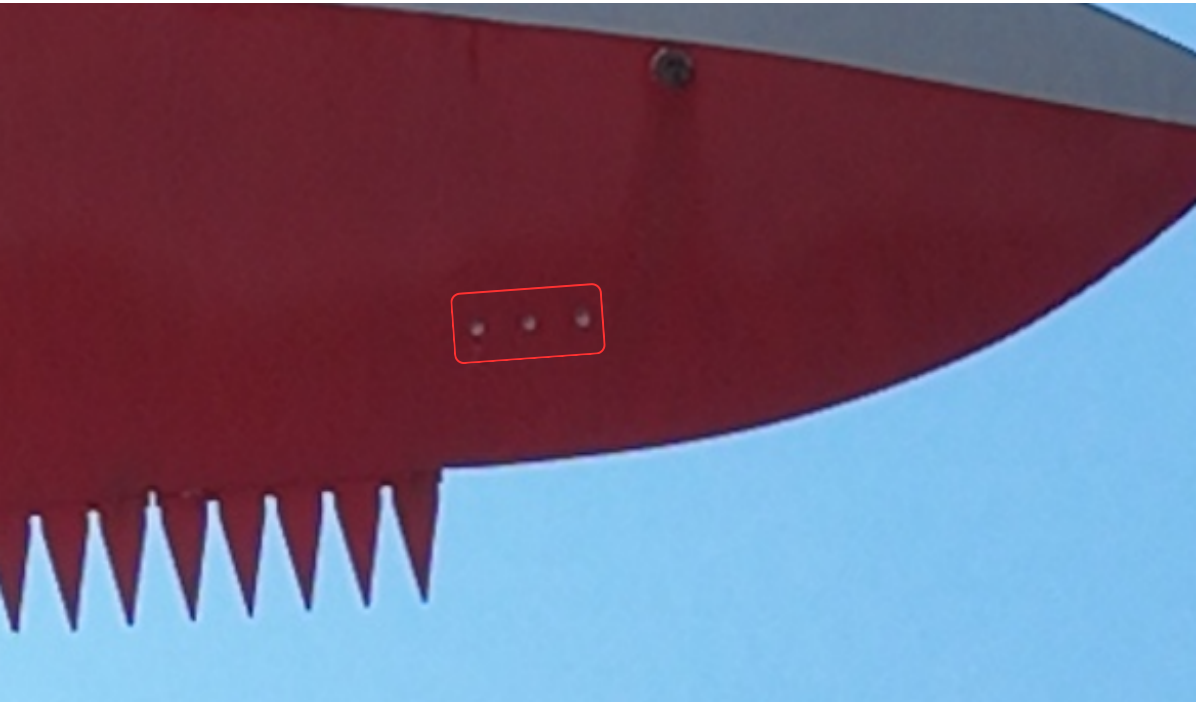
Damage 4

| Blade | C |
|---|---|
| Side | Leading Edge |
| Type | Drainage System |
| Subtype | Damaged or Obstructed |
| Severity | 3 |
