Aviation Investigation Final Report

Location:	Harlingen, Texas	Accident Number:	CEN19FA117
Date & Time:	April 9, 2019, 10:33 Local	Registration:	N7314D
Aircraft:	Air Tractor AT 502	Aircraft Damage:	Destroyed
Defining Event:	Low altitude operation/event	Injuries:	1 Fatal
Flight Conducted Under:	Part 137: Agricultural

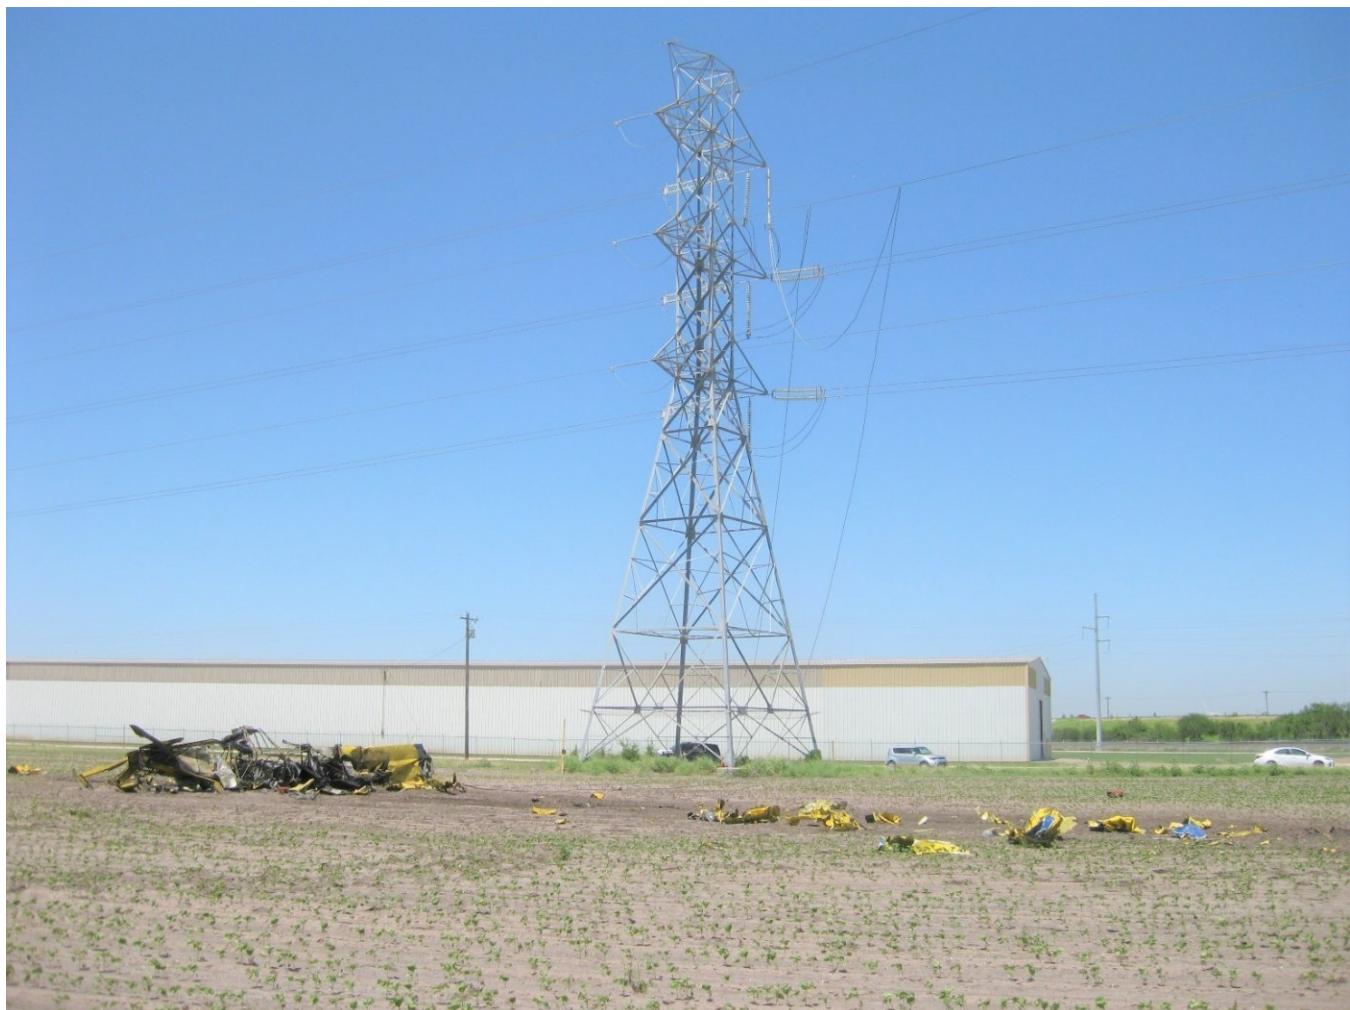
The accident site was in the cotton field that the pilot intended to spray. The airplane impacted two 1.108-inch diameter, 345-kilovolt power transmission cables strung between two 136 ft tall structures along the eastern border of the field. The airplane subsequently impacted the field about 200 ft west of the powerlines (Figure 1). A fan-shaped wreckage debris field extended about 100 ft from the initial ground impact. The overall distribution of the wreckage was consistent with the airplane traveling west-northwest when it impacted the ground. Red navigation lens material from the left wingtip was found at the initial impact with the ground.

Figure 1. Main Wreckage and Impact Debris Path

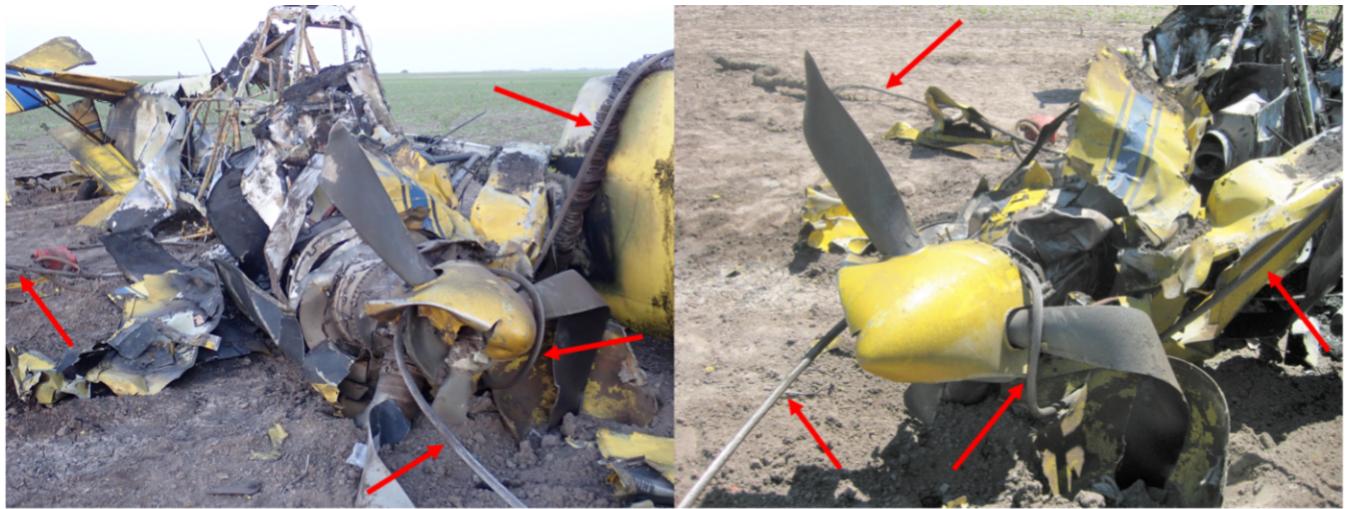
The main wreckage consisted of the fuselage, empennage, right wing, engine, and propeller. The main wreckage exhibited evidence of a prolonged postimpact ground fire. The fuselage was found upright with significant fire damage. All airframe structural components and flight control surfaces were identified at the accident site. Flight control continuity could not be established due to damage; however, all observed separations were consistent with overstress or damage sustained during the postimpact fire. The left wing was highly fragmented during impact. There were two transmission cables conjoined with the main wreckage; one wrapped

around the engine and propeller shaft, and the other wrapped around the wing carry-through structure, right wing, and fuselage (Figure 2 and Figure 3). The forward face of the left main wing spar exhibited broad vertical marks 3-6 ft from the airplane centerline that were consistent with contact with a large diameter power transmission cable (Figure 3). The right wing was largely intact with fire damage to the inboard portion of the wing.

Figure 2 – Power Transmission Cables Conjoined with Main Wreckage (red arrows point to cables)

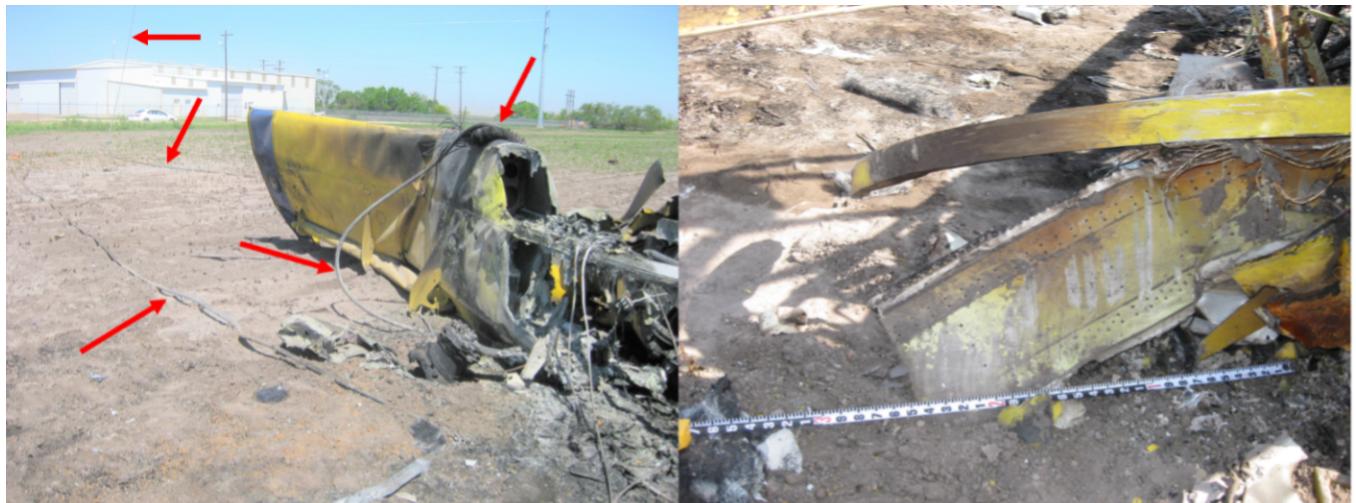
Figure 3 – Power Transmission Cables Conjoined with Right Wing (Left Image) and Cable Impact Marks to the Forward Face of the Left Main Wing Spar (Right Image)
