# Aviation Investigation Final Report

<b>Location:</b>	Upland, California	<b>Accident Number:</b>	WPR19LA129
<b>Date &amp; Time:</b>	May 1, 2019, 10:01 Local	<b>Registration:</b>	N156LZ
<b>Aircraft:</b>	STORCH FL-156C	<b>Aircraft Damage:</b>	Substantial
<b>Defining Event:</b>	Loss of engine power (total)	<b>Injuries:</b>	1 Serious
<b>Flight Conducted Under:</b>	Part 91: General aviation - Personal

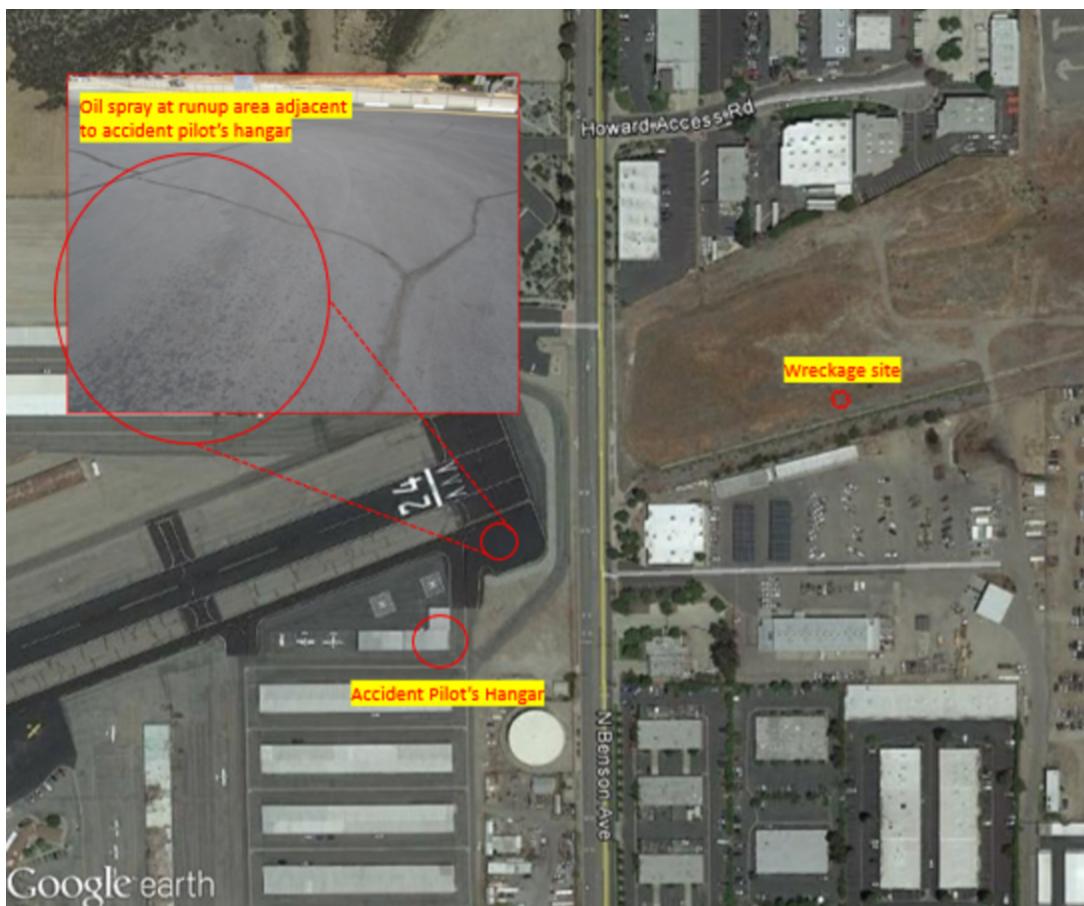
Figure 2. Oil residue discovered on taxiway in relation to pilot's hangar and wreckage site
