Aviation Investigation Final Report

Location: Bismarck, Illinois Accident Number: CEN18LA270

Aircraft: Air Tractor AT 602 Aircraft Damage: Substantial

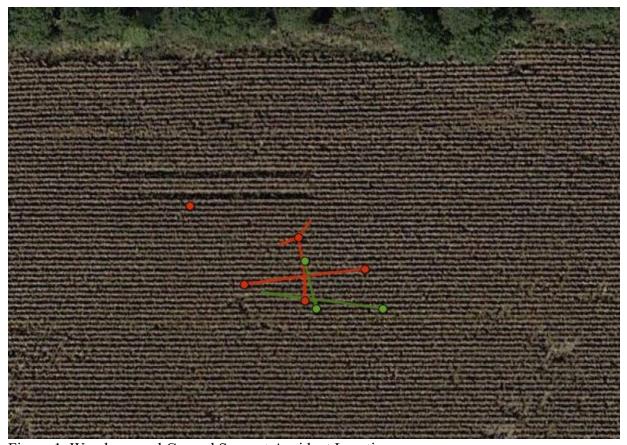
Figure 1. Wreckage and Ground Scars at Accident Location

The wreckage was found upright in the field. Ground scars at accident site were consistent with a wings- and nose-level impact attitude. Figure 1 shows the airplane location (red) and ground scar location (green) overlaid on a satellite image of the field. The single red dot located to the northwest of the main wreckage denotes the location of the rudder, which was found about 50 feet from the fuselage.
