# Aviation Investigation Final Report

<b>Location:</b>	Viborg, South Dakota	<b>Accident Number:</b>	CEN16FA344
<b>Date &amp; Time:</b>	September 2, 2016, 10:00 Local	<b>Registration:</b>	N676DT
<b>Aircraft:</b>	AVES DOUGLAS JAMES RV 6	<b>Aircraft Damage:</b>	Destroyed
<b>Defining Event:</b>	Loss of control in flight	<b>Injuries:</b>	2 Fatal
<b>Flight Conducted Under:</b>	Part 91: General aviation - Personal

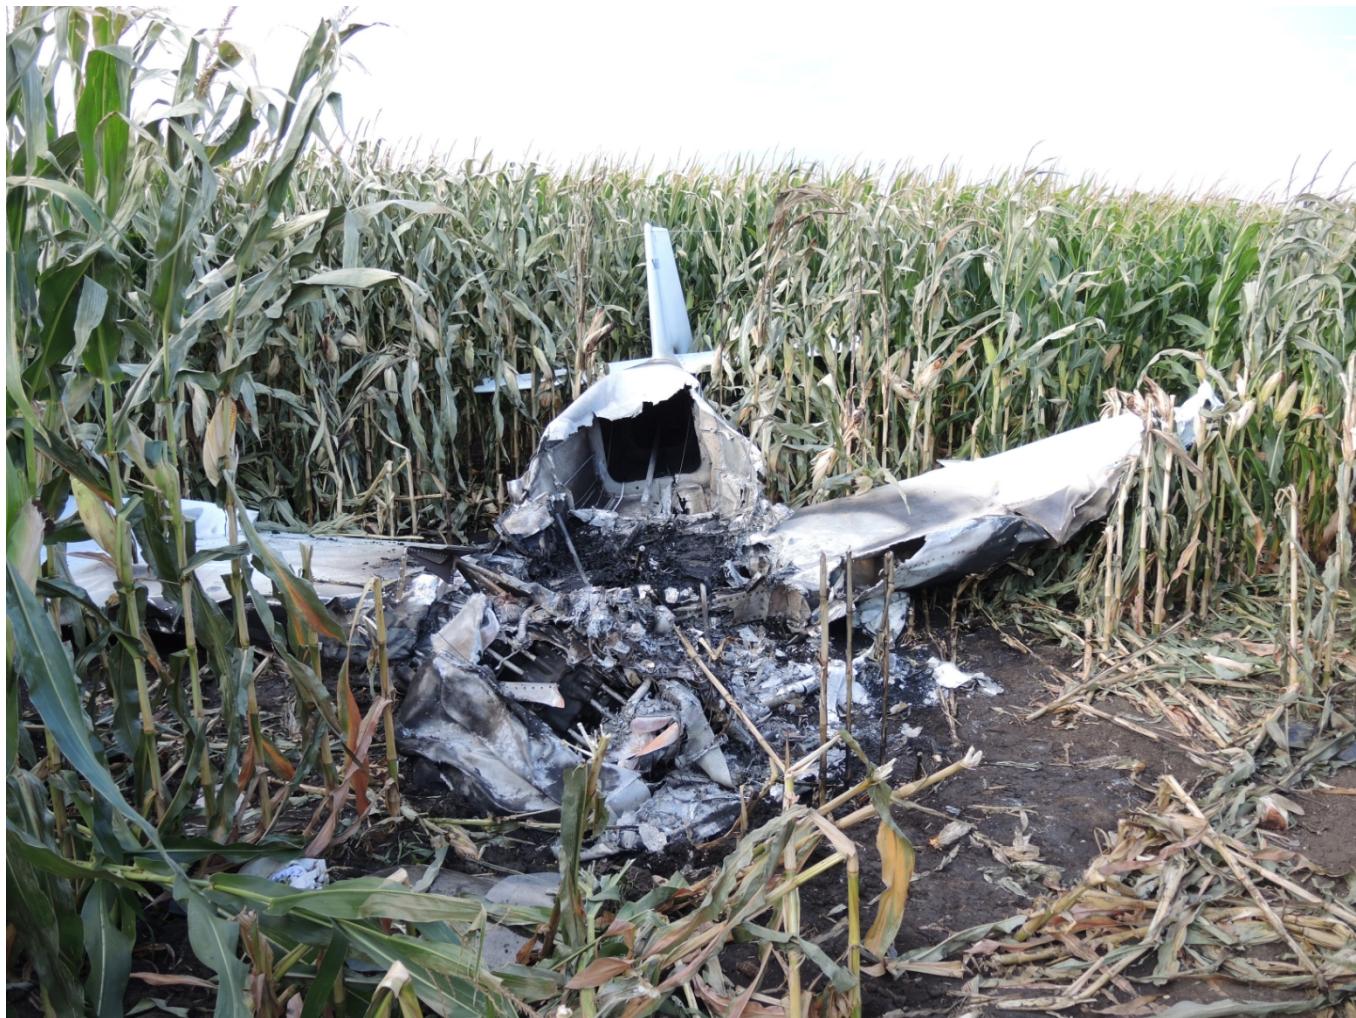
The engine cowling, cockpit, fuselage, and forward portion of the empennage were consumed by a postimpact fire (figure 1).

Figure 1 – The main wreckage viewed from the front

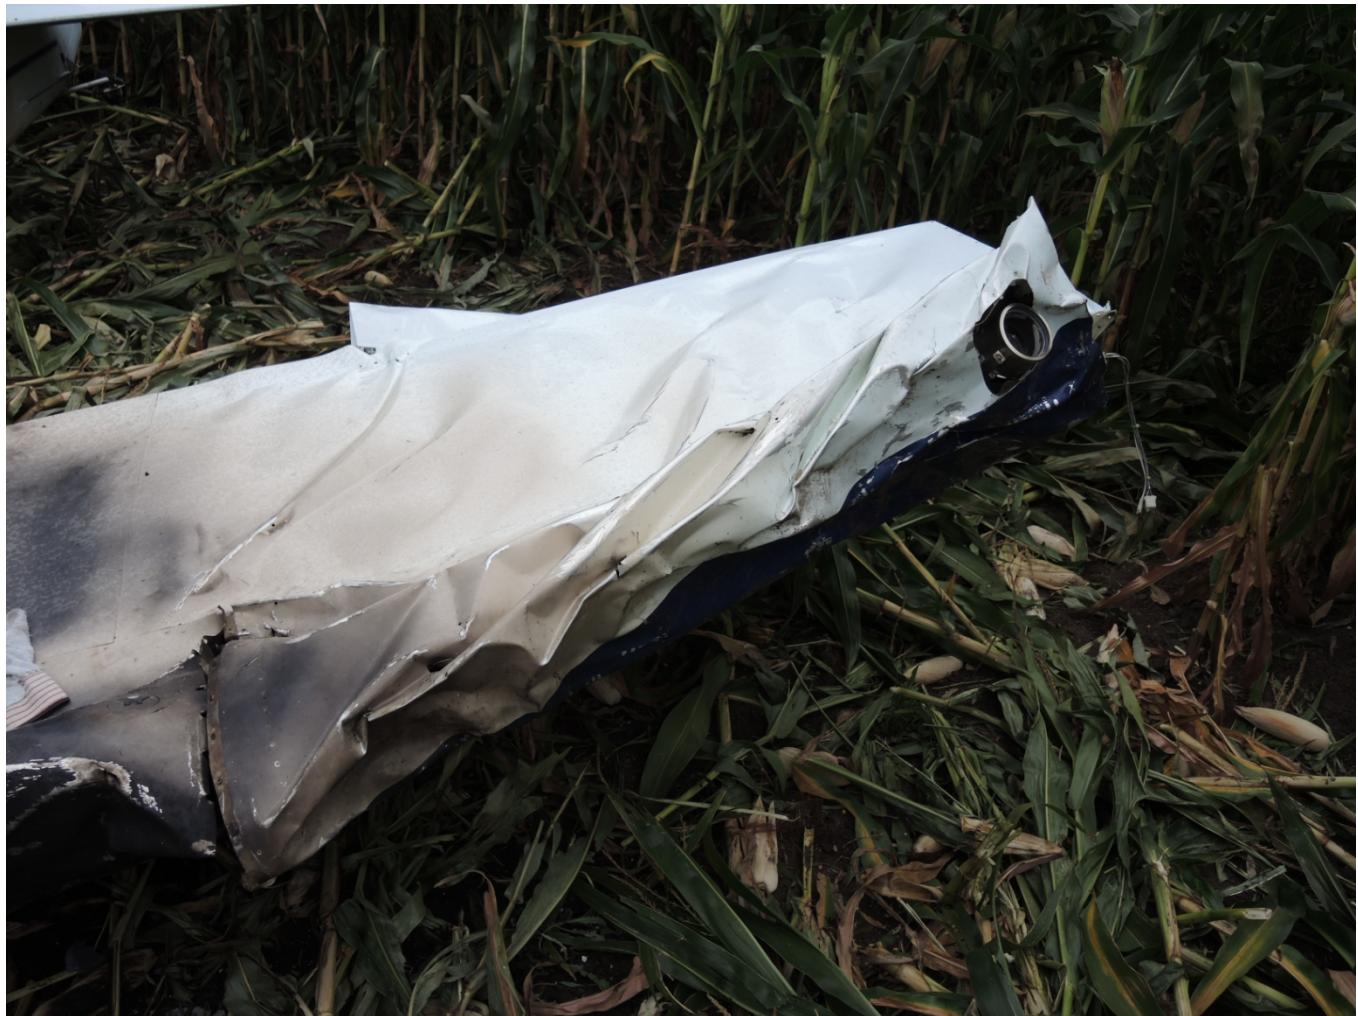
The left wing tip fairing separated from the wing and was found near the forward left side of the wreckage. The left wing exhibited rearward and upward impact crushing signatures (figure 2). Impact

marks were found under the left wing tip. The left flap was partially underneath the left wing and remained attached at the connection points. The left aileron remained partially attached to the wing; the inboard connection remained attached while the outboard connection was impact separated. The left fuel tank was breached.

Figure 2 – Left wing impact damage

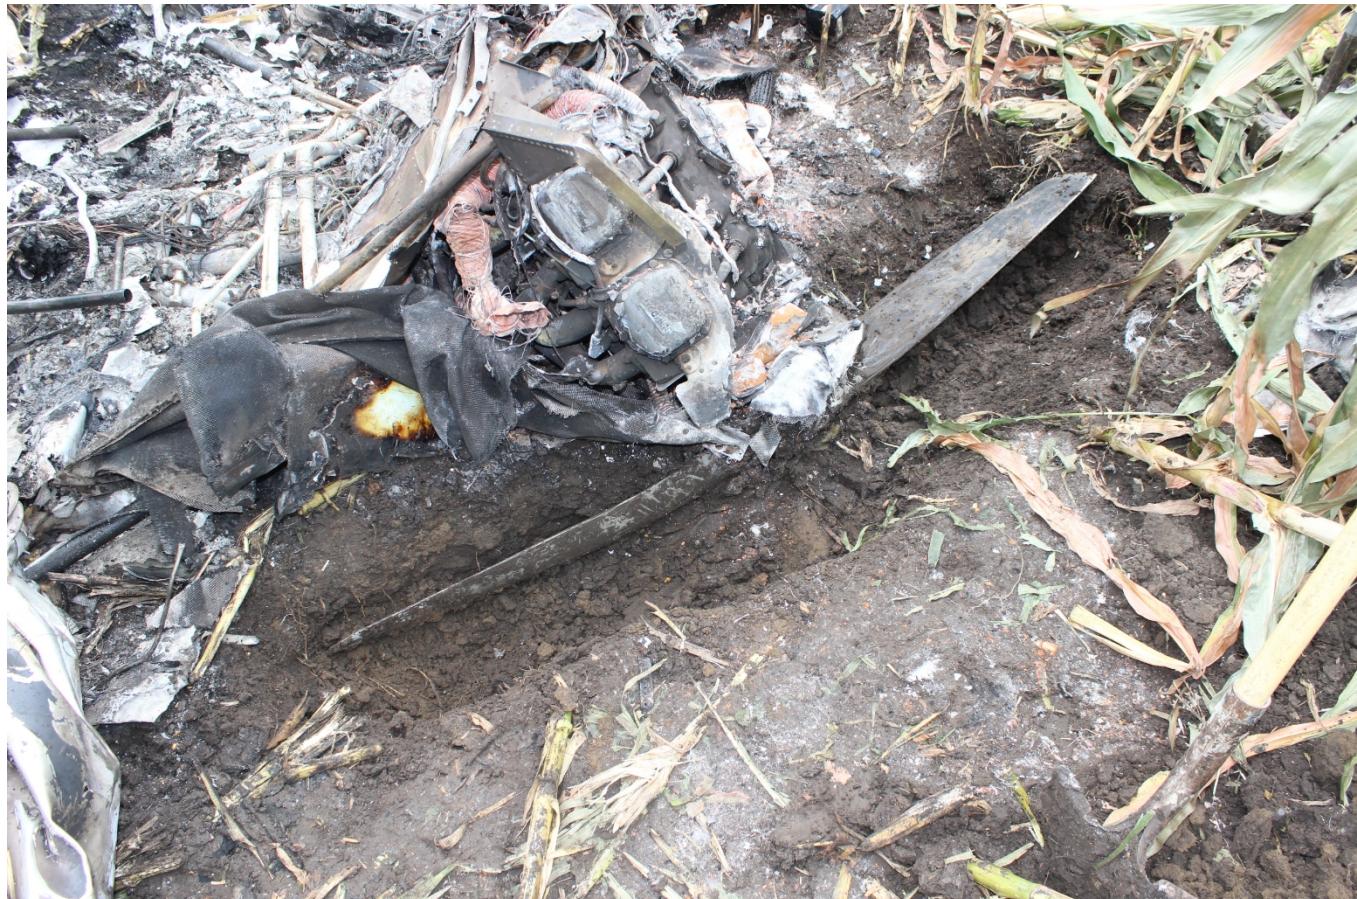
The two-bladed metal propeller remained attached to crankshaft flange. The propeller was embedded in the soil and positioned horizontally (figure 3). The propeller blades were slightly bent aft and did not exhibit any leading edge damage.

Figure 3 – The engine and propeller
