# Aviation Investigation Final Report

<b>Location:</b>	Perkinsville, Arizona	<b>Accident Number:</b>	WPR17FA213
<b>Date &amp; Time:</b>	September 22, 2017, 16:35 Local	<b>Registration:</b>	N7070Q
<b>Aircraft:</b>	Cessna 172L	<b>Aircraft Damage:</b>	Destroyed
<b>Defining Event:</b>	Turbulence encounter	<b>Injuries:</b>	2 Fatal
<b>Flight Conducted Under:</b>	Part 91: General aviation - Personal

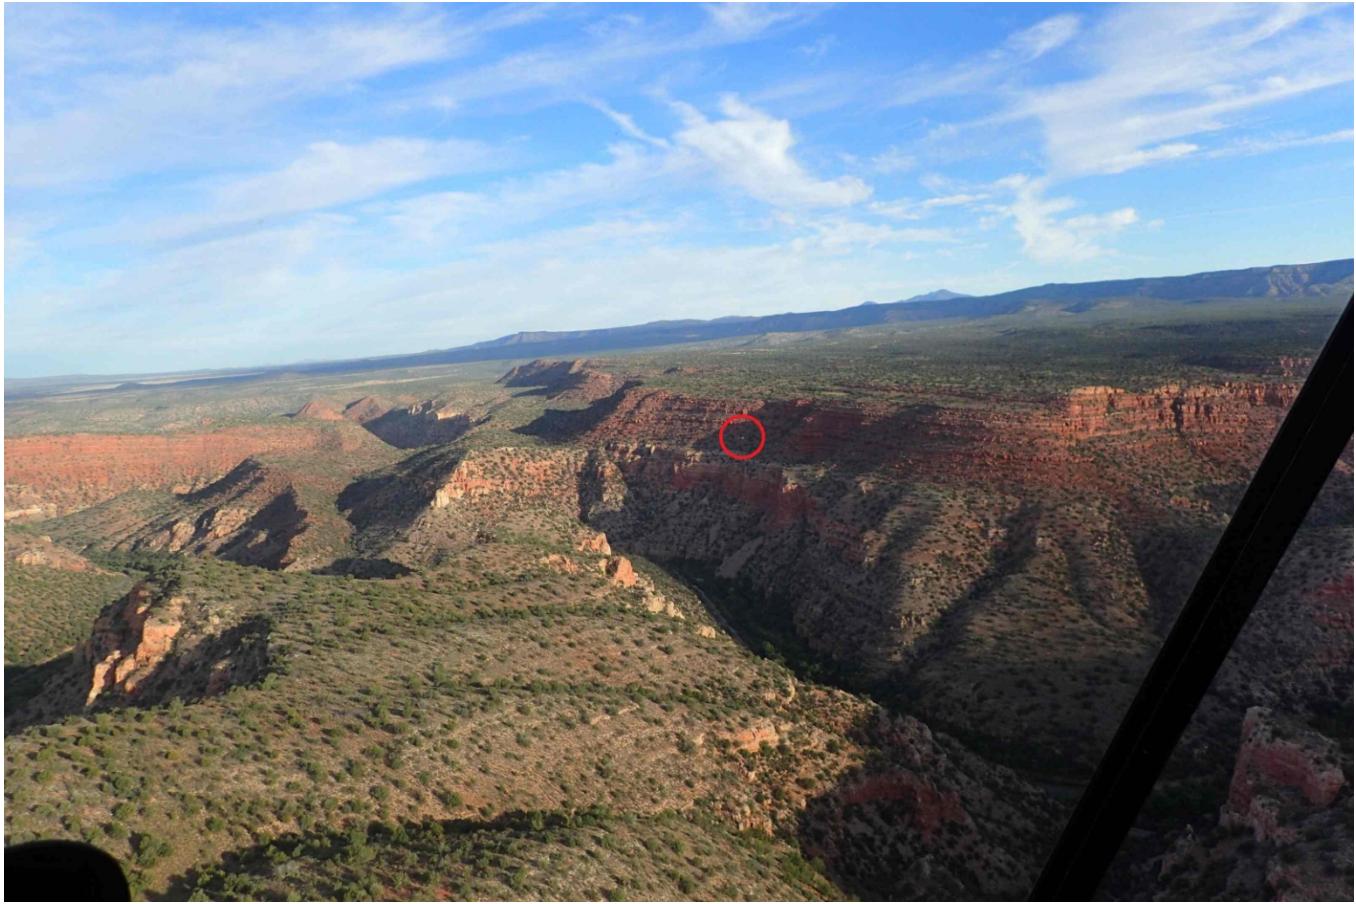
The airplane came to rest at an elevation of 4,290 ft msl on 45° sloping walls at a river turn on the north cut bank of the canyon (See Figures 3, 4). The airplane was located about 200 ft below the canyon rim and 500 ft above the river. The area was strewn with sandstone slabs, rocks, and boulders up to 8 ft in size.

Figure 3 – View of the wreckage site (circled) toward the northwest

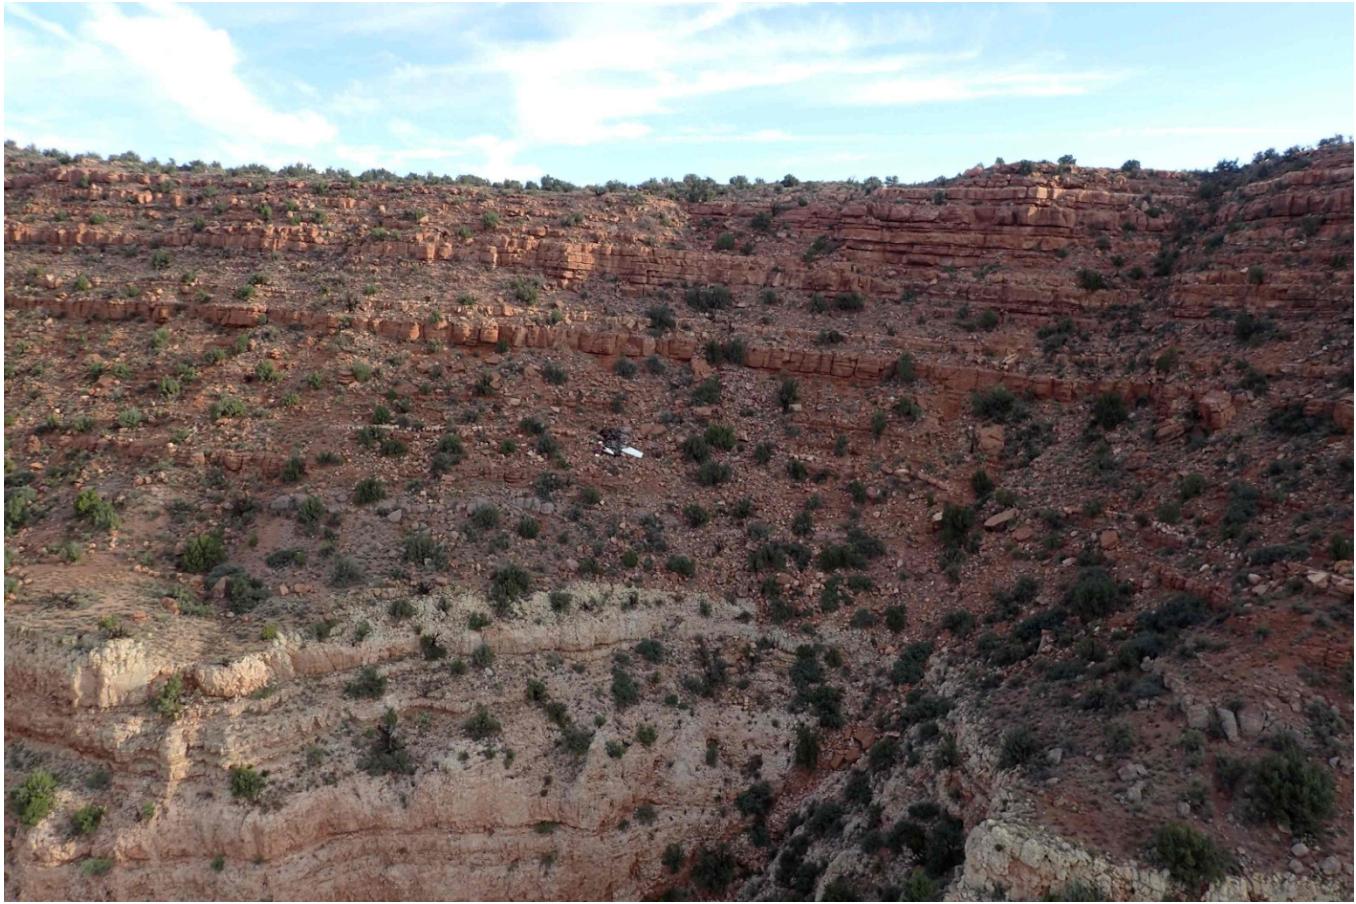
Figure 4 – Wreckage site

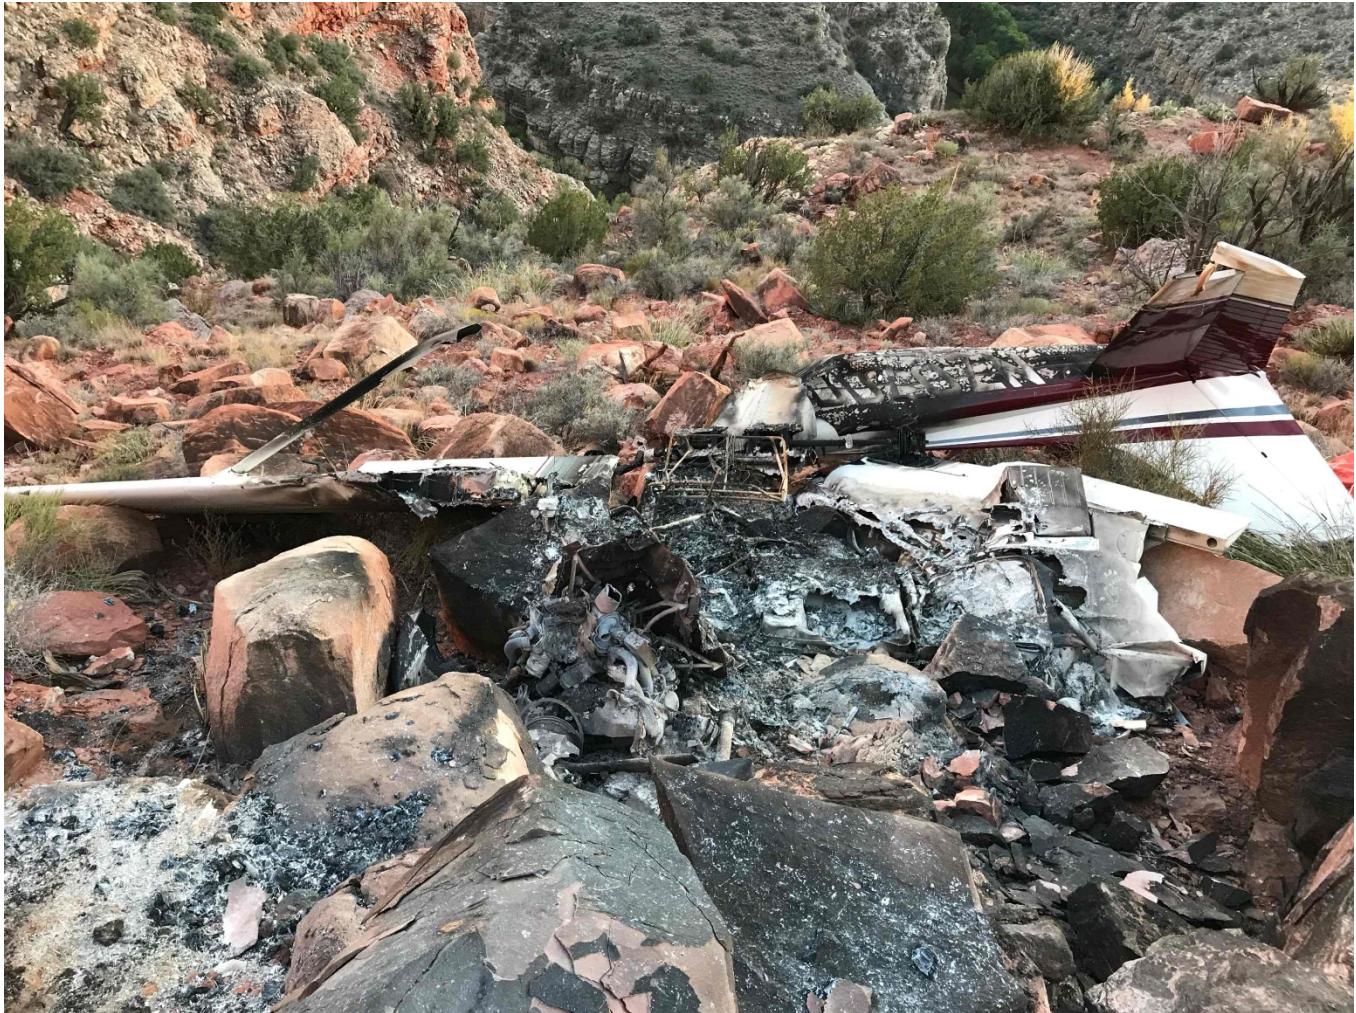
The airplane cabin and wings came to rest inverted on a heading of about 030° true. The aft fuselage and empennage had rotated 90° to the airplane's right, and the outboard right wing had folded underneath itself about midspan. Fire had consumed the main cabin and most of the right wing inboard of the aileron. The empennage and the left wing outboard of the pitot tube remained largely undamaged. The engine and firewall came to rest wedged between a set of boulders on the upsloping side of the wreckage (See Figure 5).

Figure 5 – Wreckage site viewed downhill toward turn in river
