# Aviation Investigation Final Report

<b>Location:</b>	Eagle Lake, Texas	<b>Accident Number:</b>	CEN19FA140
<b>Date &amp; Time:</b>	May 11, 2019, 08:10 Local	<b>Registration:</b>	N713LA
<b>Aircraft:</b>	Air Tractor AT502	<b>Aircraft Damage:</b>	Destroyed
<b>Defining Event:</b>	VFR encounter with IMC	<b>Injuries:</b>	1 Fatal
<b>Flight Conducted Under:</b>	Part 137: Agricultural

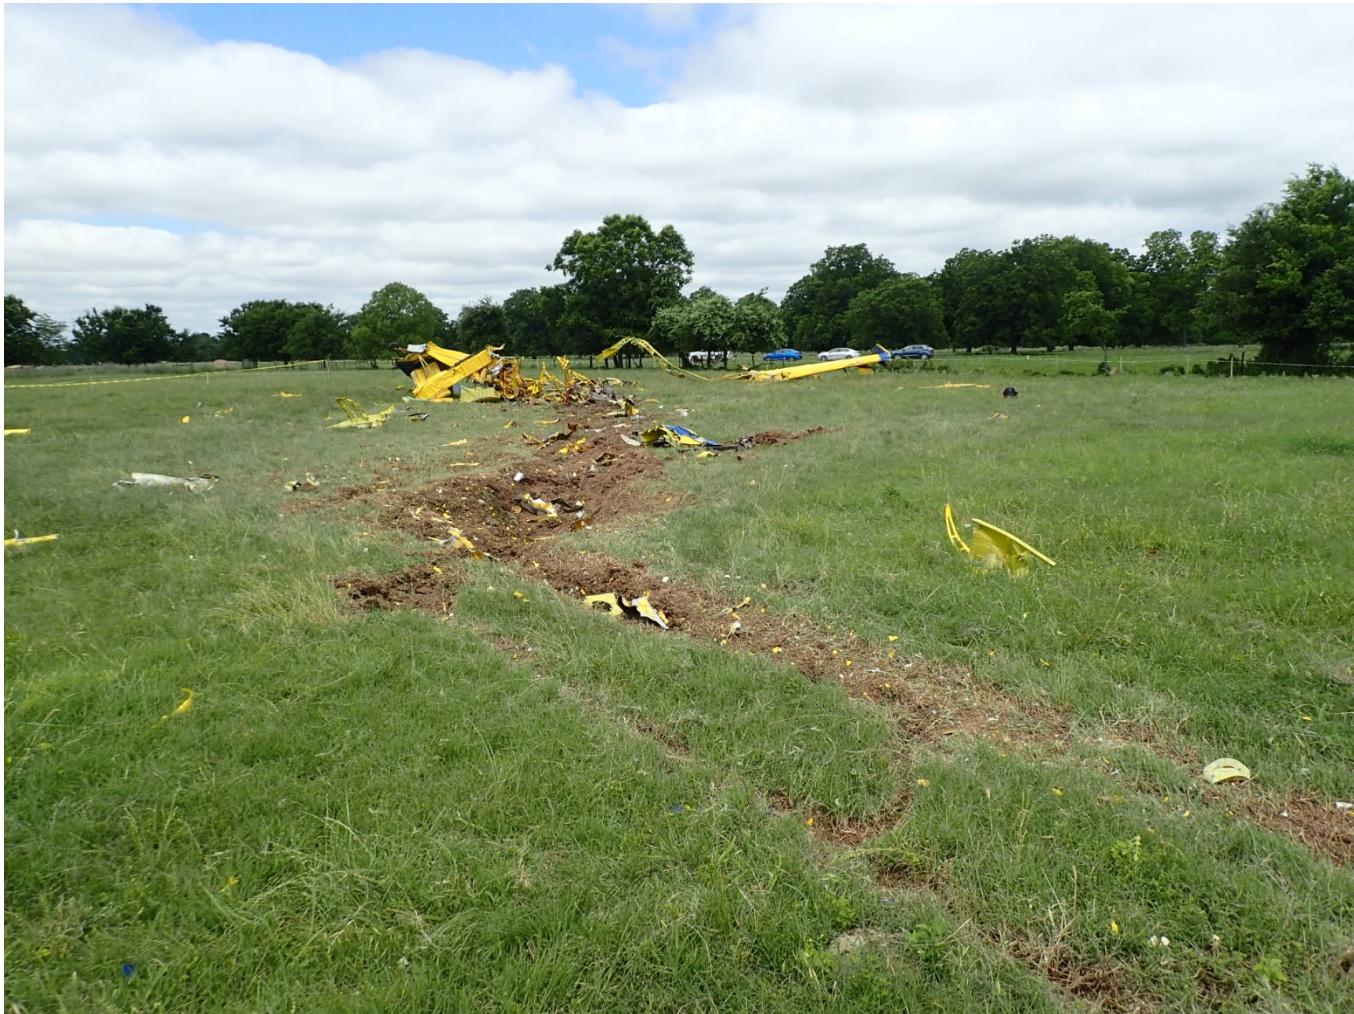
Figure 2 – View of the accident site, with the impact crater and the wreckage, looking to the north.

The accident site was located in a remote, sparsely populated area that was about 7.75 miles northeast of the operator's airstrip and about 4.50 miles north of Garwood at an elevation of about 155 ft mean sea level. The wreckage was found on private land in a flat grass field about 250 ft directly east of the western corner of the field. The trees near the accident site did not display any evidence of impact damage.

During the onsite examination of the airframe, flight control continuity was established to the extent possible, but there were some separations in the flight control system that were consistent with impact forces. All observed separations in the wreckage were consistent with overstress signatures. No preimpact mechanical malfunctions or failures were noted with the airframe.
