Aviation Investigation Final Report

Location:	Santa Rosa Valley, California	Accident Number:	WPR17FA120
Date & Time:	June 4, 2017, 15:29 Local	Registration:	N4871L
Aircraft:	Piper PA 28-180	Aircraft Damage:	Substantial
Defining Event:	Abrupt maneuver	Injuries:	2 Fatal
Flight Conducted Under:	Part 91: General aviation - Personal

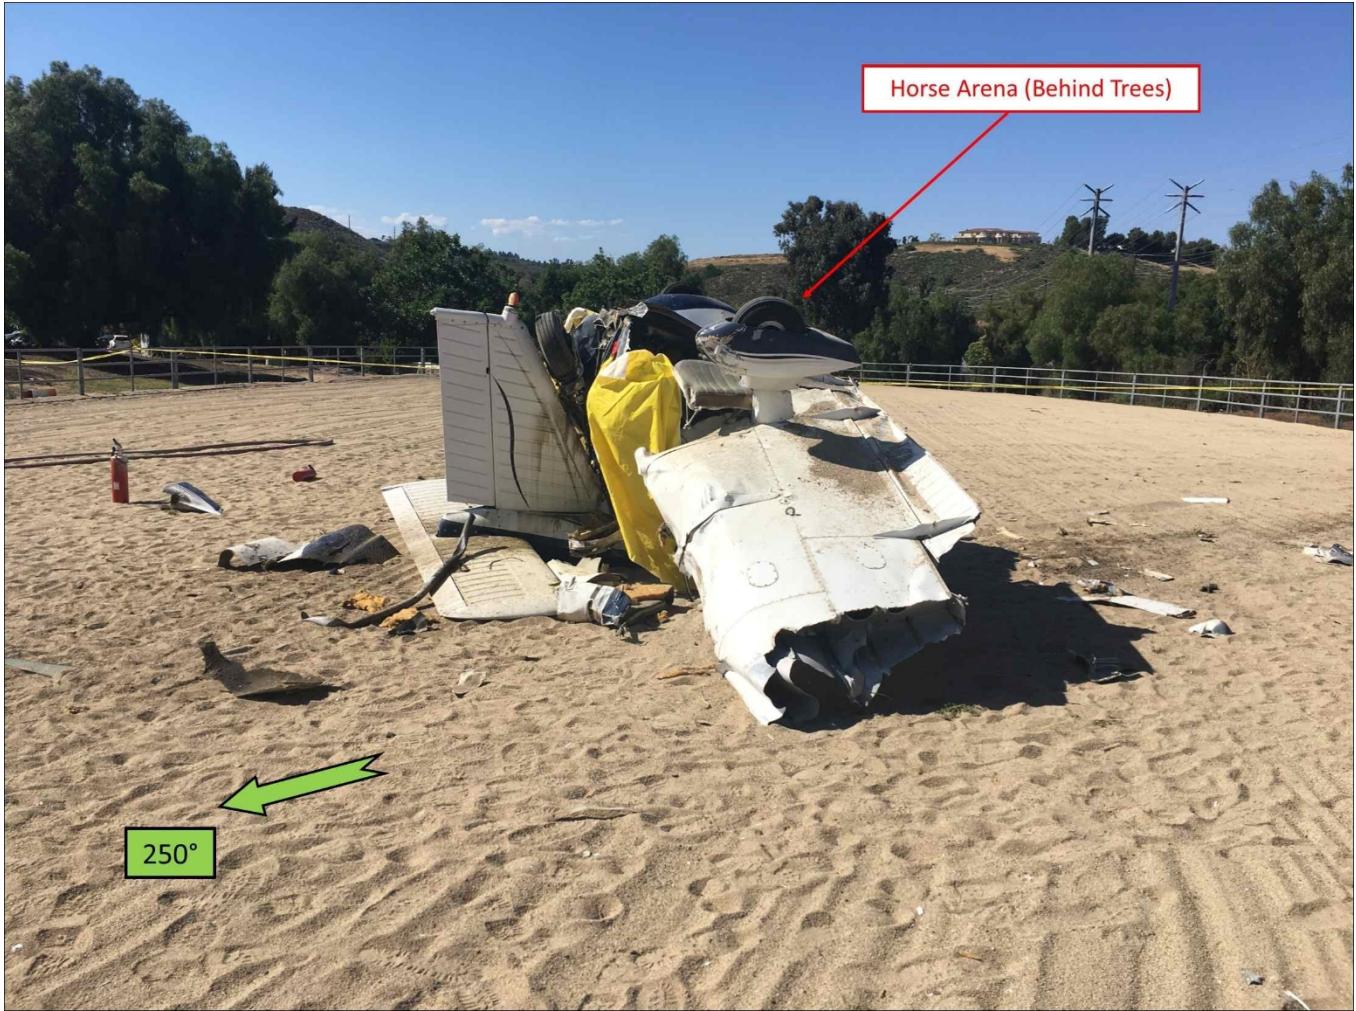
Figure 2 - Accident Site

The arena was bordered to the east by three separate sets of power transmission lines oriented north-south. The lines were positioned about 60, 85, and 180 ft east of the arena edge. The closest two sets of lines were about 65 ft above ground level (agl), with the farthest line about 75 ft agl. The horse arena where the airplane crashed and the arena that the airplane initially overflew were separated by 50- to 80-ft-tall trees (See Figure 2).

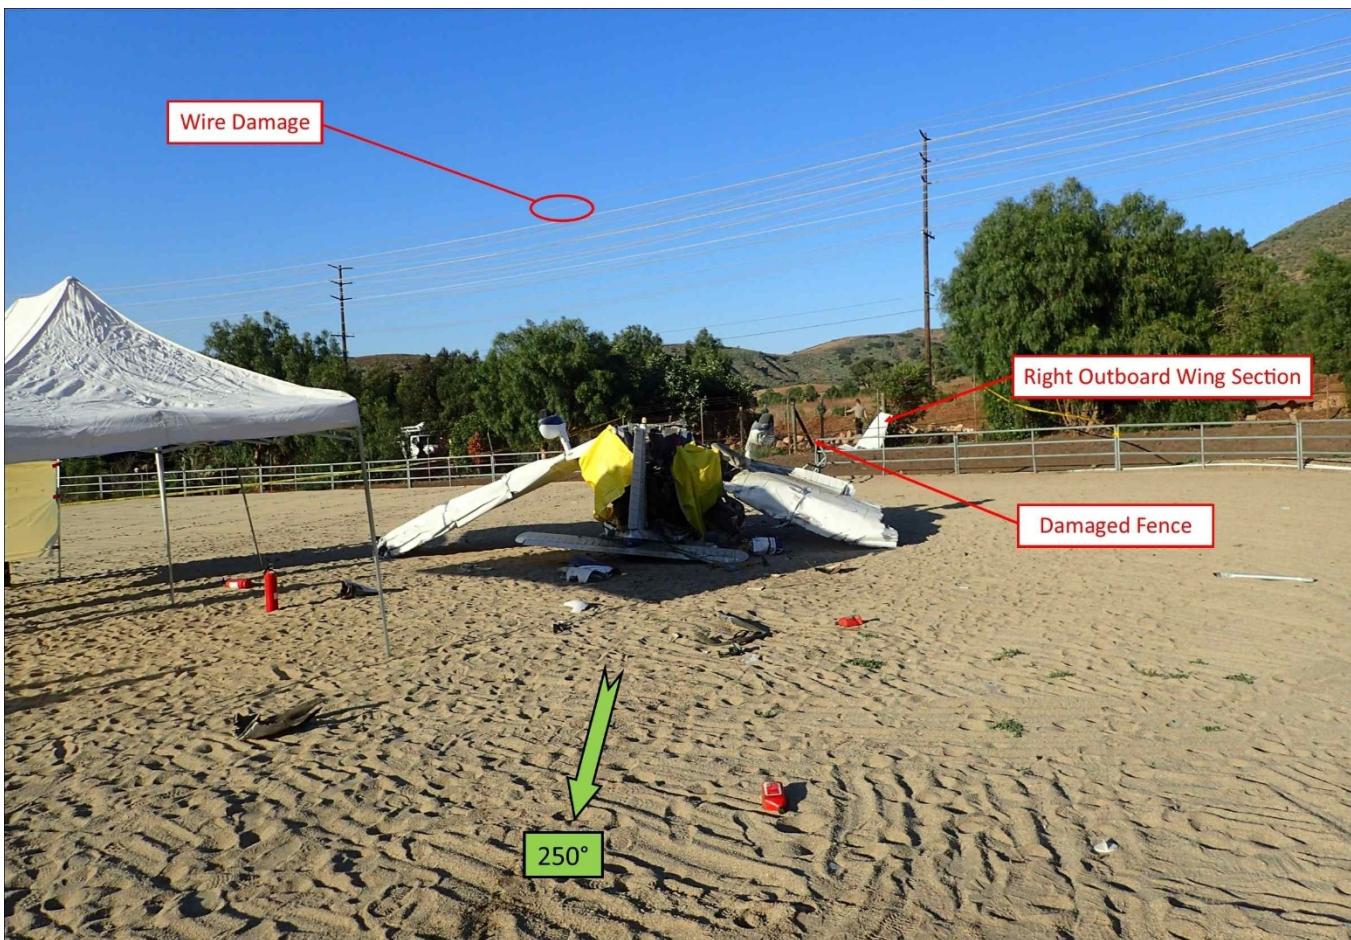
Figure 3 - Accident Site with Power Transmission Lines in the Background

The first identified point of impact was a metallic 4-ft-long transfer mark on the power line closest to the arena (See Figure 3). The outboard right wingtip and aileron section was located about 30 ft south of the mark and exhibited striation marks on the wing leading edge, consistent with power line contact.
